Weights and Weightways at American Lighthouses

By John T. Graham

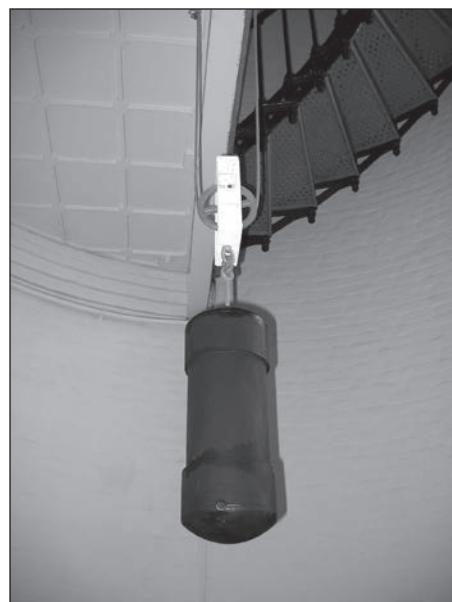
Weight at Pigeon Point, California. Photo by Thomas Tag.

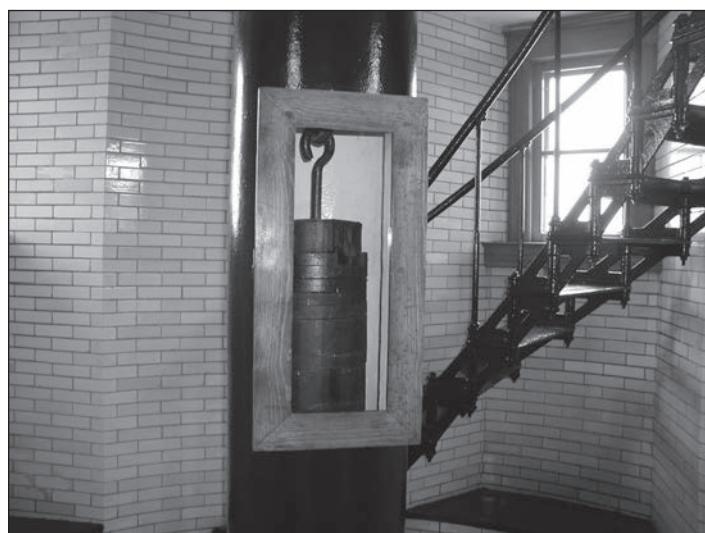
Weights visible in drop tube window, originally an access door. Split Rock, Minnesota. Photo by the author.

A classic example of a dedicated drop tube is still in use at the Split Rock, Minnesota, Lighthouse; the huge bi-valve lens here is still being turned by the weights and clockwork. The tube is separate and distinct from the spiral stairs, which are against and connected to the outside wall of the tower. It actually descends several feet below floor level and has a door at the bottom, accessed via a hatch in the floor. The 180 pounds of weights in use today can be inspected or adjusted via this door or retrieved in the case of a cable break. A second door is several feet above the floor

level. This door was replaced with a glass window to allow visitors to see the weights as they descend. The window also alerts staff that it will be another 45 minutes before the weights bottom out and the lens will stop turning. The weights are intentionally allowed to settle on the bottom of the tube when staff wants to stop the lens rotation.

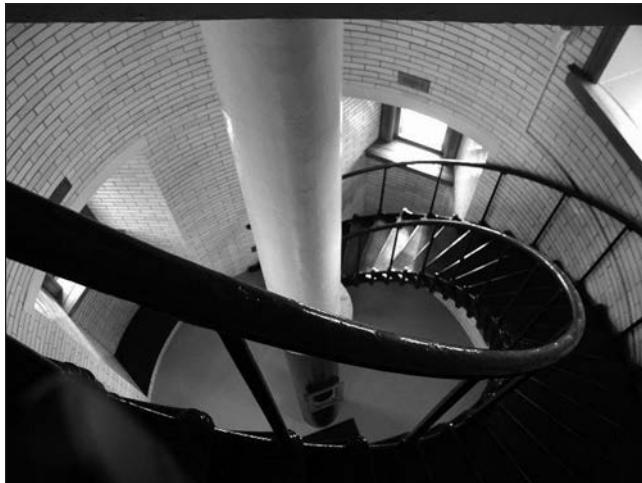
Centered drop tube, Split Rock, Minnesota. Photo by Lee Radzak.

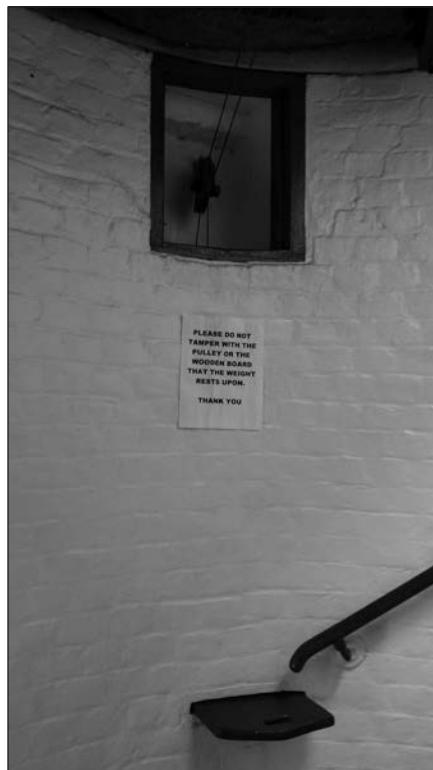
Photo shows both the upper access door and the weight-resting shelf below. White River, Michigan. Photo by Matt Varnum, SPLKA.

A unique additional feature of several of these towers is a horizontal slot in the wall, a few feet below the upper door. A wooden or metal "shelf" could be inserted into this slot. During the day, or when work had to be done on the clockwork, this shelf would be inserted and the weights would be lowered on to it, thus taking the strain off the cable drum of the clockwork.

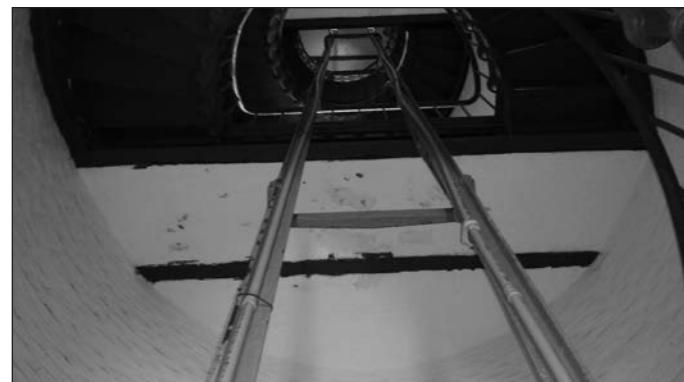
Post 1913 rail system for guiding weights – no longer in use – Cape Hatteras, North Carolina. Photo by Jami Lanier, National Park Service.

The tower at Cape Hatteras, North Carolina, is the tallest in the U.S., thus one would think that once wound up the weights here could descend a long way over a long period of time. This is not the case. The weights here could descend all the way to the bottom. They were not wound all the way to the top, however, but rather only a short distance up from the bottom. (See more information on this system in a section below.)

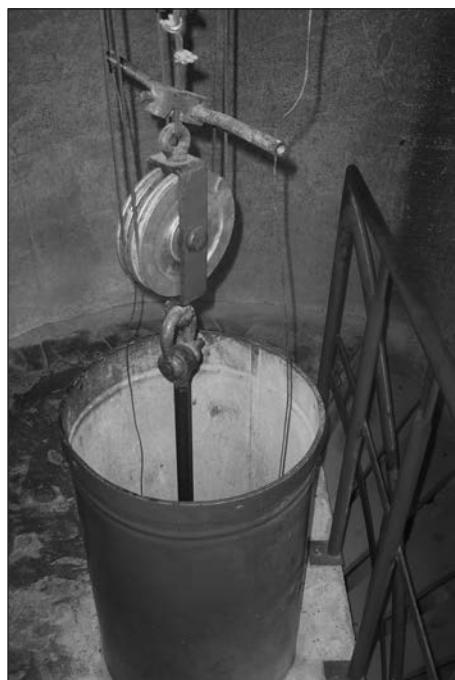
Open top of weight tube, Cap Madeliene, Quebec, Canada. Photo by the author.

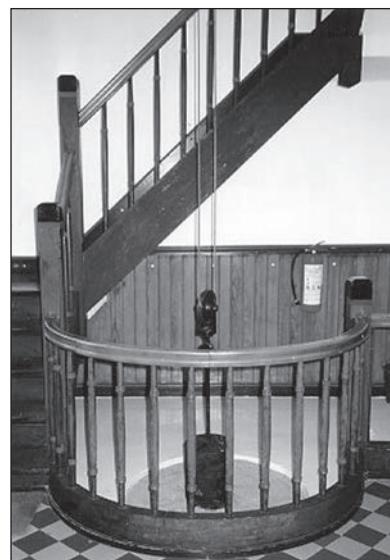
Weight pit, Keldsnor Lighthouse, Denmark. Photo from the Egbert Koch collection, courtesy of Thomas Tag.

in. The photo of the Keldsnor Lighthouse in Denmark that accompanies this article shows the pit filled with sand. Pigeon Point, California; St. Augustine, Florida; and Cape Hatteras, North Carolina, are other lighthouses that have such a pit.

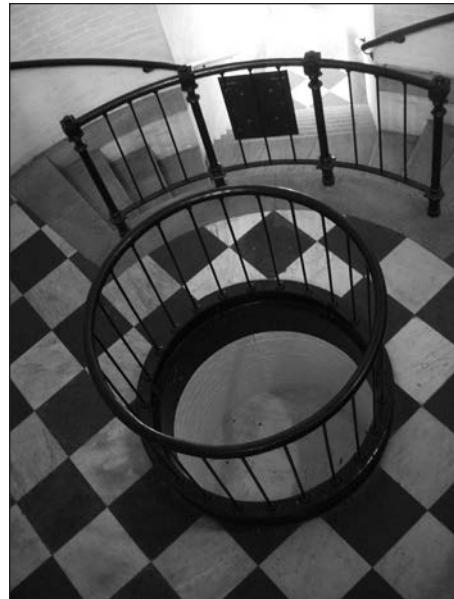
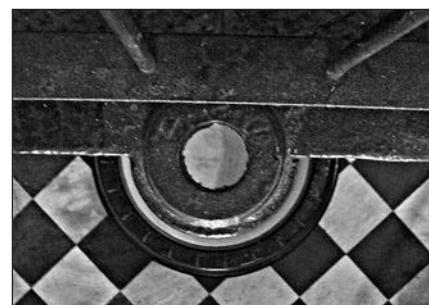
Above: Weight pit, St. Augustine Lighthouse, Florida.

Below: Guide "eye" on landing for the weight cable, centered over the weight pit at St. Augustine. Photos by Kathleen McCormick.

A common feature of the towers in which the weights hung down the center was a well-like pit, approximately four feet in diameter and several feet deep. This was in the center of the floor and usually surrounded by a railing. These pits are usually found where a first-order lens, which required many pounds of weights to turn it, was in a very tall tower. If the cable on which the weights hung should break, the weights could plummet a long way down and potentially do great damage to people or objects in the way or to the tower floor itself. This pit, which was filled with sand, provided a "cushion" onto which the falling weights and cable could land.

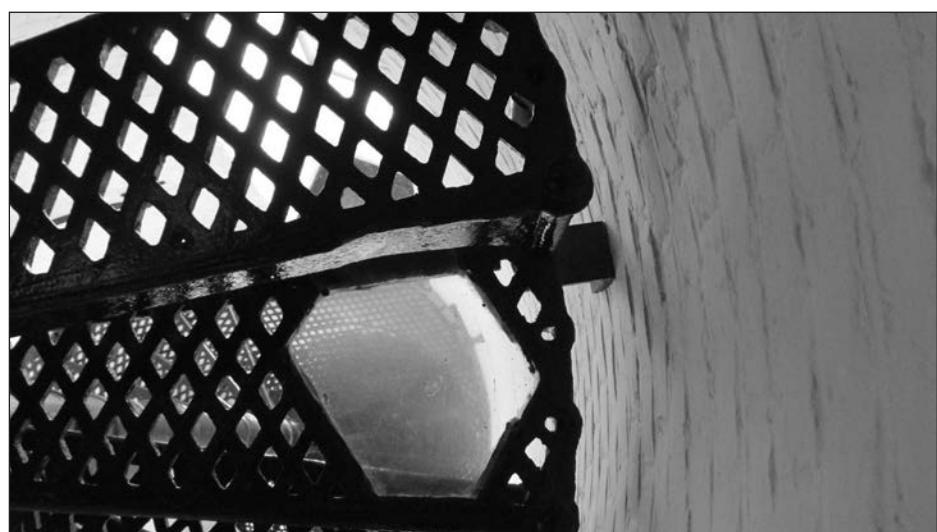
Hole in stairs for weights, Jupiter Inlet, Florida. Photo by Josh Liller.

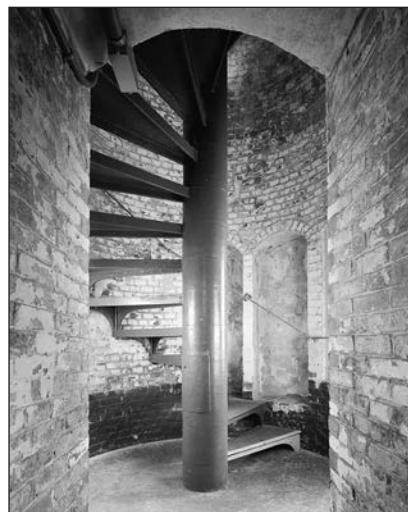
Central stair column that also serves as weight tube, Burnt Island, Maine. U.S. Coast Guard photo.

In towers where the stairs were attached to a central column, this column often served as the weightway as well. This central steel column that supports the stairs is called a “newel post” or simply a “newel.” The Burnt Island, Maine, Lighthouse is one such example. An opening at the bottom of the stair column allowed inspection of the weights as well as retrieval should the cable break. The Fire Island, New York, Lighthouse had another example of this type of weightway, as did that at Sanibel, Florida.

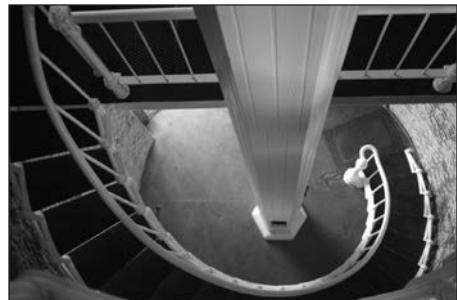
Drop tube, Point Sur, California. Photo by Carol O'Neil.

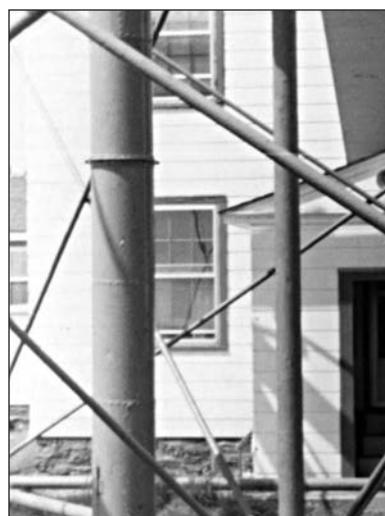
External drop tube of a skeletal tower. Manitou Island, Michigan. U.S. Coast Guard photo.

Photos of the skeletal towers at Detour Point, Michigan, and Manitou Island, Michigan, show that such separate exterior tubes were at these lights at one time also, but I have turned up no evidence of others.

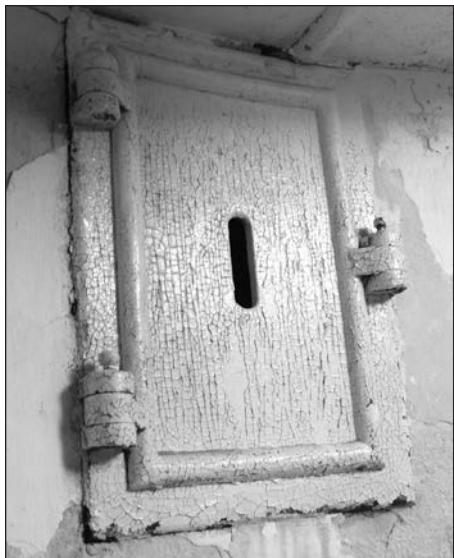
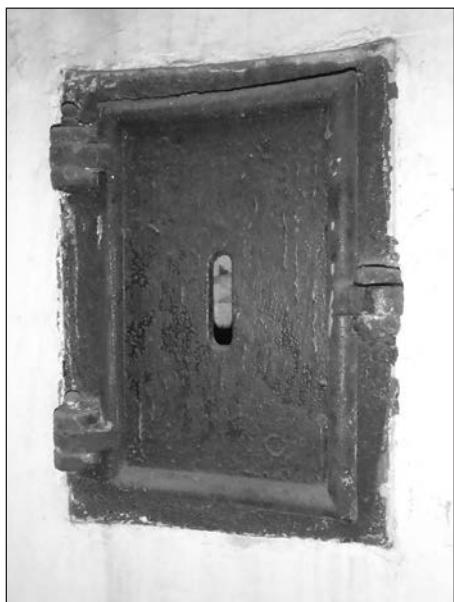
Upper doors into inter-wall space at (above) Cana Island, Wisconsin (photo by Lee Radzak) and (below) Outer Island, Wisconsin (National Park Service photo by David Cooper.)

Special access doors into the between-the-wall space were installed in most of these towers when they were built, even though some of them never displayed a rotating lens. The upper door was located just below the pedestal deck and had a vertical slot through which the cable entered the wall. The cable then went around a pulley inside that upper door and the weights hung down from there. A lower door, without the need for the slot, was located some distance below. Should the cable break, the weights could be retrieved for reinstallation via this lower door.

The lighthouse at Outer Island, Wisconsin, exhibits a unique feature not found in any of the other similar towers—a third access door into the weight channel. This one is located just below the upper door where the cable entered the chamber and is significantly longer than the upper one. When the weights were wound to the uppermost position, they would have been hanging right inside this door and easily accessible for either inspection or for adjustment. If this was the reason for this third larger door, I have no explanation as to why it is not found in any of the other similar towers as well.

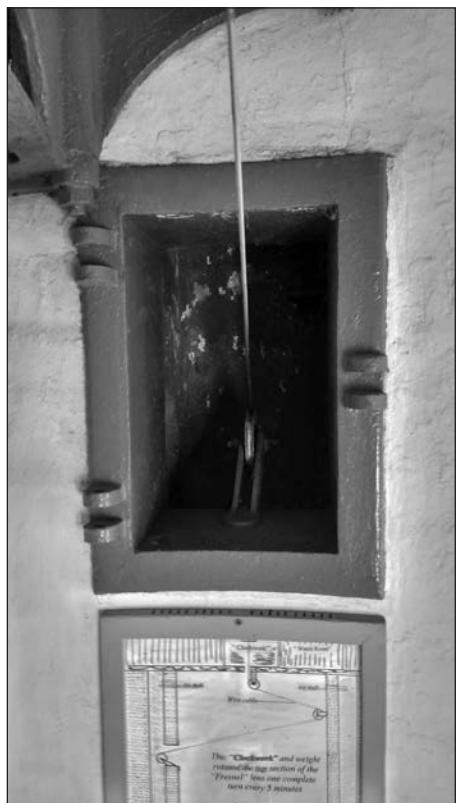
Upper door opening into inner-wall space (door removed), showing cable going around the pulley inside. Little Sable Point, Michigan. Photo by Matt Varnum, SPLKA.
