## Historic Lighthouse Preservation Handbook

The Historic Lighthouse Preservation Handbook was created through a cooperative partnership between the National Park Service, [U.S. Coast Guard](#), Department of Defense Legacy Resource Management Program, and U.S. Lighthouse Society. The 328-page preservation manual, released in August 1997, focuses primarily on the maintenance problems associated with the many different materials and construction techniques used in these unique structures. In addition to

sections devoted to preservation treatments, it includes a brief history of the U.S. Lighthouse Service and lighthouse construction types; existing historic preservation laws, standards, and guidelines; case studies for both lighthouse rehabilitation and restoration projects; related activities (interpretation, funding, safety management, etc.); and sources for more information.

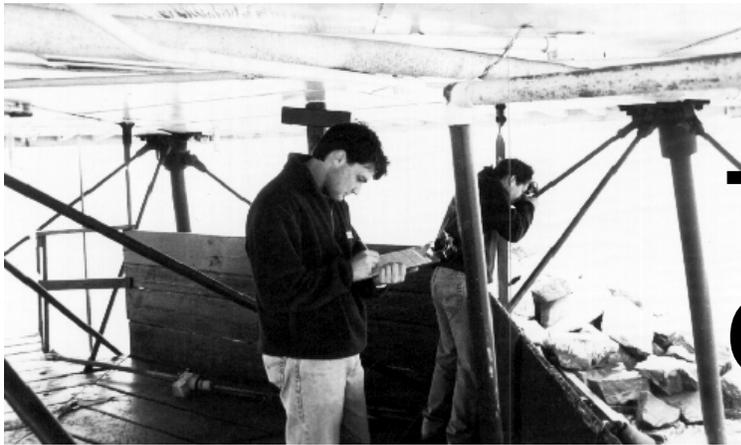
**Figure 1.** Mike Seibert and Paul Neidinger of Williamsport Preservation Training Center perform a condition assessment of Thomas Point Shoals Light Station, Maryland, in 1995.

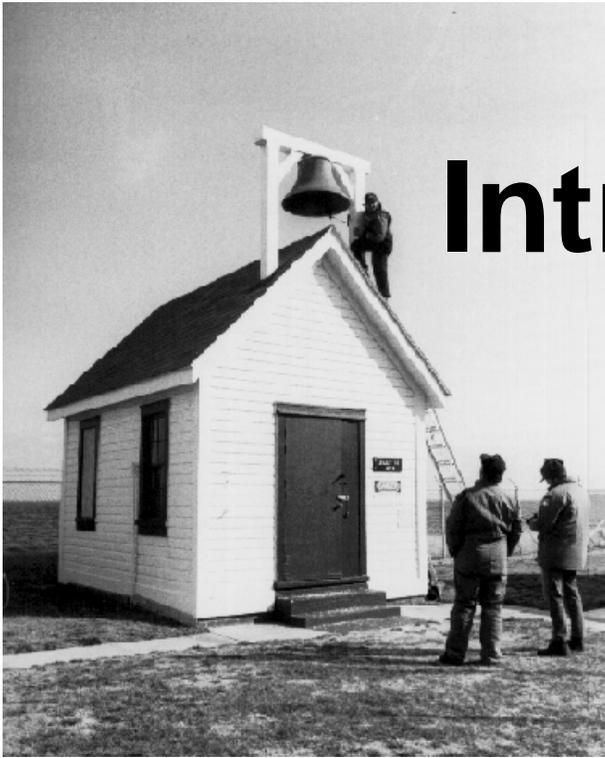
**Figure 1.** Conducting a condition assessment at Cove Point Light Station, near Lusby, Maryland, in 1995.

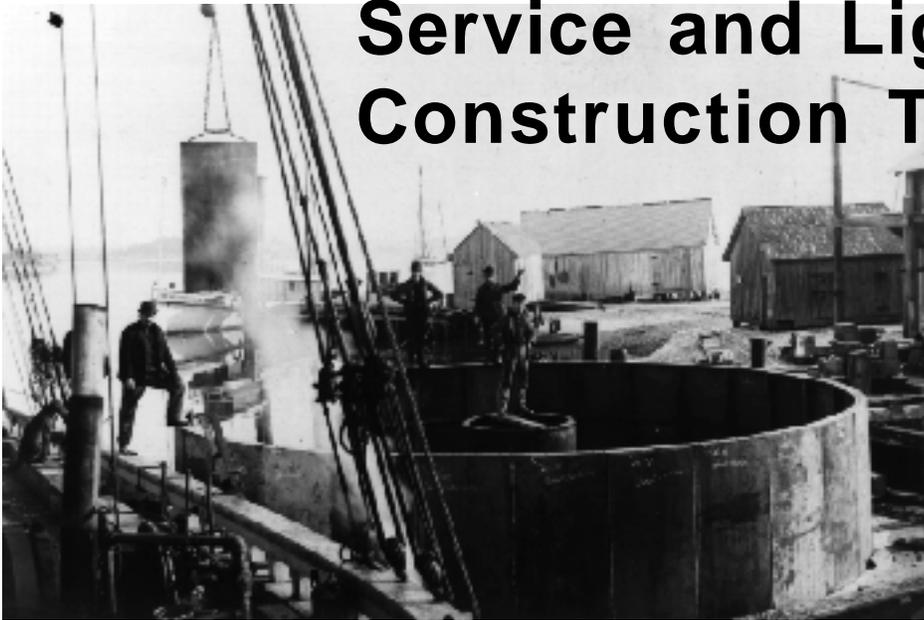
**Figure 1.** Assembly of Point No Point Lighthouse caisson at Solomons, Maryland, before being transported to site in Chesapeake Bay.

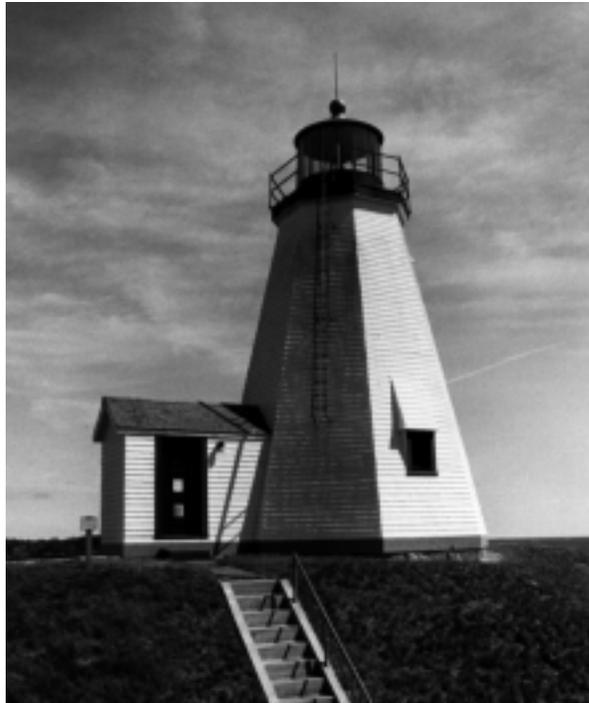
**Figure 3.** Gurnet Point Lighthouse, wooden tower near Plymouth, Massachusetts.

**Wooden tower:** Most early wooden towers have burned and/or been replaced. Prospect Harbor Lighthouse (1891), Maine, is a good example of a stand-alone, conical wooden light tower. Plymouth/Gurnet Point Light (1843),

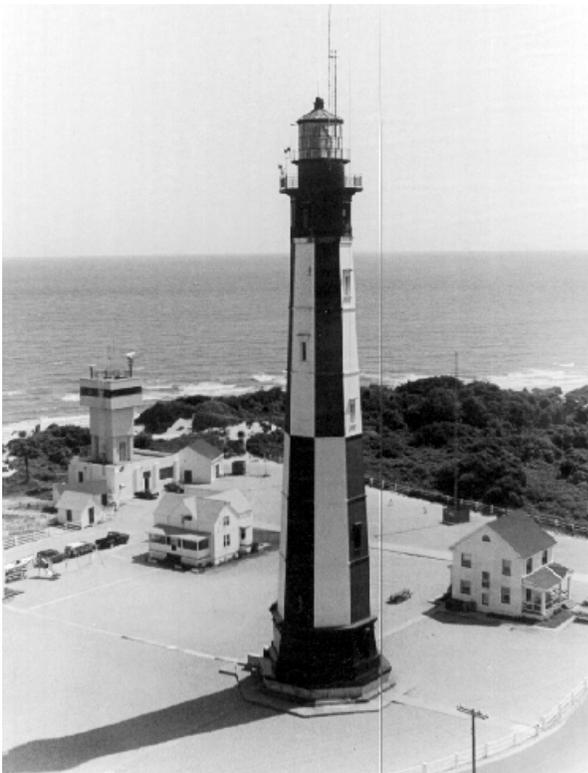
**Figure 4.** Cape Henry Light Station, cast-iron tower, Fort Story, Virginia.

**Cast-iron-plate tower:** Cast iron was lighter than stone or brick, relatively inexpensive, strong, watertight, and had a slow rate of deterioration. The second Cape Henry Lighthouse (1881), Virginia, is the tallest cast-iron-plate tower in the United States at 163 feet. Steel and wrought-iron plate was also sometimes used. This construction type was capable of being dismantled and moved; examples include Cape Canaveral, Florida and Hunting Island, South Carolina.

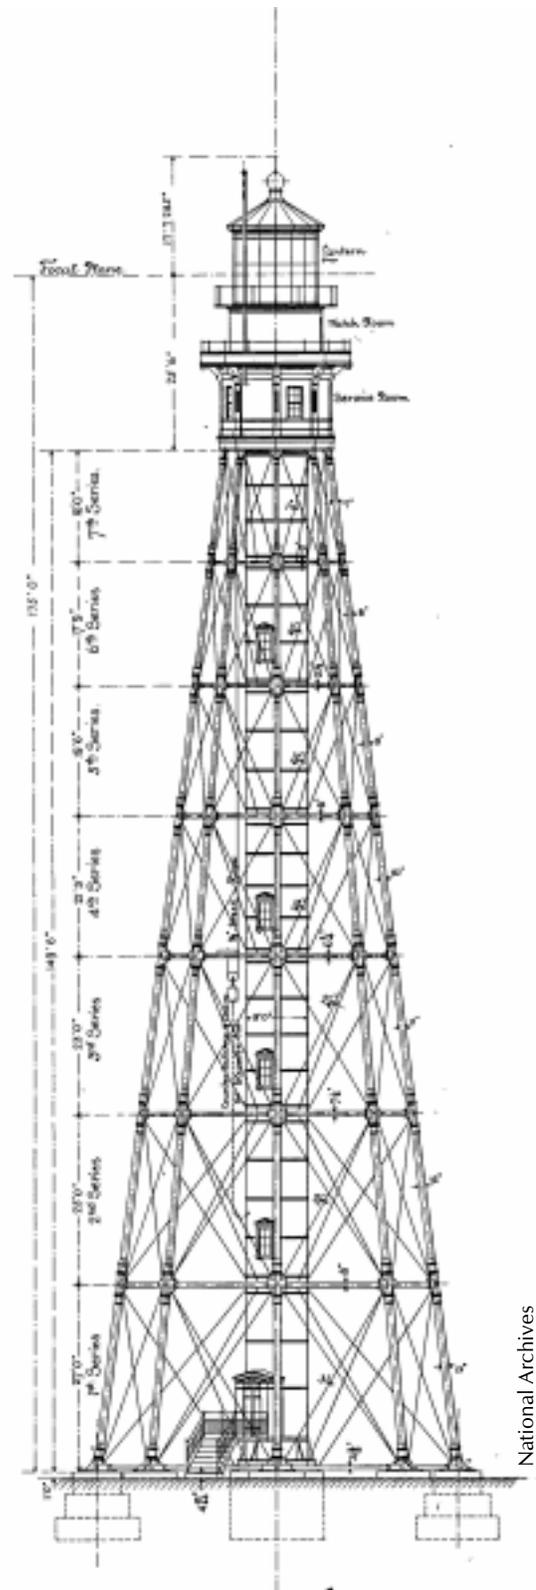
**Figure 5.** Construction drawing for Cape Charles Lighthouse, Virginia, an onshore skeletal tower.

**Skeletal tower:** Onshore skeletal towers were built of metal and were typically constructed on concrete foundations. Offshore skeletal towers were also built of metal and typically constructed with straight or screwpile foundations (discussed below). Manitou Island Lighthouse (1861) and Whitefish Point Lighthouse (1861), Michigan, both built from the same plan, are the earliest onshore skeletal towers built in the United States. Like the cast-iron-plate tower, skeletal towers could also be dismantled and moved.

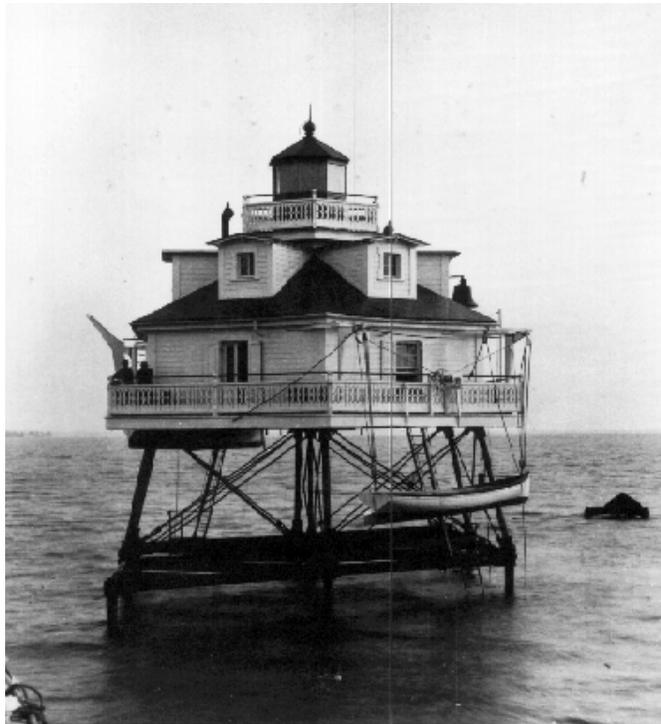
**Figure 6.** Thomas Point Shoals Lighthouse with screwpile foundation located in Maryland's Chesapeake Bay; shown here in 1885.

- Thomas Point Shoals Light Station, Maryland, built in 1875, is the last largely unaltered spider-foundation cottage-type screwpile lighthouse in the United States. As such, it is significant for American architecture and engineering.

**Screwpile:** To increase the holding power of the pile, a screw-like flange was fastened to the bottom of the pile and wound like a screw into the substrate. There are two principal screwpile type lighthouses, 1) low spider-like foundations for rivers, bays, and sounds, and 2) tall offshore coastal towers. Perhaps as many as 100 spider-like screwpile lighthouses were built throughout the Carolina sounds, the Chesapeake Bay, Delaware Bay, along the Gulf of Mexico, and one even at Maumee Bay (1855) on Lake Erie in Ohio. Thomas Point Shoals Lighthouse (1875), Maryland, is the oldest extant, unmoved, spider-like screwpile lighthouse in the United States. The first of the tall skeletal screwpile coastal towers built in the United States was Carysfort Reef Lighthouse (1852), Florida, which still stands. A few offshore screwpile skeletal tower lighthouses built on coral reefs used foot plates or disks to help disperse the weight of the tower. Examples in the Florida Keys include Carysfort Reef Lighthouse (1852), Fowey Rocks Lighthouse (1878), and American Shoal Lighthouse (1880).

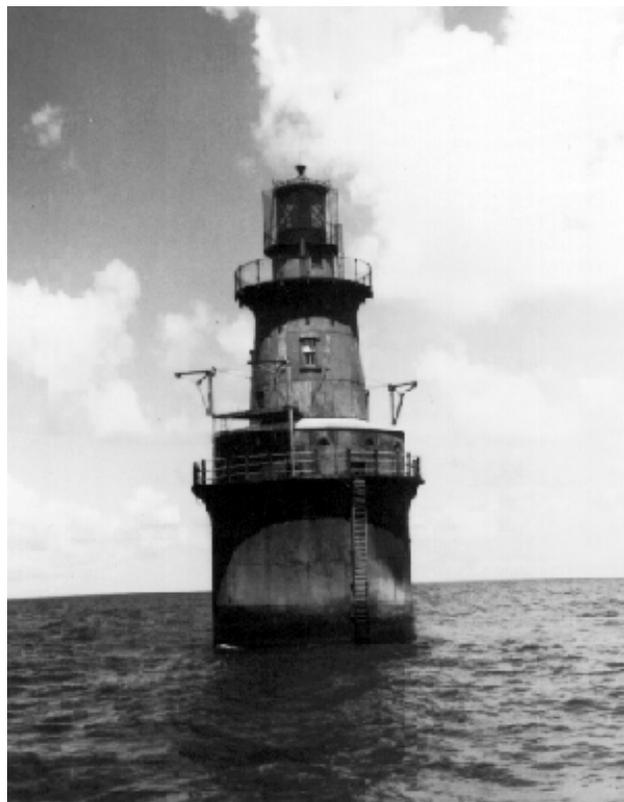
**Figure 7.** Sabine Bank Lighthouse with caisson foundation in Texas.

<sup>6</sup> The caisson type lighthouse, though superior to the screwpile lighthouse type as far as stability is concerned—especially in northern locations where ice flow conditions exist, did not prove satisfactory for offshore ocean locations because of severe bottom scouring. In the late 1880s, a 54-foot-diameter pneumatic caisson foundation with a tall steel light tower was sunk off Diamond Shoals, thirteen miles off the shore from Cape Hatteras, North Carolina. But water currents scoured the site and tilted it out of level. The contractors gave up in disgust as did the Lighthouse Board after a few more unsuccessful attempts. (Wayne C. Wheeler, "Diamond Shoal Lighthouse: The Lighthouse That Never Was," *Keeper's Log* (1988) 4(3):24-29.)

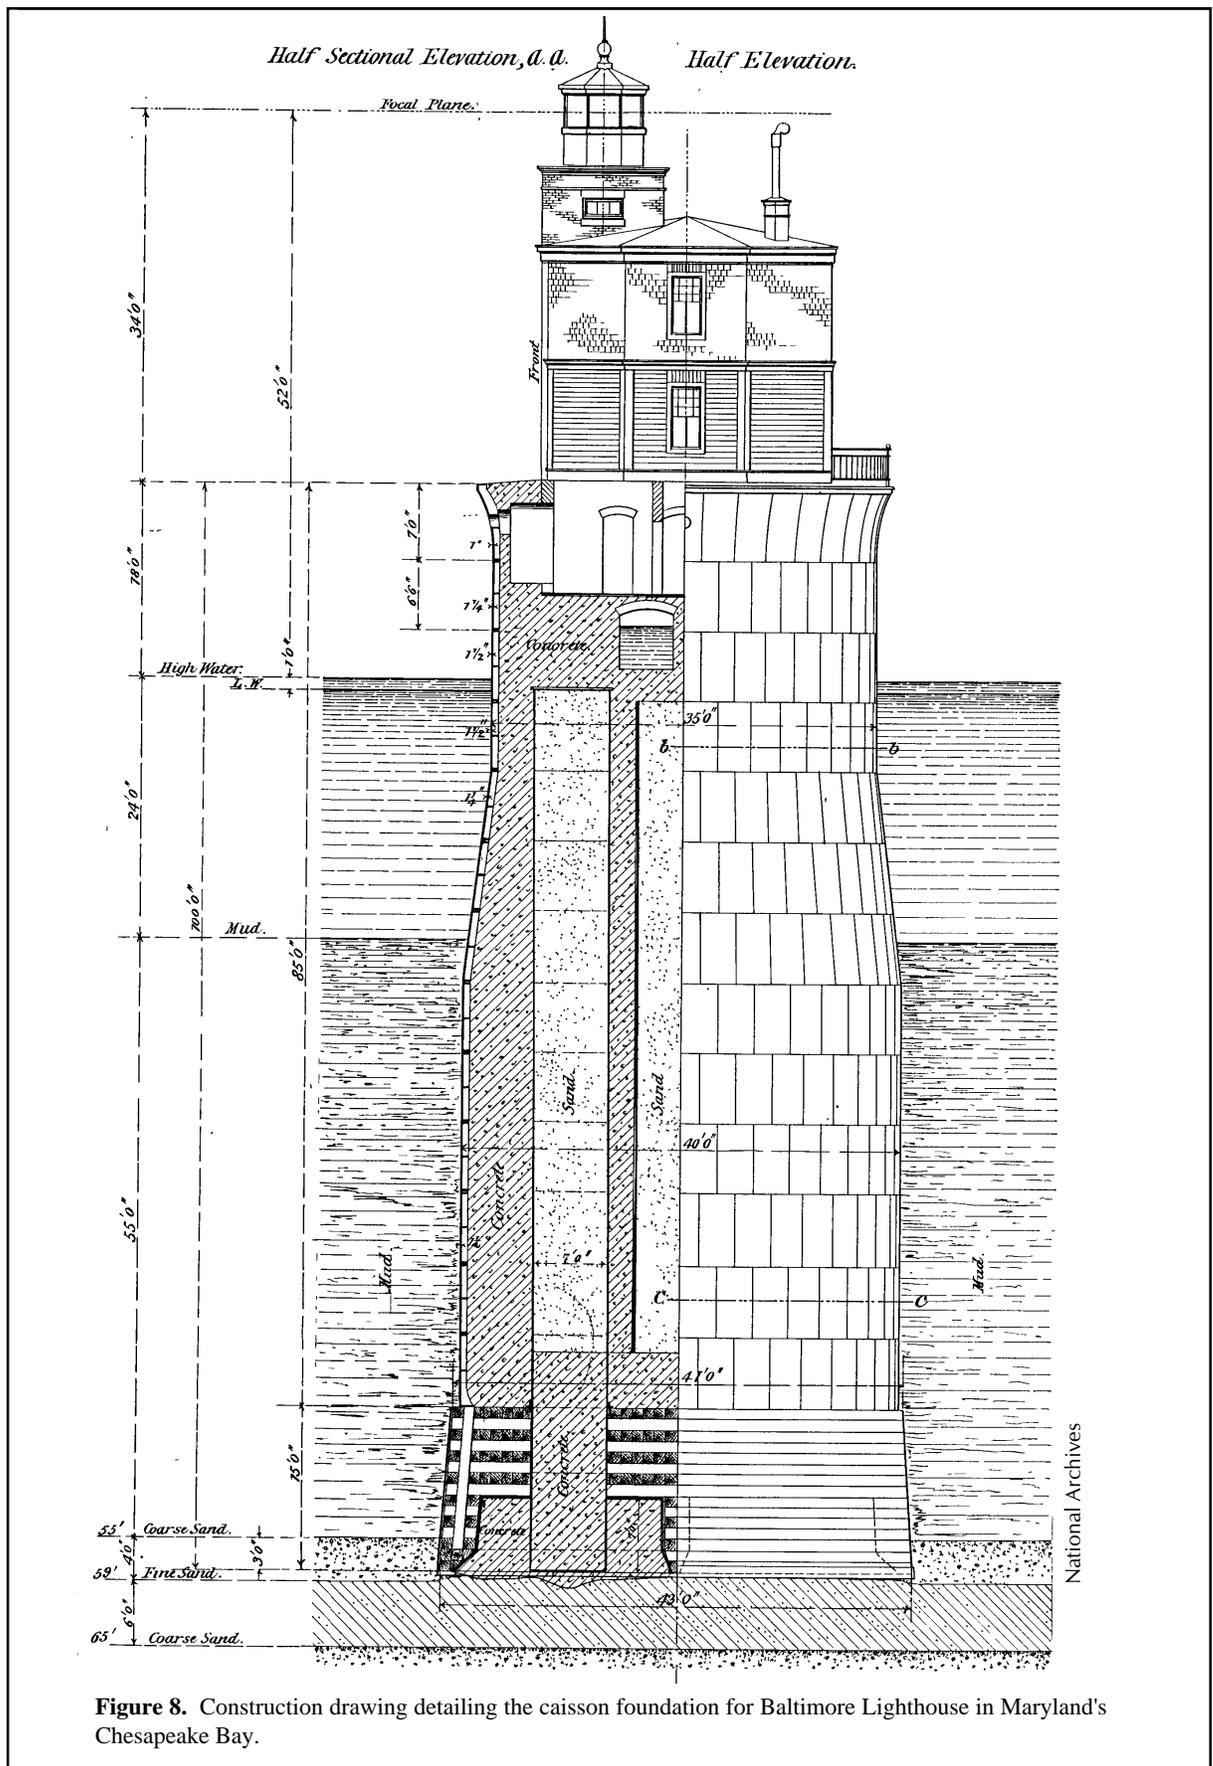
**Figure 8.** Construction drawing detailing the caisson foundation for Baltimore Lighthouse in Maryland's Chesapeake Bay.

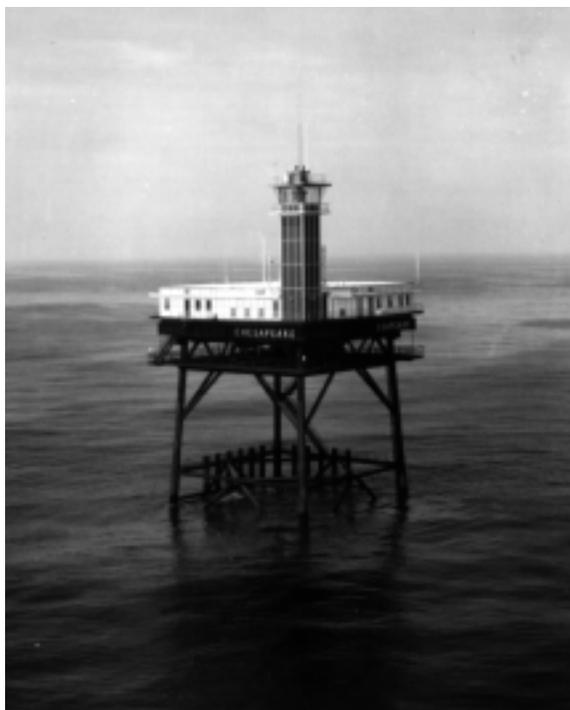
**Figure 9.** Chesapeake Light Station, Texas tower at entrance to Chesapeake Bay.

**Texas Tower Type:** A relatively recent technological development in lighthouse construction was the Texas tower type which replaced exposed lightships offshore. These so-called Texas towers were adaptations modeled on the offshore oil drilling platforms first employed off the Texas coast. The first Texas tower lighthouse in the United States was the Buzzards Bay Light, located in Buzzards Bay, Massachusetts, and commissioned on November 1, 1961. It has been extinguished and may be dismantled. A total of six Texas tower lighthouses have been constructed.

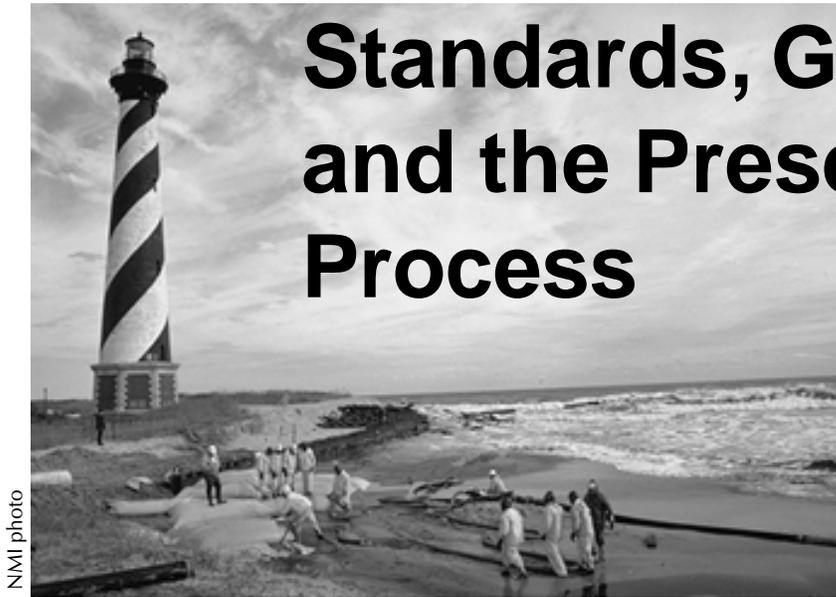
**Figure 1.** Sandbags are used to protect Cape Hatteras Lighthouse, Buxton, North Carolina, from further shoreline erosion.

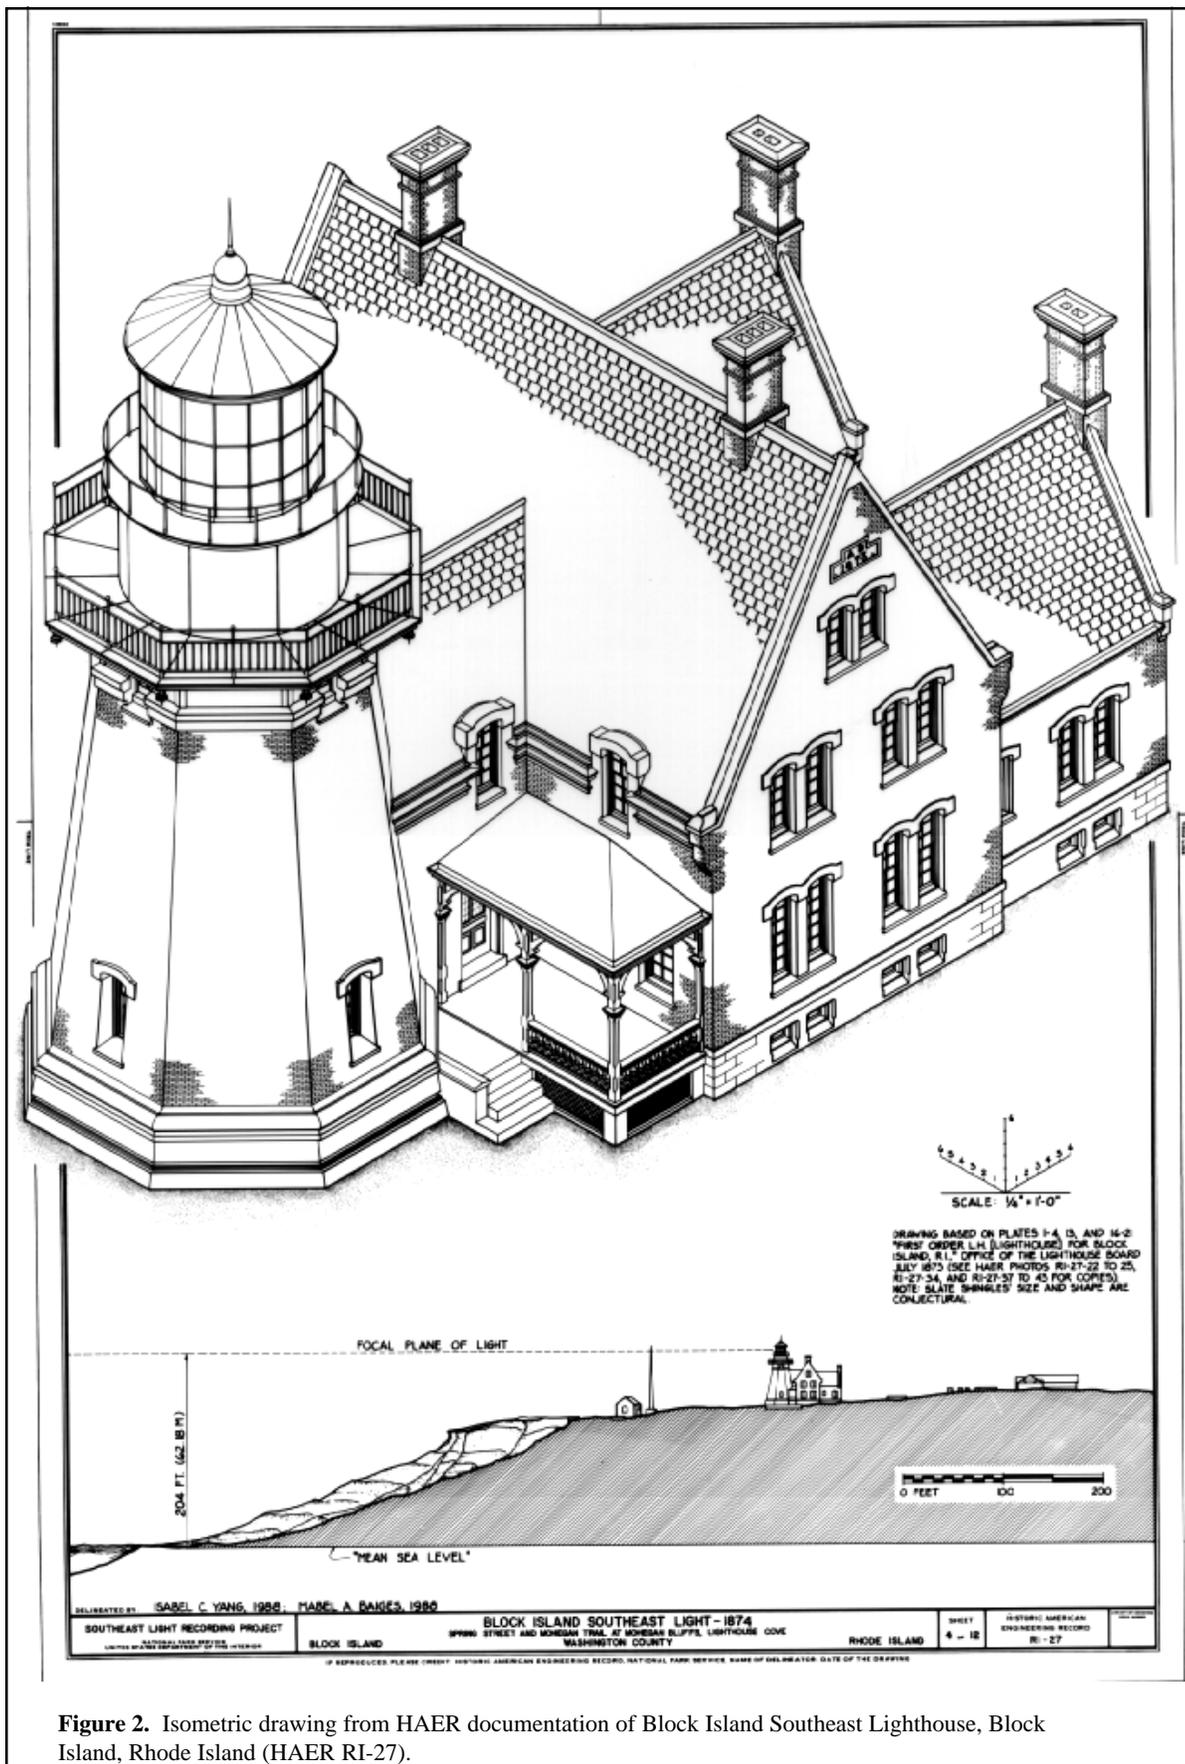
**Figure 2.** Isometric drawing from HAER documentation of Block Island Southeast Lighthouse, Block Island, Rhode Island (HAER RI-27).

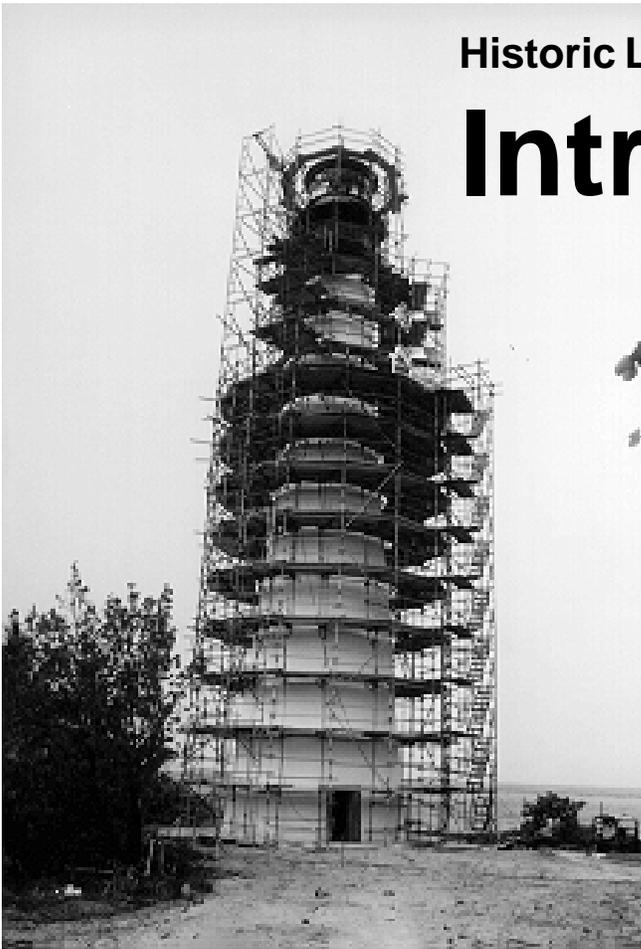
**Figure 1.** Brick replacement in 1996 restoration at Cape Florida Lighthouse on Key Biscayne, Florida.

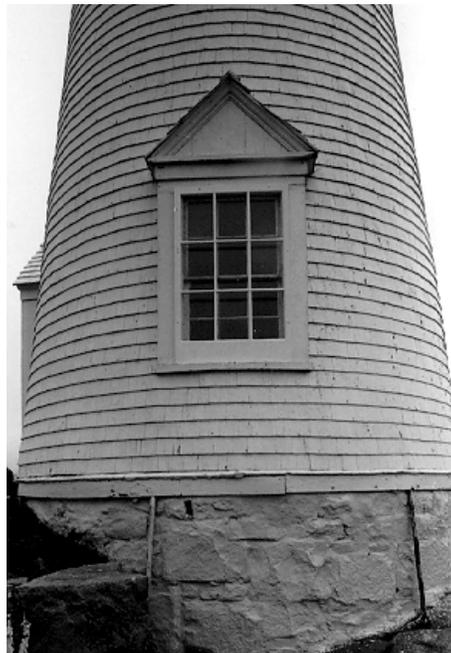
**Figure 2.** Stone masonry foundation in a 38-foot-tall wood-frame lighthouse in Maine.

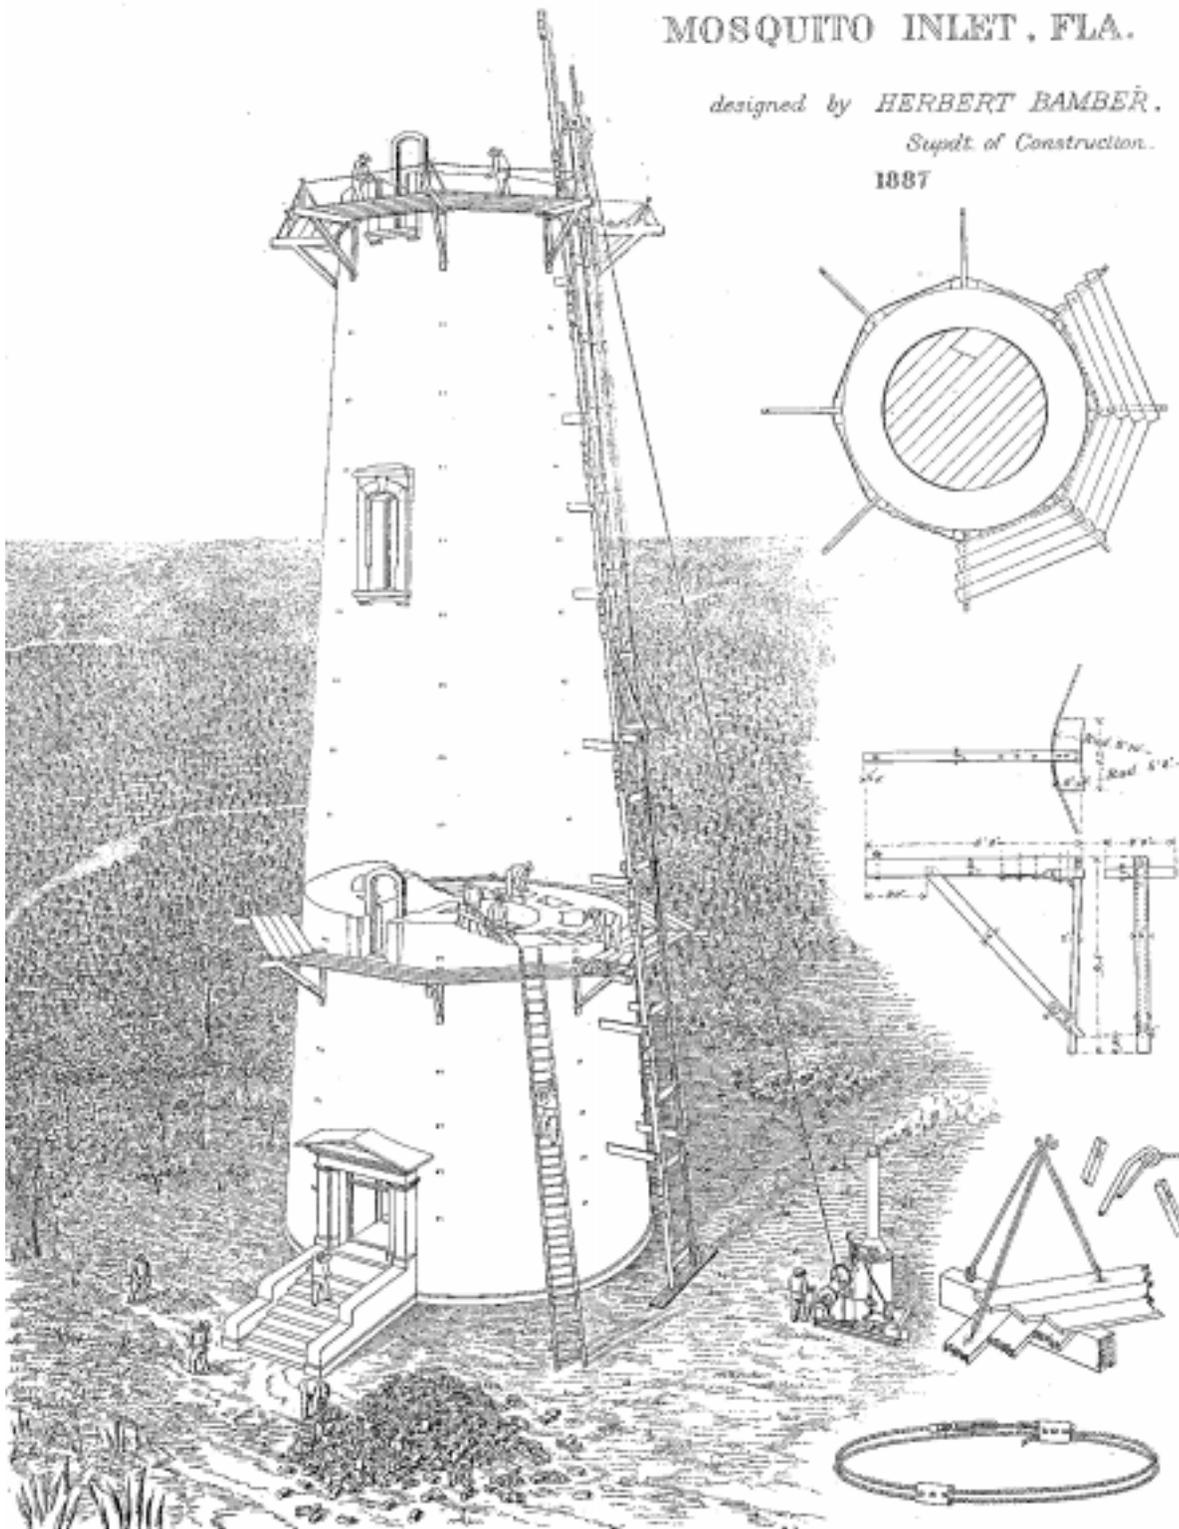
**Figure 3.** This construction drawing for Mosquito Inlet Lighthouse, Florida, shows the voids or cavities in the walls of tall masonry towers.

Masonry lighthouses are typically constructed in one of two configurations: solid wall or hollow cavity wall. Shorter towers tend to be solid-wall construction because the cross section of wall can be thin enough to support the lantern and interior stairs as well as economical to build. Tall towers are typically constructed with radiating cavities or voids. The exterior of the tower is the frustum of a cone while the interior is typically a cylinder. From the cylinder are radiating walls that tie into the exterior walls and create voids or cavities. The voids in the wall structure save weight while at the same time do not compromise the strength of the wall. The voids are typically vented to encourage air movement through the internal cavities. This ventilation system should be preserved and maintained.

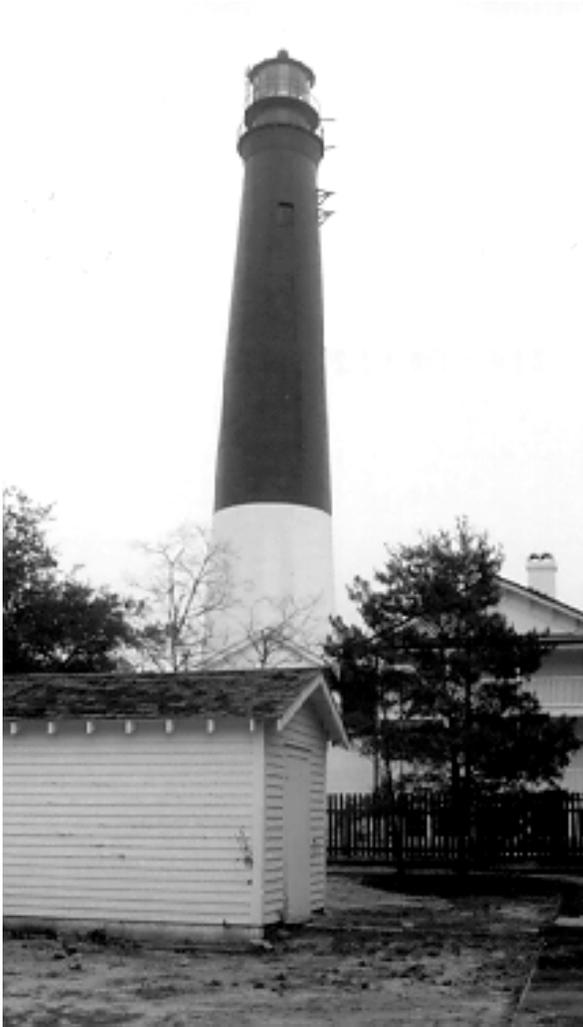
**Figure 4.** Brick masonry construction in the 171-foot-tall Pensacola Lighthouse in Florida.

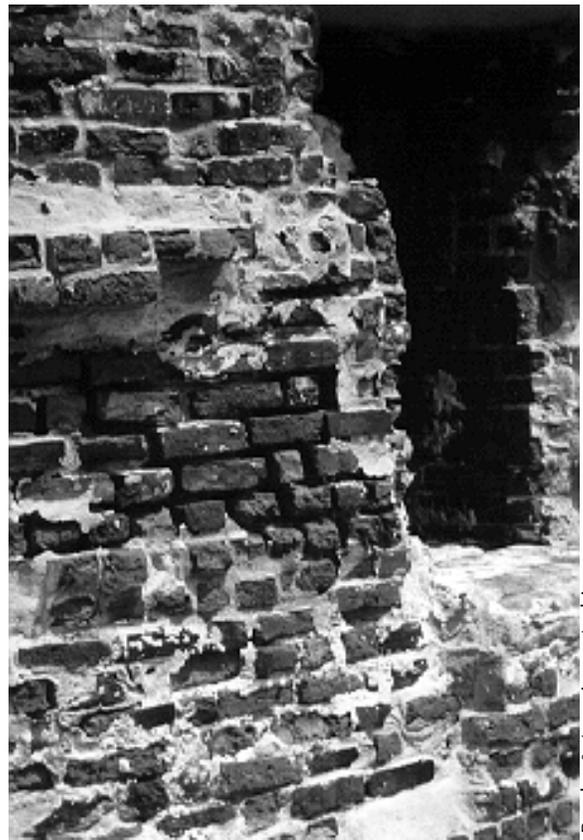
**Figure 5.** The coating that once protected the soft bricks of this lighthouse was not maintained; the severe deterioration required the replacement of nearly 25,000 bricks.

In some instances the vulnerable, softer masonry surfaces were not covered with a protective coating, or the protective coating was not maintained and the masonry has since deteriorated. In these cases the protective coating needs to be reinstalled after the required repairs are made, or the masonry may need to be consolidated by a qualified architectural conservator.

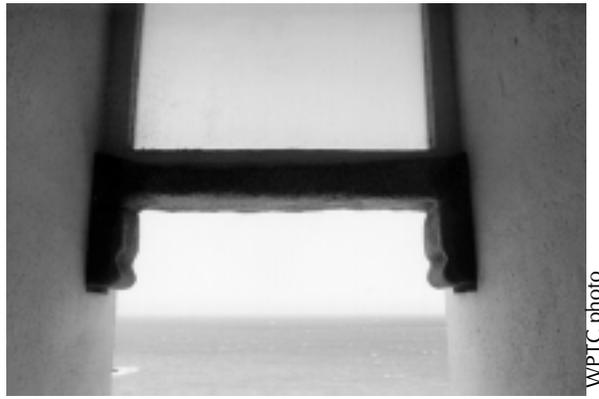
**Figure 6.** The once crisp edges of this decorative granite lintel have been eroded by constant high winds and airborne sand.

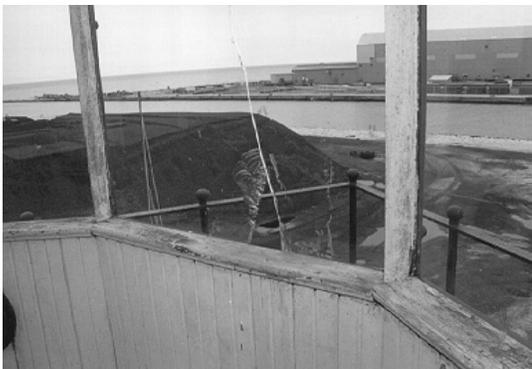
**Figure 7.** Lantern glass with holes and/or cracks should be replaced as soon as possible to minimize water infiltration. If immediate replacement is not feasible, the glass can be temporarily patched.

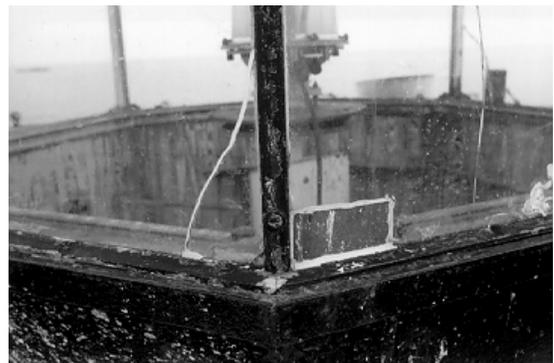
**Figure 8.** Detail of an acceptable temporary repair to a lantern glass using a piece of painted sheet metal that has been adhered to the glass with a high quality, exterior grade caulk. This type of temporary repair will prevent water from entering the lantern and therefore help avoid further damage. This fix should be considered only as an interim treatment until replacement of the lantern glass.

- **Lantern glass:** Lantern glass, frames, and roofs must be weathertight before mothballing. Refer to the **Lantern** section of this handbook for more information concerning weatherproofing lantern components.

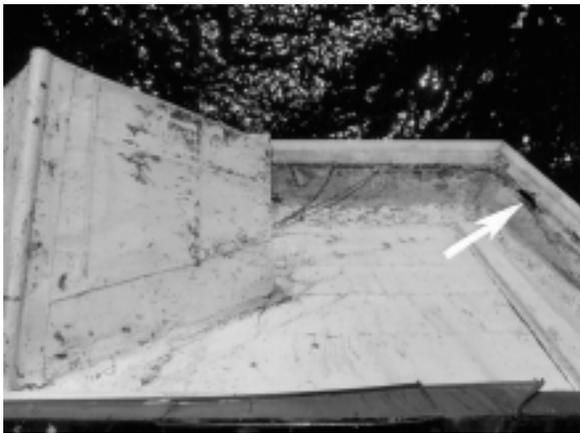
**Figure 9.** View of built-in gutter system on a mansard-style roof; the arrow indicates where a fist-size hole exists. This hole allows water to enter the interior of the lighthouse.

- **Built-in gutter systems:** All rainwater gutter systems (lantern roofs, or other tower roof forms) should be cleaned and checked for holes. All holes and non-functioning gutter system components should be repaired. For more information refer to the discussion on roofing in the **Lantern** section of the handbook.

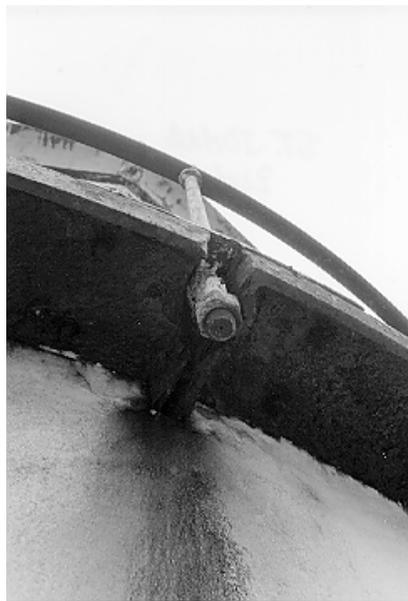
**Figure 10.** View of underside of gallery deck; the streaks on the stucco indicate that water is passing between the deck plates and possibly entering the masonry wall.

- **Gallery decks:** In most masonry lighthouses gallery decks are cast iron, sheet-metal-covered wood, stone, or concrete. These decks are generally laid directly on top of the masonry wall structure. The decking should be sloped away from the lighthouse to shed the water away from the structure. If the decking material is not weathertight, moisture can enter the interior cavity of the masonry wall. See Figure 10 for signs that a gallery deck is failing. Refer to the **Lantern** section of this handbook for more information concerning the weatherproofing of gallery decks.

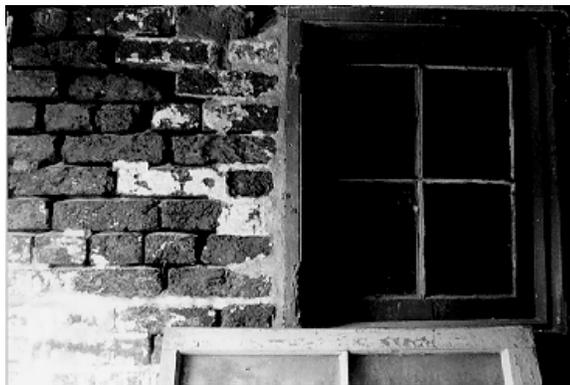
**Figure 11.** Detail of severely eroded brick and painting.

- **Loose or eroded mortar joints:** If pointing between masonry units is loose, cracked, eroded, or is completely missing, moisture will penetrate (see Figure 11). In order to prevent this infiltration, all pointing that is in disrepair must be removed and the affected joints repointed. For more information refer to the discussion on repointing under the **Repair** treatment in this section of the handbook.

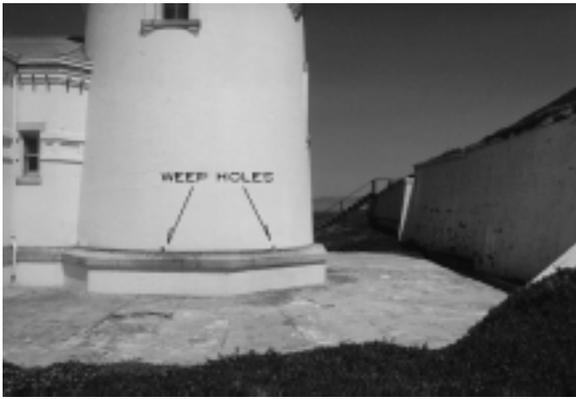
**Figure 12.** Typical masonry lighthouse weep hole locations. Each weep hole provides drainage for each individual cavity within the masonry wall.

- **Weep and vent holes:** If the walls have cavities between the interior and exterior walls, weep holes may exist at or near the base of these walls. Weep holes typically range in size from small slits to large brick headers. These holes allow any moisture that has entered the cavity between the walls to drain out. These openings must be kept clear in order to provide sufficient drainage of the cavity. In some instances the walls may have vent holes (larger than weep holes) that allow the movement of air through the cavities or voids. Typically vent holes open into the interior. These openings must be kept clear in order to provide sufficient ventilation (see Figure 12).
- **Protective coatings:** Lighthouses were often painted as a protective measure and for identification as a daymark. As part of a

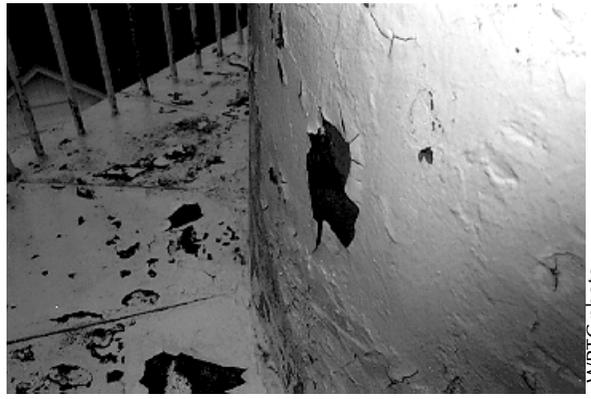
**Figure 14.** Detail of failing paint, a problem which should be addressed during stabilization and protection. In this particular case, spot painting may be all that is required to maintain a weatherproof protective coating.

mothballing treatment, the exterior coating should be checked for loose and flaking paint. Any deteriorating areas should be scraped and repainted to match the existing color. Ultimately, as part of a mothballing treatment the entire lighthouse should have all loose and flaking paint removed and a new coating applied according to the manufacturers specifications. If the overall condition of the coating system is sound and there are only a few bare spots, however, the lighthouse can be spot painted to provide a weatherproof coating. Either of these actions will result in a coating

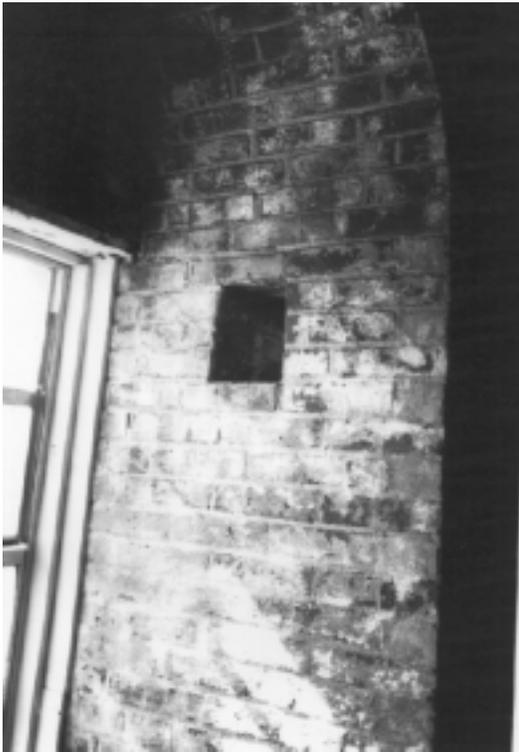
**Figure 13.** Vent hole located in the window well of a brick lighthouse.

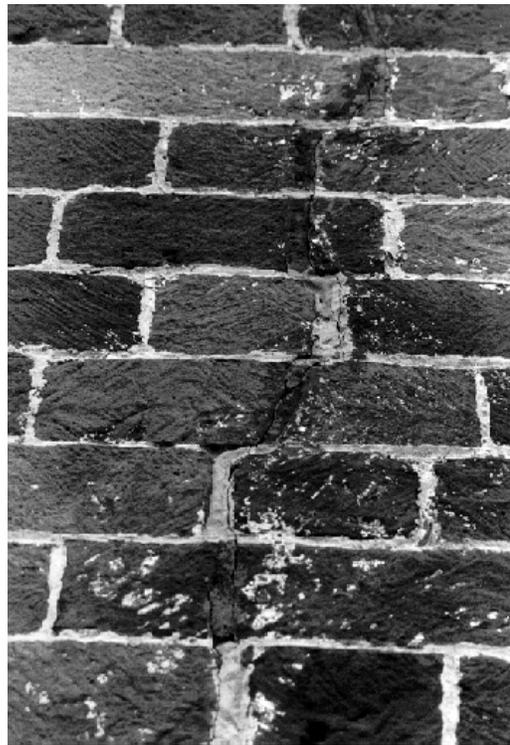
**Figure 15.** Cracks such as these in a sandstone lighthouse should be monitored for movement prior to treatment.

- **Open cracks in walls:** Cracks in exterior masonry walls indicate that movement has occurred, either caused by shrinkage (in the case of stucco) or by settlement or mechanical impact. Cracks should be monitored to determine if movement is still occurring and

structural stabilization is necessary before the crack is filled. Refer to the following repair section for more information concerning wall repair.

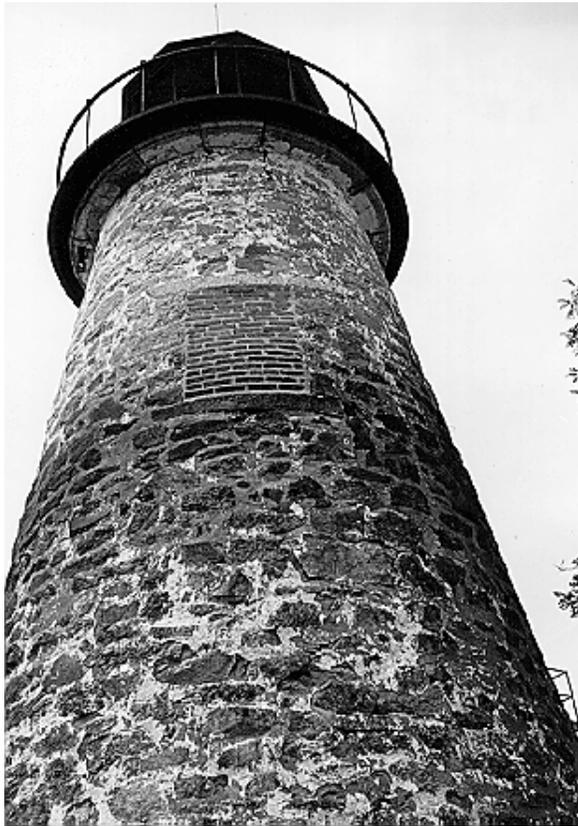
**Figure 16.** An example of a reversible masonry stabilization treatment for the window opening that has prevented structural deterioration and moisture infiltration.

‘mothballed’ period. If funds are insufficient to make structural repairs, structural stabilization should be performed as a less expensive temporary alternative. Temporary blocking in of window and door openings and installation of interior or exterior shoring or bracing are all stabilization methods. Figure 16 illustrates a window opening that has been stabilized with brick infill. Brick is a historic stabilization method in stone masonry construction. If this method is used, the

mortar employed should be soft enough to not permanently adhere to the historic masonry, thus making the treatment reversible. Other methods of door or window opening stabilization include fitting the opening with a structural wood frame covered with a painted plywood panel that has large louvers to aid in venting the interior of the lighthouse. The stabilization treatment utilized should not permanently damage historic character-defining features and should be easily reversible so that when the budget allows, the structure can be properly repaired.

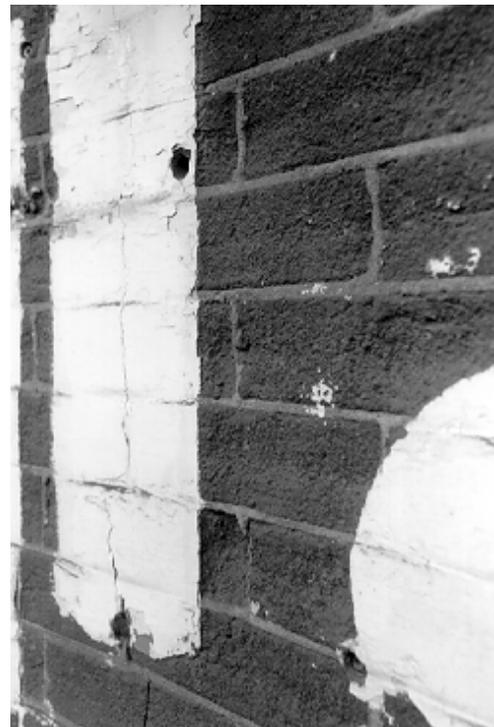
**Figure 17.** Deeply eroded brick as a result of sandblasting. The white areas are where electrical components were attached to the wall at the time of sandblasting.

- Clean masonry only when necessary to halt deterioration or when heavy soiling must be removed to prevent damage to the masonry.
- Carry out masonry surface cleaning tests after it has been determined that such cleaning is necessary. Do not clean masonry merely to improve appearance.
- Clean masonry surfaces with the gentlest method possible, such as using low pressure water and detergents and natural bristle brushes. To select the gentlest method possible, tests should cover a period of time sufficient to determine both the immediate and long-range effects.
- Always allow for thorough drying time of the masonry (months or possibly years) before proceeding with any sealing of the exterior or interior.
- Always neutralize any chemical treatment.
- Do not sandblast brick or stone surfaces using dry or wet grit or other abrasives. These methods of cleaning permanently erode the

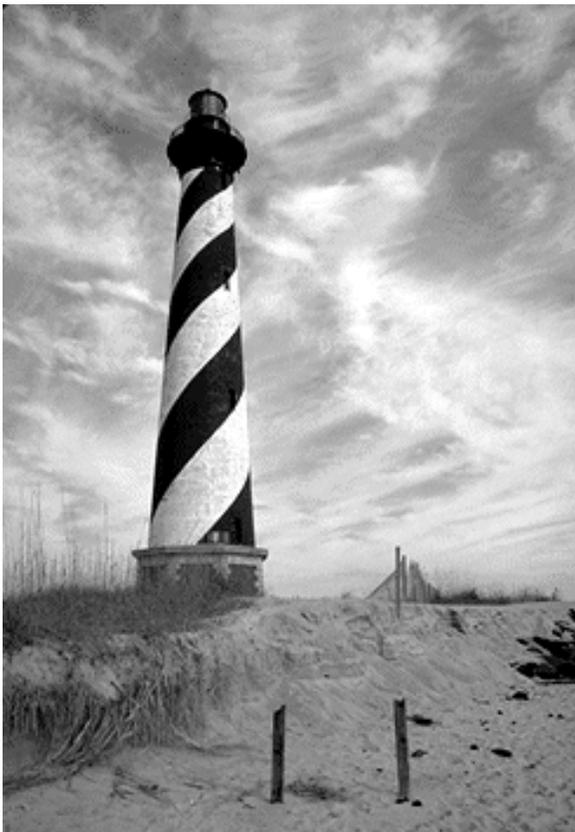
**Figure 16.** Daymark patterns are a character-defining feature and should be preserved.

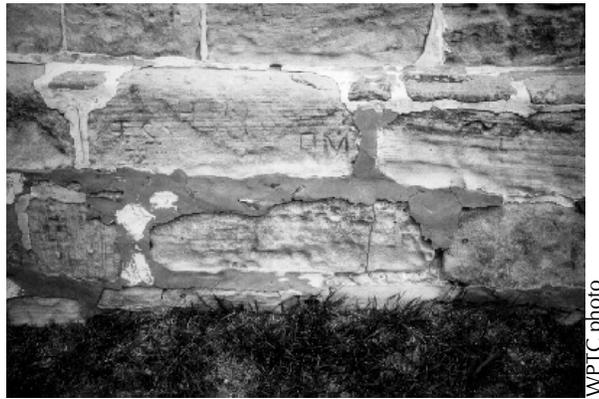
**Figure 19.** The use of hard portland cement mortar and sloppy pointing technique have aided in the deterioration of this soft sandstone wall.

Modern portland cement has a higher compressive strength than the lime-based mortars. This quality makes the portland-based cements less flexible than the lime-based mortars; therefore, the pointing tends to resist the expansion and contraction of the softer historic bricks. This resistance will ultimately cause the faces of the bricks to fracture and spall off the body of the brick. In some cases the exterior wythes of brick may shear from the inner core of the wall, resulting in the failure of the outer sections of the wall.

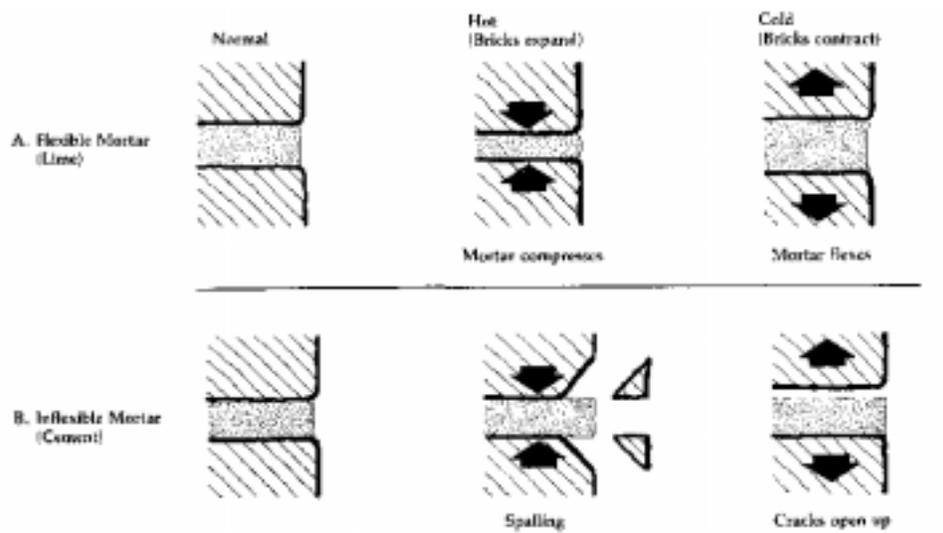
**Figure 20.** Diagram showing the behavior of lime-based mortar and cement-based mortar during relative temperature changes of the surrounding masonry. (Source: NPS *Preservation Briefs 2*, 1980)

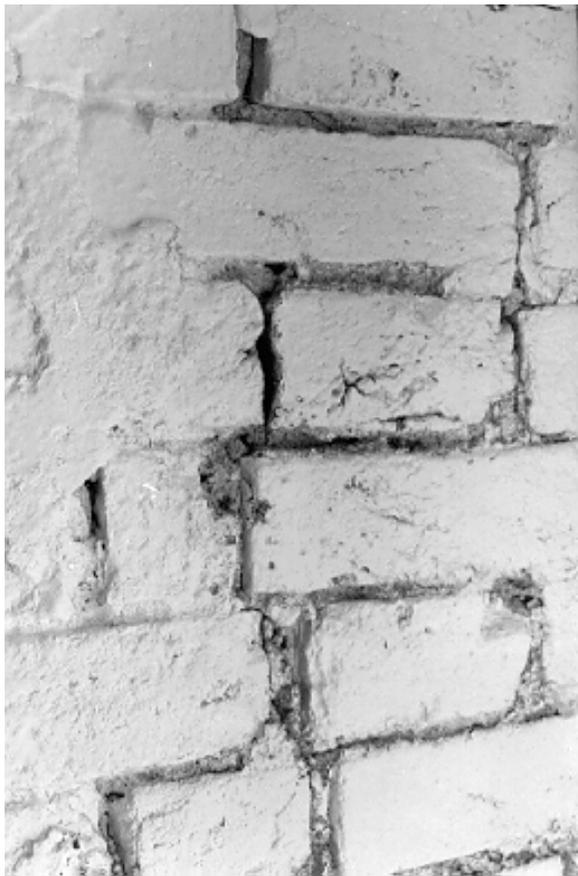
**Figure 21.** Detail of eroded pointing.
