## Historic Lighthouse Preservation Handbook

The Historic Lighthouse Preservation Handbook was created through a cooperative partnership between the National Park Service, [U.S. Coast Guard](#), Department of Defense Legacy Resource Management Program, and U.S. Lighthouse Society. The 328-page preservation manual, released in August 1997, focuses primarily on the maintenance problems associated with the many different materials and construction techniques used in these unique structures. In addition to

sections devoted to preservation treatments, it includes a brief history of the U.S. Lighthouse Service and lighthouse construction types; existing historic preservation laws, standards, and guidelines; case studies for both lighthouse rehabilitation and restoration projects; related activities (interpretation, funding, safety management, etc.); and sources for more information.

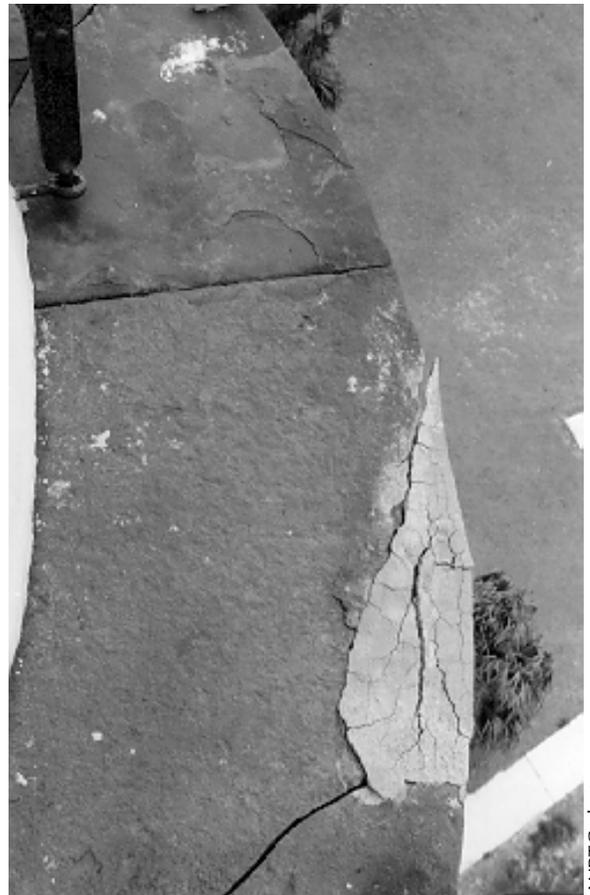
**Figure 22.** A failing repair made to a stone gallery deck using a simulated stone material. A stone dutchman repair should have been used.

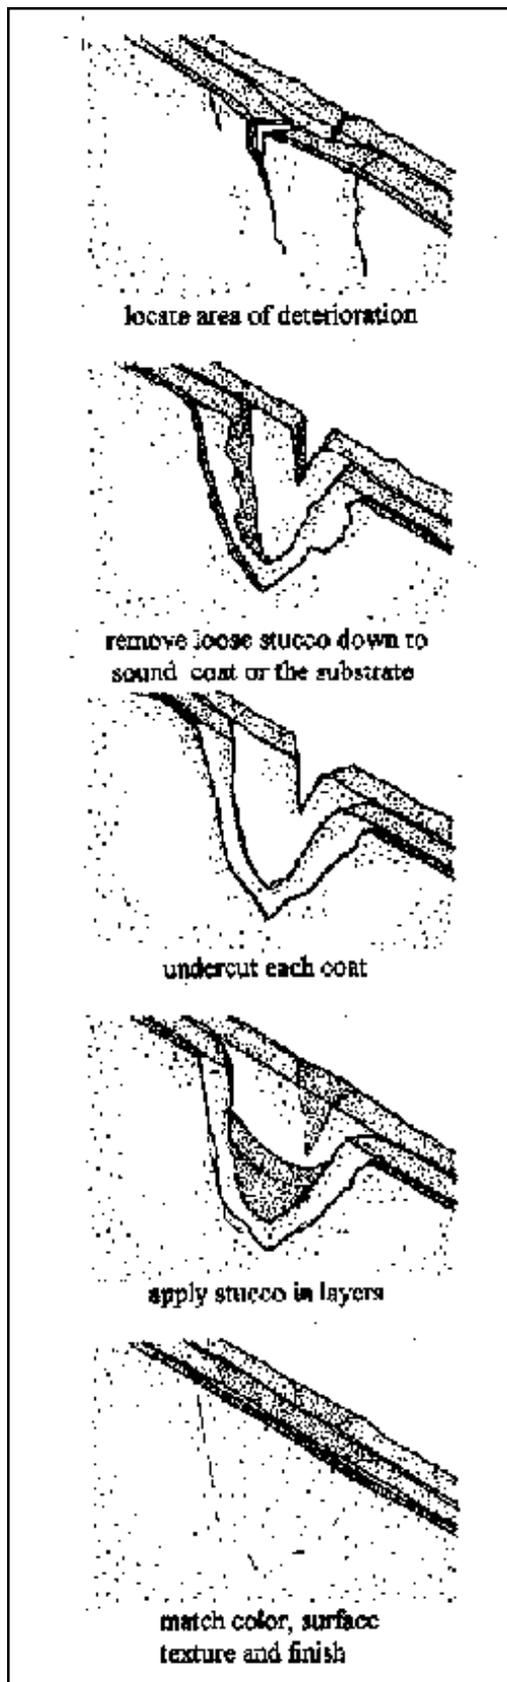
**Figure 23.** The five basic steps of stucco repair; each layer of stucco must be patched separately. (NPS drawing)

- Remove previous patches that do not match texture, color, or strength of the original stucco.
- Undercut the repair boundaries to create a dovetail-shaped mechanical bond between the old and new stucco.

- Test new stucco in an inconspicuous location and allow test samples to weather as long as possible, ideally for one year. Matching the original material will probably require a number of test samples.

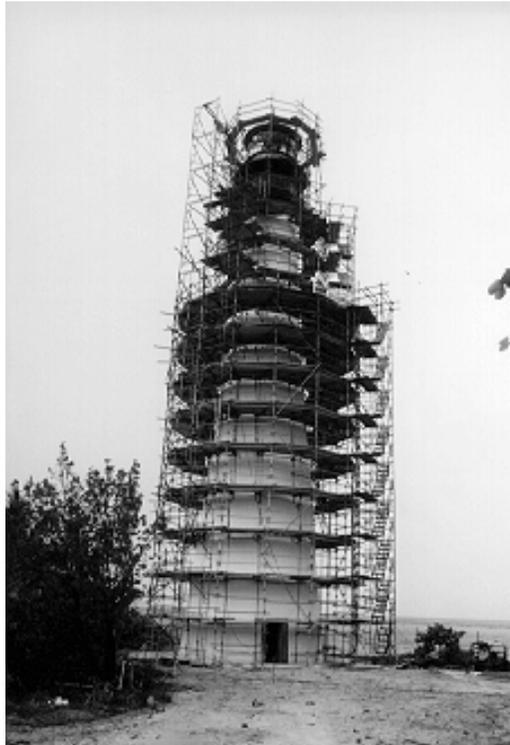
**Figure 24.** Cape Florida Lighthouse with scaffolding used during the 1996 restoration. The white coating on the tower is the lime mortar wash applied to help protect the damaged brick and to restore the tower to its 1846 appearance.

Lime mortar wash is typically a three-layer coating. The first coat consists of lime, water, and sand; the second, half as much sand; the third, just lime and water. Whitewash is lime and water only. Both of these coatings are meant to be reapplied every three to five years. More information on this coating and its application can be found in the Cape Florida Lighthouse sidebar on page 23.

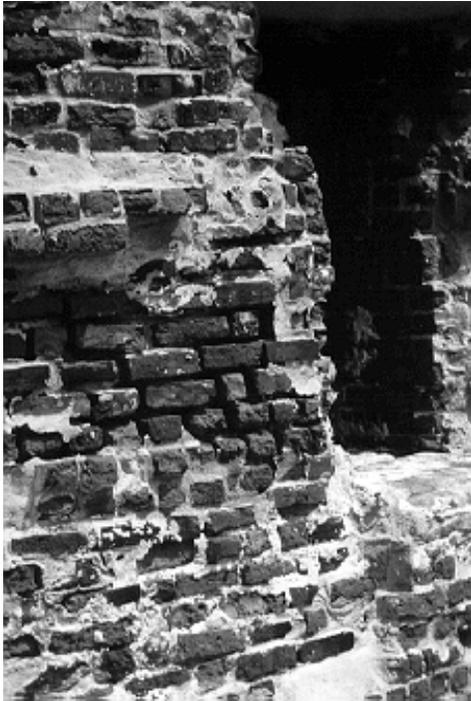
**Figure 25.** View of the lower portion of the tower showing the more severe deterioration. Note that a large percentage of the first brick wythe is missing or has been removed. The white areas are remains of a portland-cement-based parging applied in the late 1960s in an effort to protect the deteriorating bricks.

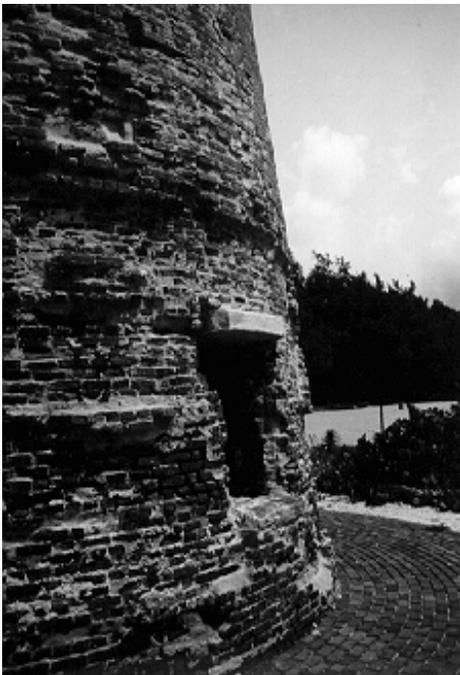
**Figure 26.** View of the lower tower window; note the depth of the brick deterioration at the window openings. The face of the protruding granite lintel above the window opening represents the face of the original wall.

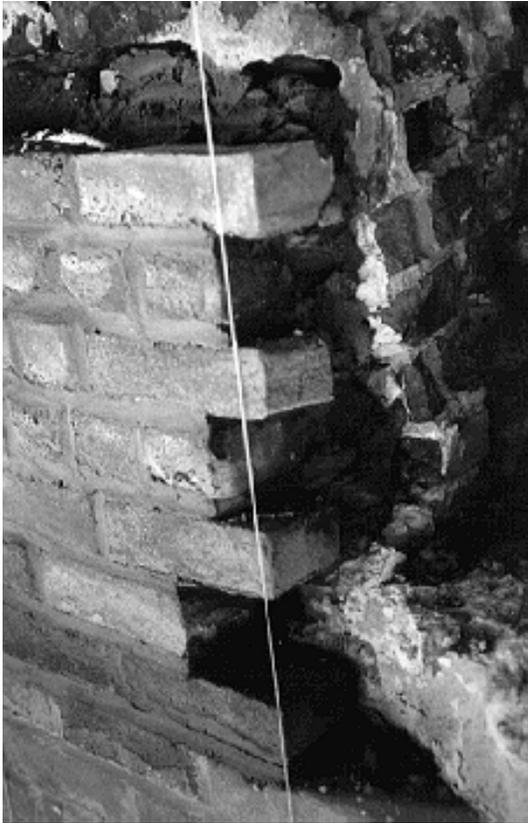
**Figure 27.** View of repairs being made to the exterior wall. A new brick wythe is being installed where bricks were missing, using mortar that matches the strength of the new and historic bricks. Masonry anchors are used to attach the new wythe to existing wall. The deteriorated mortar joints in the extant wall were repointed with a matching mortar mix.

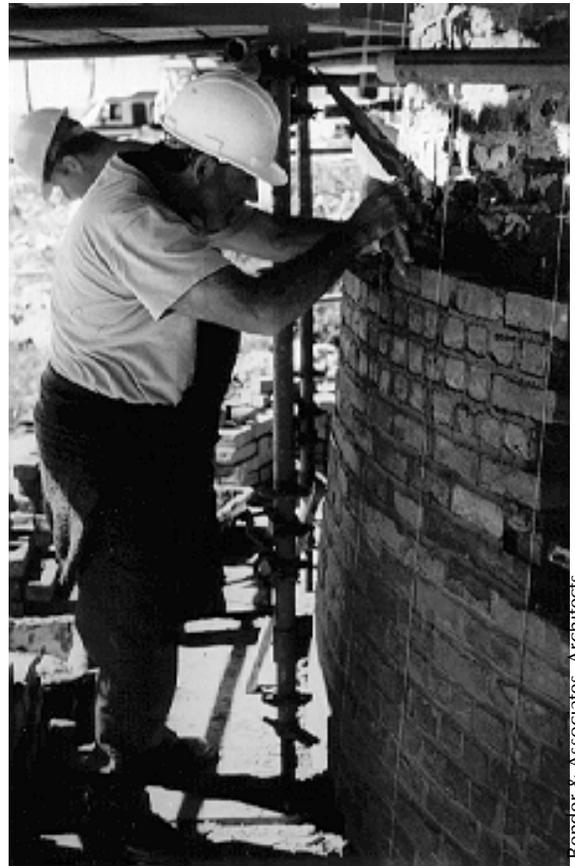
**Figure 28.** Here a mason is implementing repairs to the exterior wall. The missing bricks were replaced with in-kind materials: the bricks match the historic bricks in size shape and strength. The mortar joint sizes are also being made to match the historic in size, color, and texture, as demonstrated in this photo. The vertical strings over the brickwork define the wall plane, so when the mason places the bricks, they maintain the taper of the conical tower.

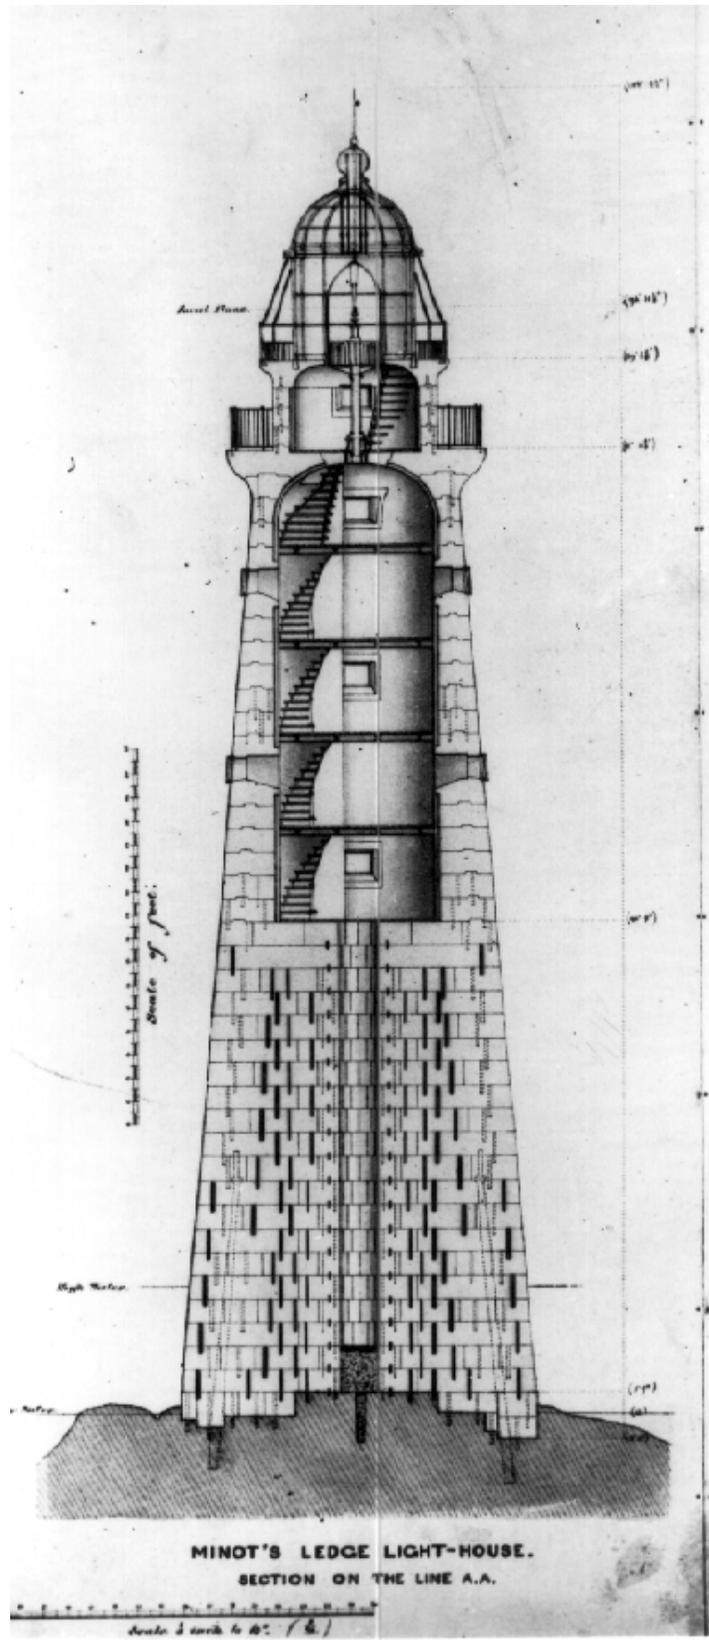
**Figure 29.** Cross section for 114-foot Minots Ledge Lighthouse.

For many people, their vision of a classic lighthouse is a wave-swept tower. John Smeaton, an Englishman, built the first successful wave-swept tower in 1759 at Eddystone Rock, in the English Channel, made famous by the song *Eddystone Light*. This was the first interlocking-masonry-block lighthouse tower. Later Smeaton developed a cement that would set up in water. These two inventions revolutionized open-sea lighthouse construction and remained the principal method for their construction until concrete and steel came into use just after the turn of the 19th century. Wave-swept towers were built by interlocking large cut stones, both horizontally and vertically. This integral interlocking formed a monolith of great weight, which combined with their conical shape, diverted the energy of the waves away from the tower, enabling them to withstand the heavy pounding of the surf.

Minots Ledge Lighthouse, located on a rock barely visible above the sea near the entrance to Boston Harbor, Massachusetts, is America's

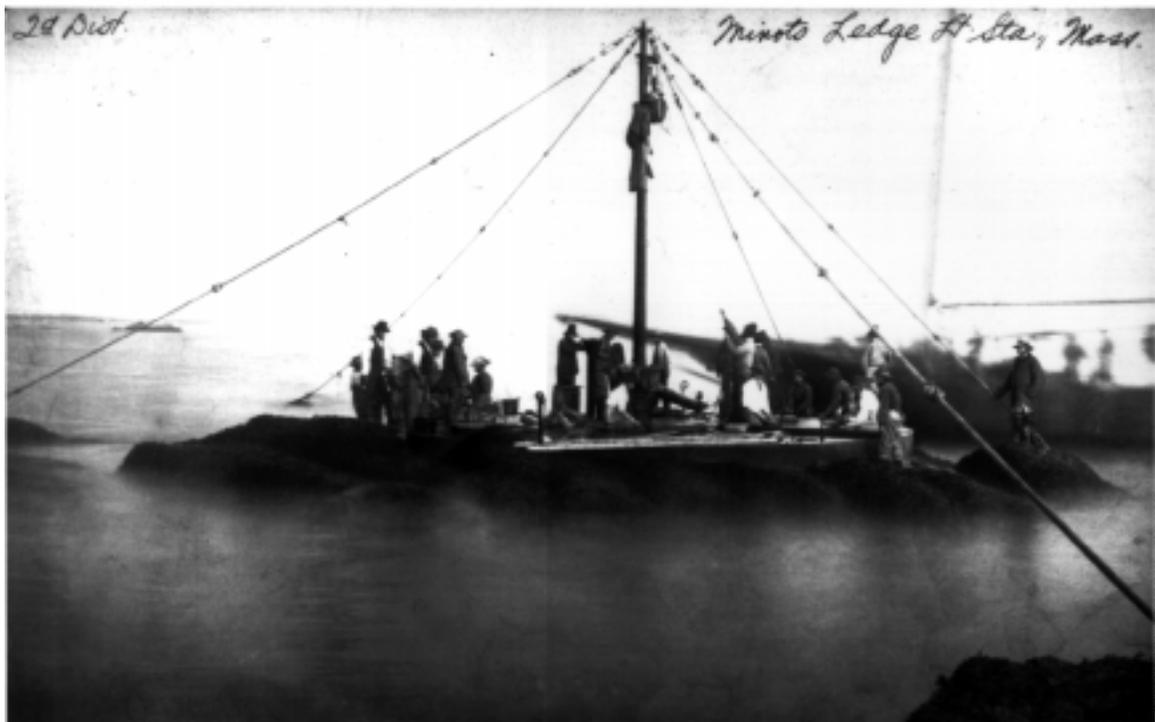
**Figure 30.** Workers on a calm day, completing the first course of granite block for the foundation of Minots Ledge Lighthouse, 1858

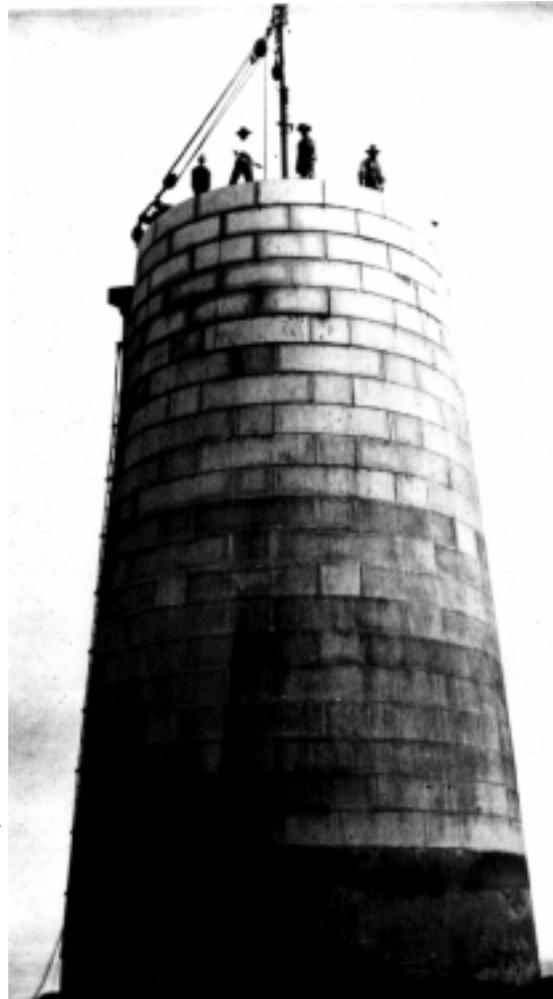
**Figure 31.** Work on Minots Ledge Lighthouse as it progressed just above the entrance level which is visible on the left. The tower below this level was essentially solid.

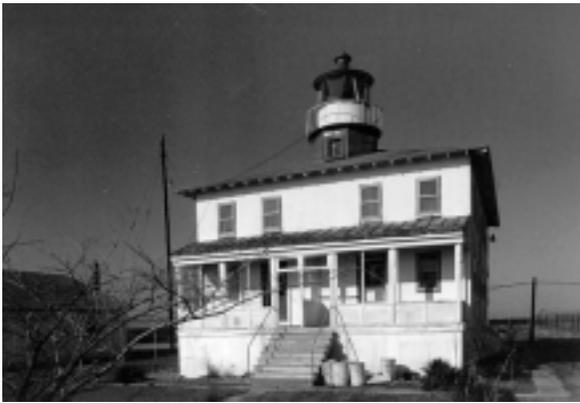
**Figure 2.** Example of a keeper's quarters fitted with a prefabricated cast-iron-and-steel lantern.

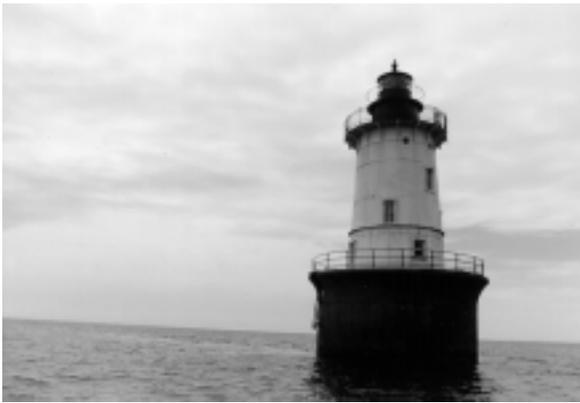
**Figure 3.** Example of an all-cast-iron construction "sparkplug" caisson-style lighthouse.

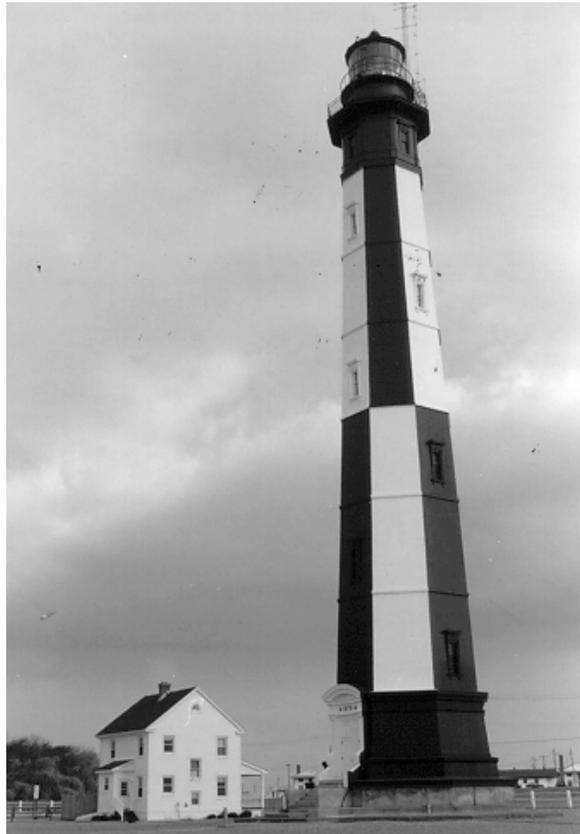
**Figure 4.** Double-wall, cast-iron, first-order 163-foot-tall coastal tower at Cape Henry, Virginia.

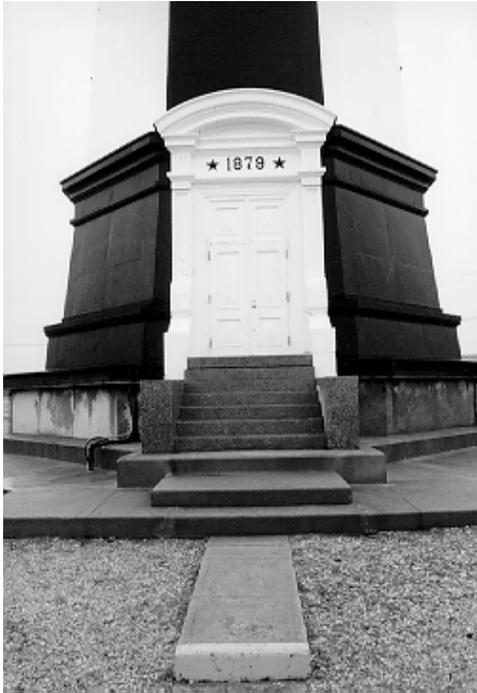
**Figure 8.** An example of the level of detail achieved with cast-iron construction.

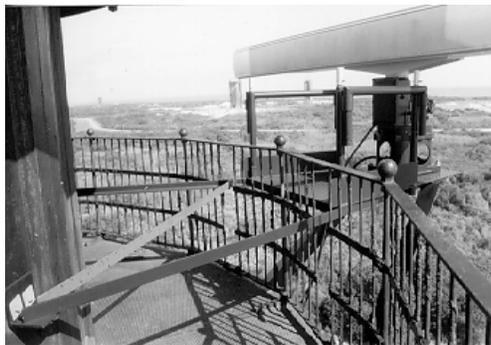
**Figure 9.** A modern range finder attached to the gallery deck using modern steel members.

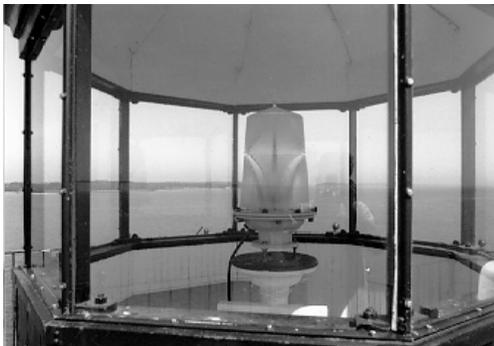
**Figure 10.** Close-up of a lantern glass frame: note the use of stainless steel bolts; the lower clamps are also stainless steel that have been painted black.

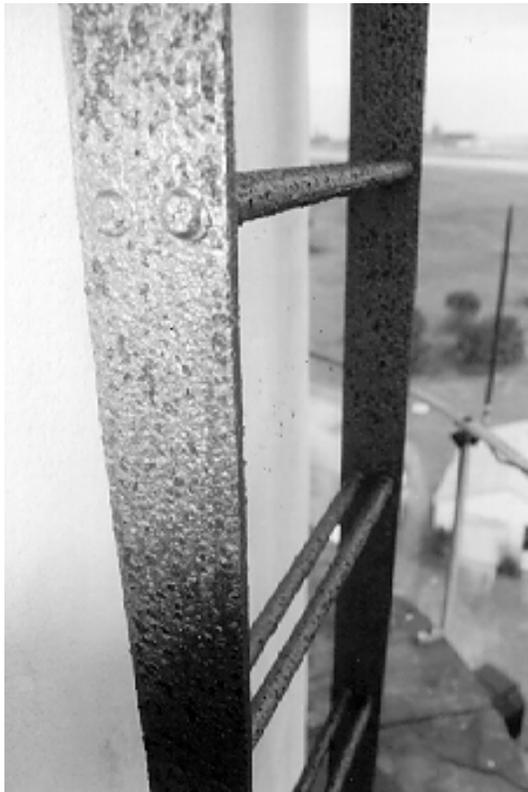
**Figure 11.** Detail view of a steel ladder that has been uniformly attacked by corrosion.

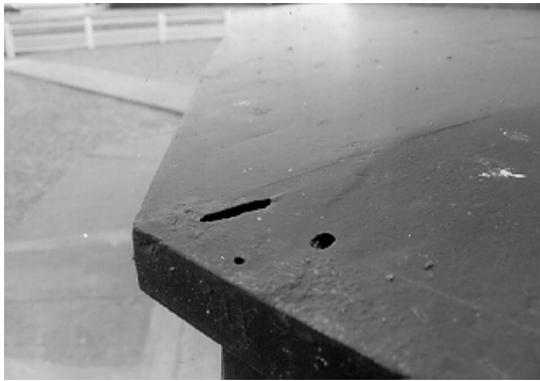
**Figure 12.** Close-up of localized corrosion or pitting where the corrosion has eaten through the cast iron.

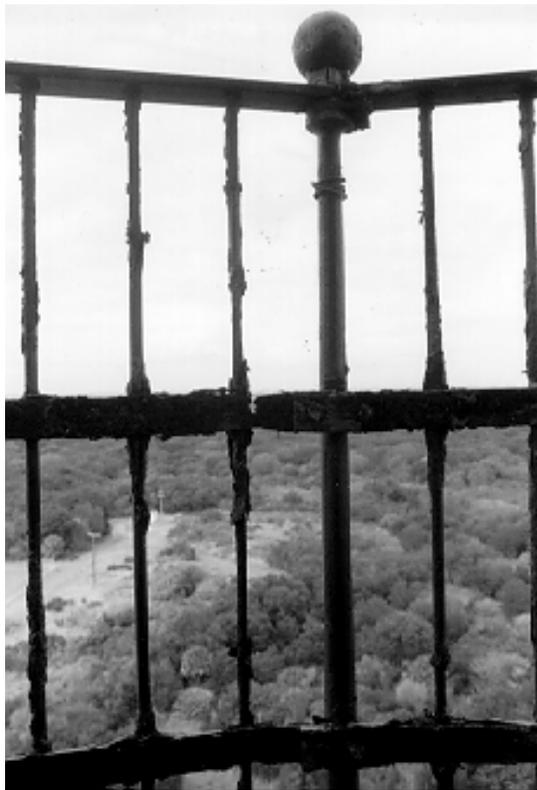
**Figure 13.** View of a steel railing where corrosion has occurred in distinct locations either because of variations in composition or localized failure of the coating system.

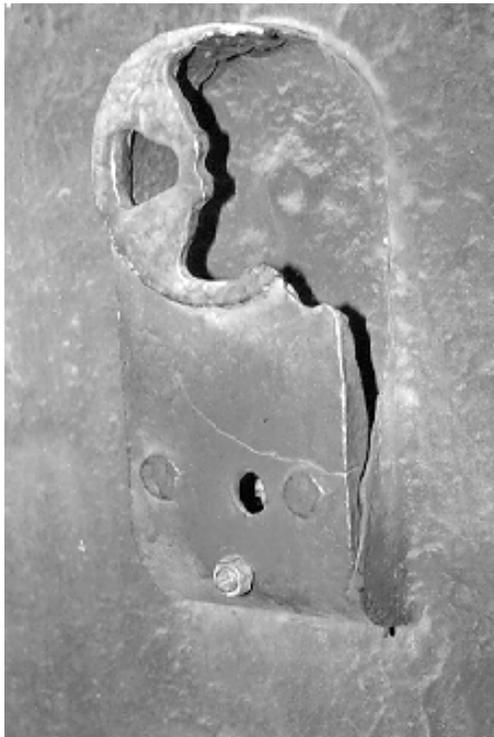
**Figure 14.** Nearly 30% of this ventilation shroud has been lost to two forms of abrasion: first, sand or grit blasting abraded away a majority of the material; second, human touch has smoothed the once rough surface.

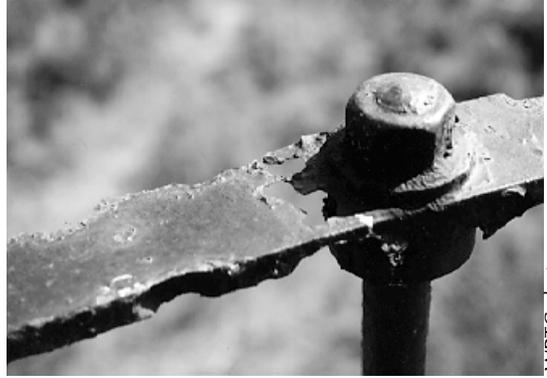
**Figure 15.** As corrosion attacked this steel handrail, wind and airborne sand eroded the loose and flaking surface rust.

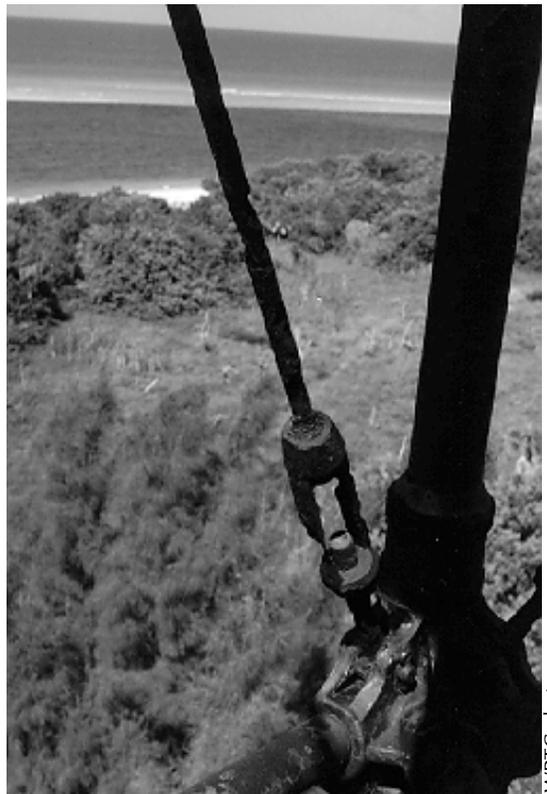
**Figure 16.** As corrosion attacked this steel turnbuckle, wind and airborne sand eroded away the flaking rust.

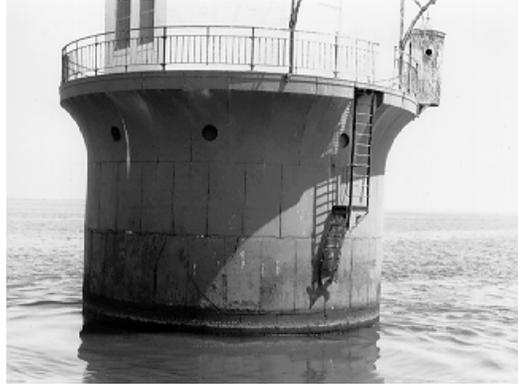
**Figure 17.** The cyclic pressure of the different rates of expansion and contraction of the exterior cast-iron plates and the interior brick lining of the caisson-style lighthouse has caused the cast-iron plates to fatigue and crack.

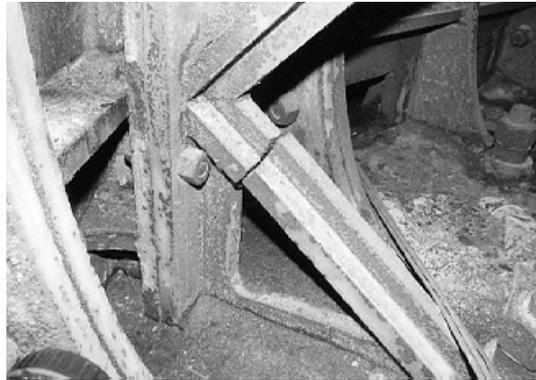
**Figure 18.** The internal structural skeleton of this lighthouse is cracked because of overloading possibly during assembly.

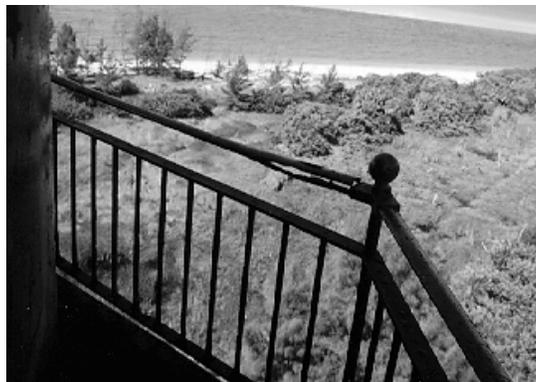
**Figure 19.** This handrail has been damaged by rust-jacking; rusting began between the two pieces of flat bar stock that formed the rail.

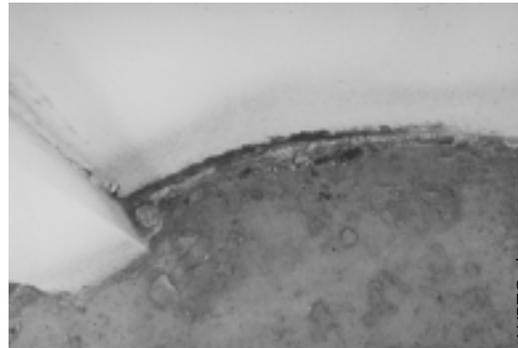
**Figure 22.** Interior of a sheet-iron parapet wall that is rusting from the inside to out along the lantern room door. This is the result of water entering the interior cavity of the parapet wall.

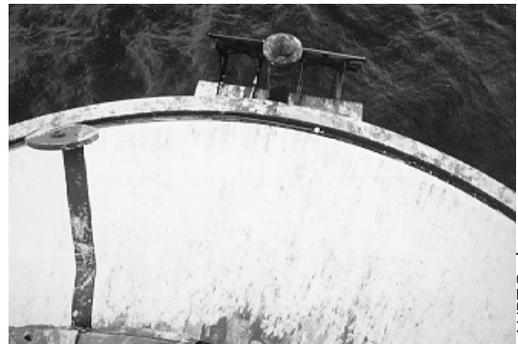
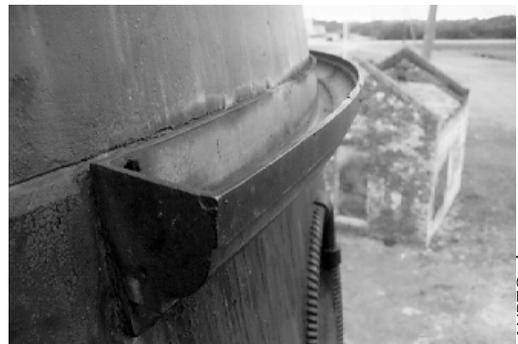
**Figures 23 and 24.** Two types of gutters found on iron lighthouses; the gutters must be in proper working order and checked regularly during the mothballing period.

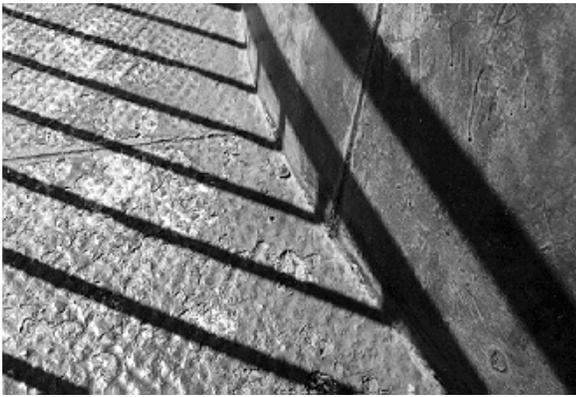
**Figure 25.** The seams between the deck and wall plates of this lighthouse were not properly sealed; as a result the areas collected water and began to rust.

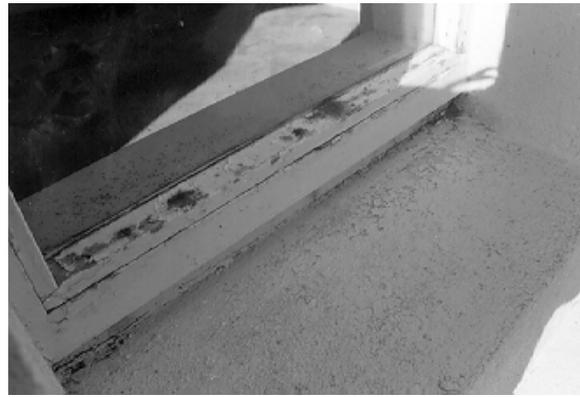
**Figure 26.** This steel casement window frame was not sealed properly and as a result has begun rusting from the inside out.

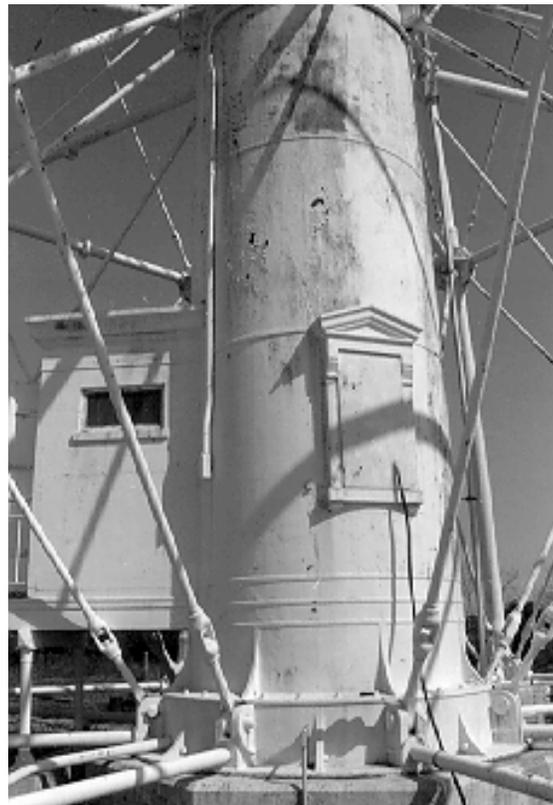
**Figure 27.** Blistering paint, as pictured here, should be removed and the affected areas properly primed and painted.

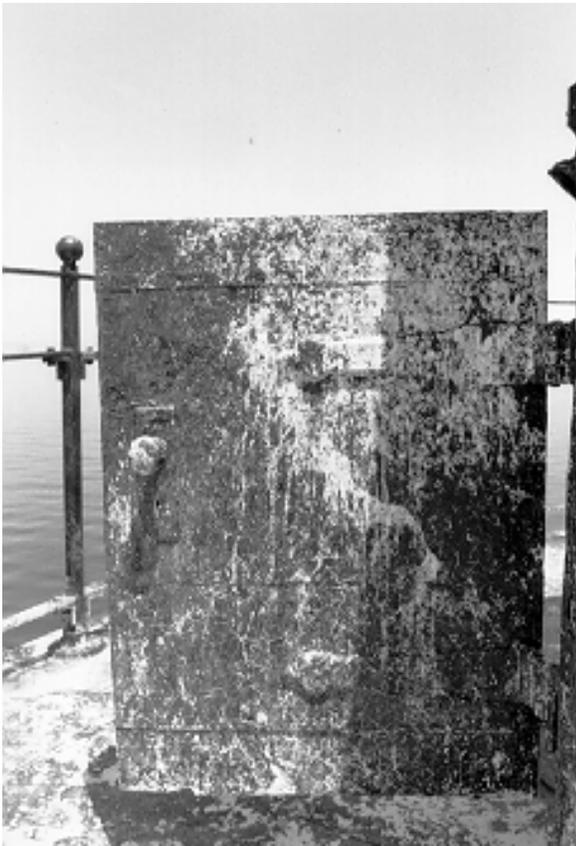
**Figure 28.** Surfaces such as this sheet-steel-covered parapet door that are covered with seagull guano should be thoroughly cleaned before mothballing and should be checked and cleaned once a year during the mothballing period.

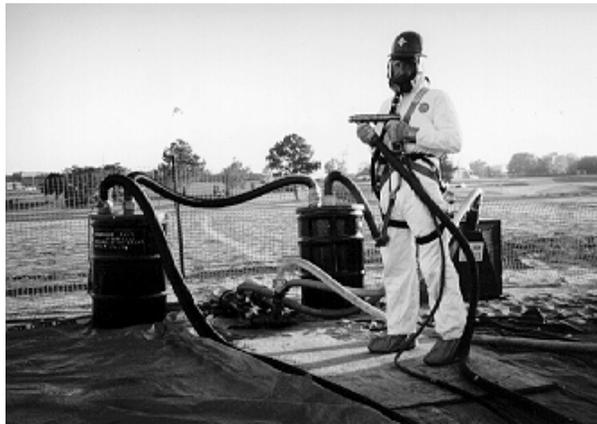
**Figure 29.** Worker dressed in full personal protective gear. The full-face-shield self-contained respirator provides both respiratory and eye protection. The worker is wearing protective coveralls, gloves, and boot covers to prevent lead dust contact. The harness is part of a full protection system. He is holding a pneumatic needle gun that is hooked to a two-stage HEPA (High Efficiency Particulate Air) filtered vacuum system.

outfitted with dust-collection hoods with vacuum hookup. As with any paint removal procedure, personal protective equipment required for health protection should be worn. Typical personal protective equipment includes eye/face protection, respiratory protection, gloves, coveralls, hard hat, and protection from falling if working 6 feet or higher above the ground (see Figure 29).

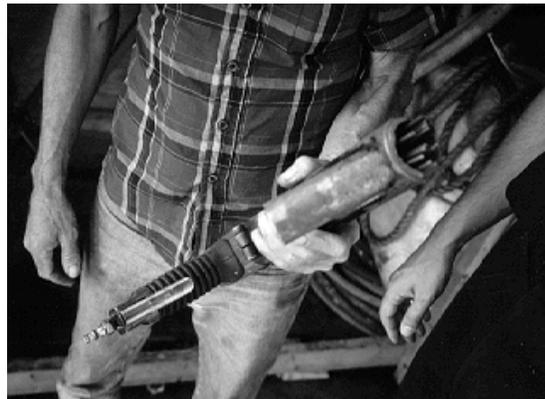
**Figure 30.** Close-up of a pneumatic needle gun. This tool works well for hard-to-reach and detail areas. The needle gun can be pressure-controlled to minimize impact on the iron substrate. This figure shows the vacuum-shroud connection on the right and air-hose connection on the base of the pistol-grip handle on the left.

Figures 30 through 33 are paint removal tools used during the Sand Key Lighthouse rehabilitation. Sand Key Lighthouse is located in open water off the coast of Key West. The paint being removed contained lead; therefore it was essential that all debris be contained for proper disposal.

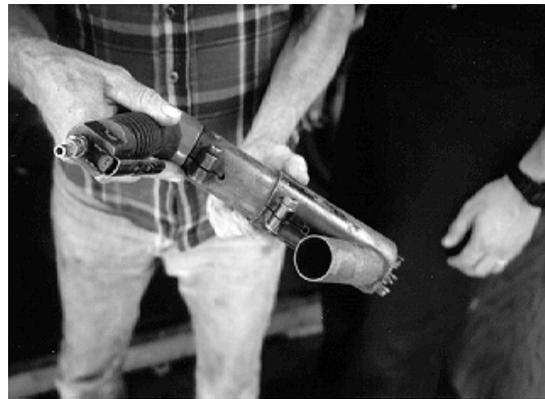
**Figure 31.** The gun is activated by squeezing the lever on the rubber pistol grip. The amount of air pressure controls the speed and impact of the pulsating needles against the iron substrate. The needles can be seen protruding from the vacuum shroud.

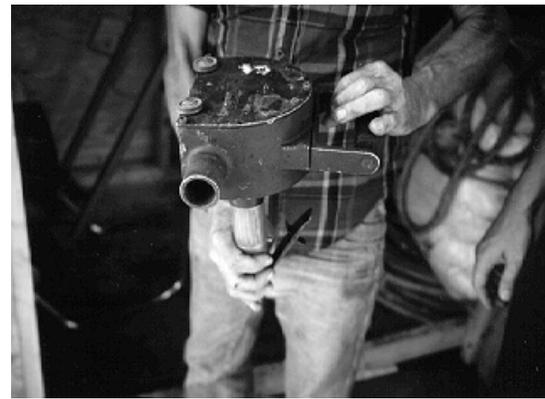
**Figure 32.** Close-up view of a pneumatic flush-plate tool. During the Sand Key Lighthouse rehabilitation this tool was used for all flat surfaces and for removing paint from the light-tower columns. The rollers located at the top and bottom of the shroud guide the tool over the flat and curved surfaces. The amount of air pressure controls the speed and impact of the rotating head against the iron substrate. To contain the paint dust and chips, the shroud has been outfitted with a vacuum hookup.

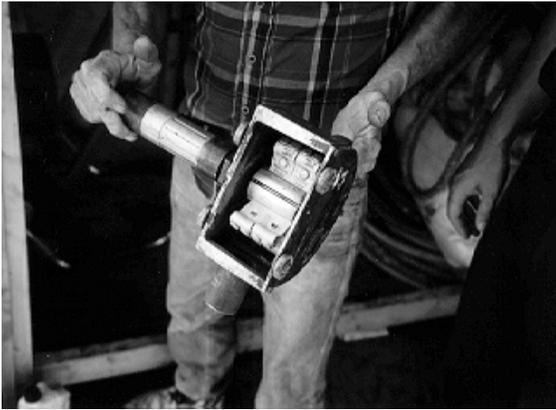
**Figure 33.** Close-up of the studded flaps mounted on the rotating head. To use the tool, it is held against the face of the iron member and as the studded flaps spin they “slap” the surface and “knock” the paint off the iron.

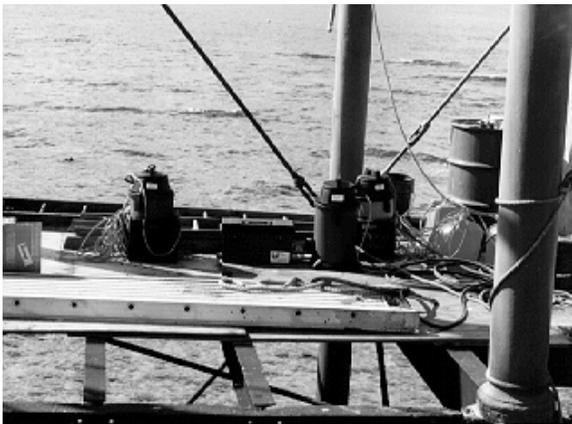
**Figure 34.** The small vacuums used at Sand Key Light are shown in this photo. Each vacuum has a HEPA filtration system to ensure that no lead dust escaped into the atmosphere. The conditions at Sand Key Lighthouse made the use of a large central vacuum system impractical. Using portable vacuums allowed for paint removal at numerous locations at any one time.

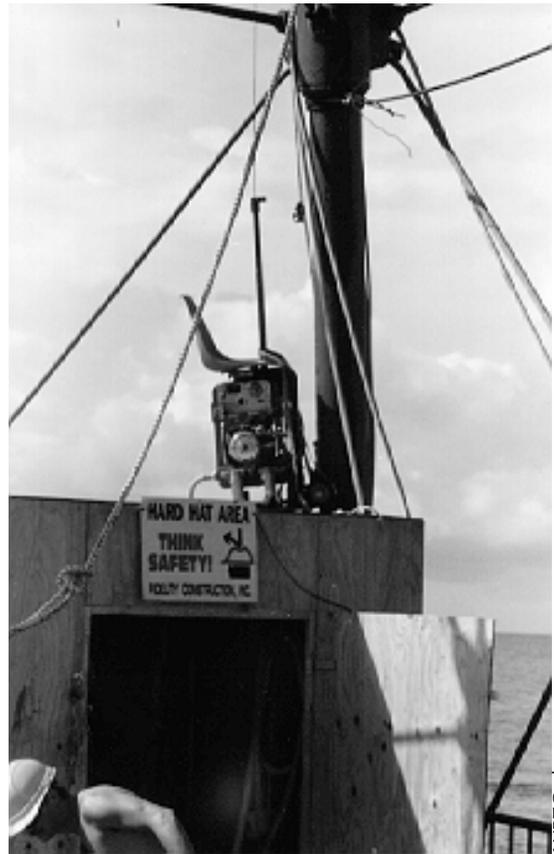
**Figure 35.** This motorized chair was used to hoist workers as they removed paint from the cast-iron columns at the Sand Key Lighthouse. The chair’s motor is attached to a hoist, so the chair actually climbs a cable that has been strung alongside the column.

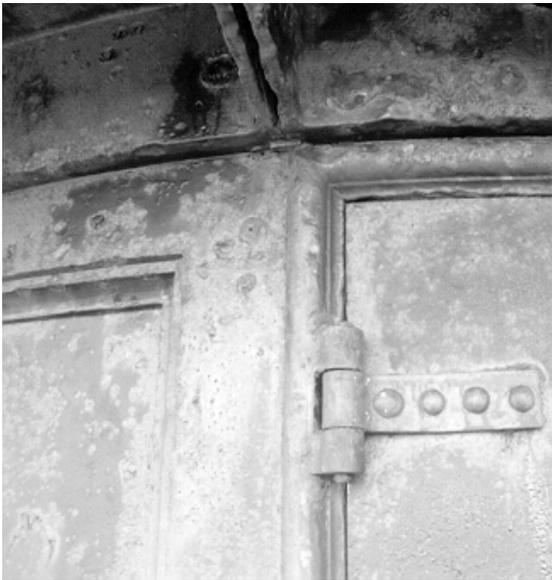
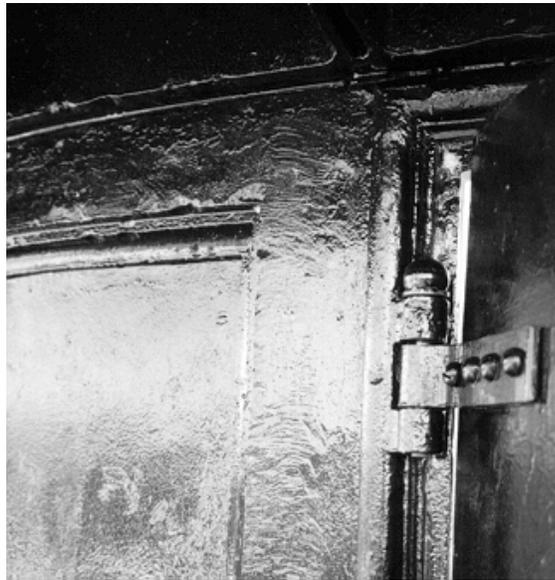
**Figures 36 and 37.** The left image shows the condition of the iron exterior service room wall before rehabilitation. The right image shows the same area after power hand tool cleaning and coating. The crescent shaped scars in the iron are from the arc of a grinding wheel.

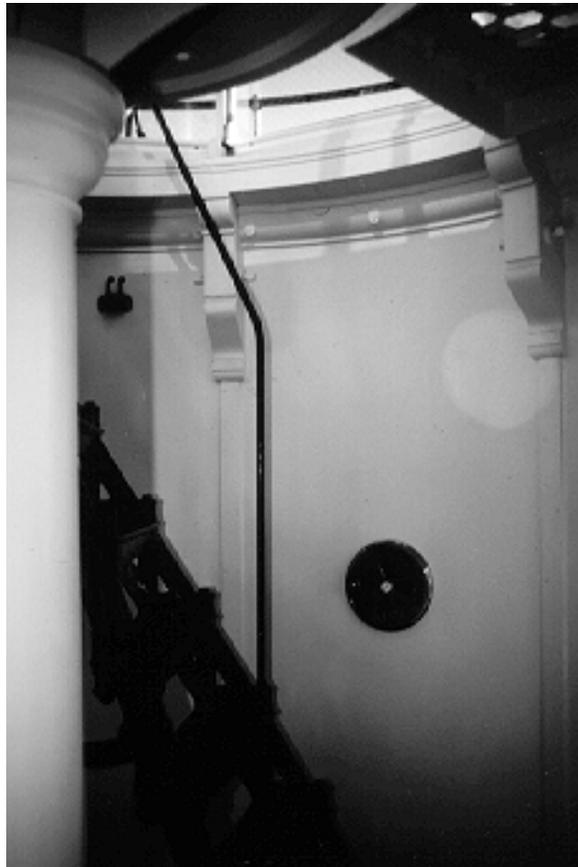
**Figure 38.** Service room bracket after chemical cleaning.

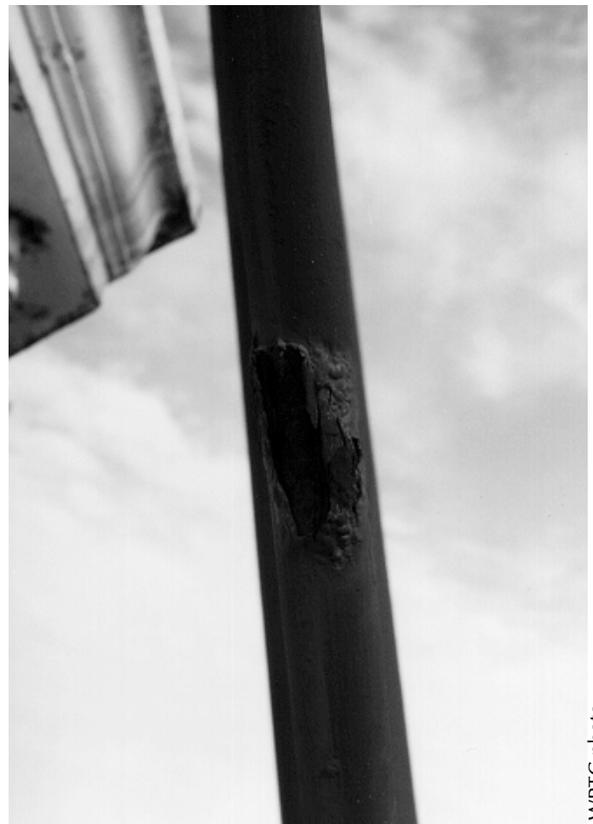
**Figure 39.** The finish on this tension rod failed and localized corrosion (rust) has formed. The rust is exfoliating in layers that are trapping moisture and causing corrosion to occur deeper and deeper into the tension rod. The result is pitting that will compromise the strength of the tension rod. If the area had been touched up in time, the corrosion might not have formed.

The effective protective life span of an existing paint or coating can be greatly increased by routinely touching up areas of deterioration. A small break in the protective finish can lead to accelerated corrosion of the underlying iron (see Figure 39). Areas where the paint or coating has been damaged by mechanical impact or blistering has occurred should be addressed immediately. These areas should have all loose paint and rust scale removed using one of the recommended methods

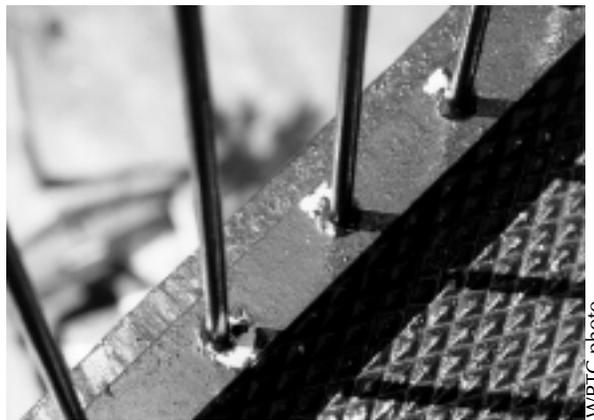
**Figure 40.** The paint on this stainless steel replacement gallery deck has begun to peel less than three months after it was painted. This could have been prevented if the stainless steel parts were first cleaned and then lightly glass-bead blasted.

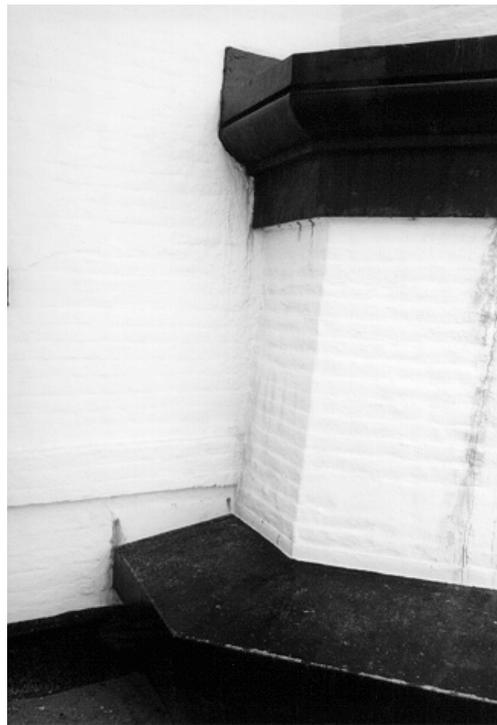
**Figure 41 (left).** This masonry lighthouse has been detailed with a two-tier cast-iron water table (the iron portions are painted black). Rust-bleed is occurring along lower edge of the upper tier.

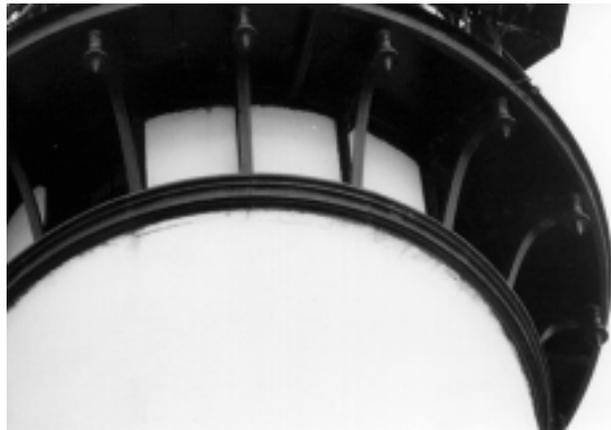
**Figure 42 (above).** The lower gallery deck of the same masonry lighthouse has rust-bleed occurring along the lower edge of the iron belt course that supports the gallery deck brackets.

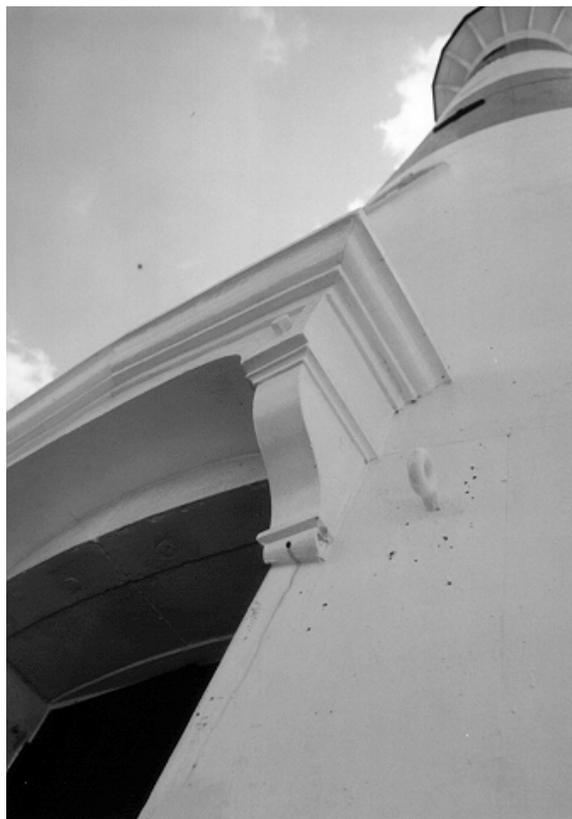
**Figure 45.** Within three months after painting, the rust began to bleed through this weep hole on the bottom of this pediment bracket. Two lessons are to be learned from this condition: 1) keep weep holes open to allow any water that may have entered the casting to escape, and 2) keep joints around applied castings sealed; apparently this was not done and water has entered the hollow cavity of the pediment, causing rust to form inside.

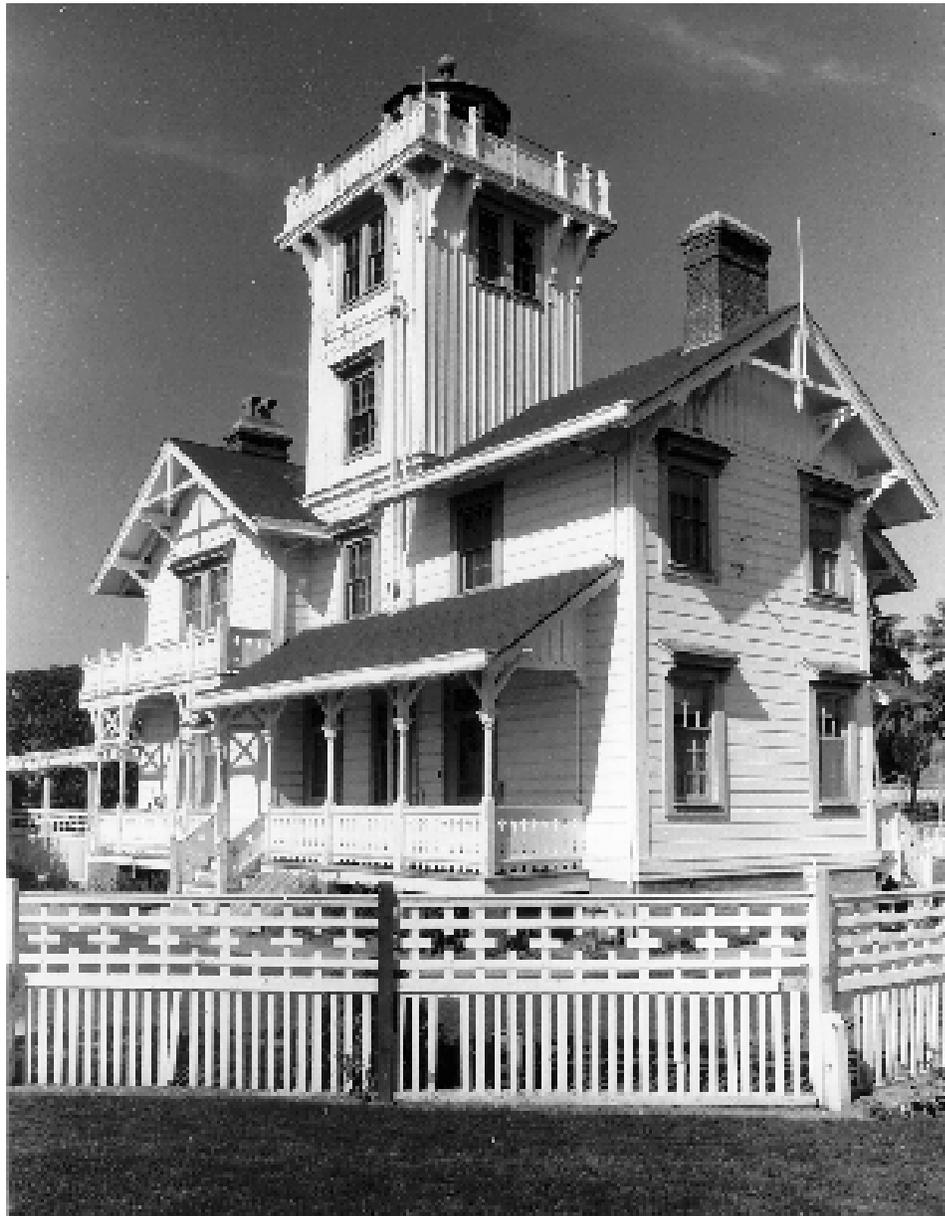
**Figure 2.** Wooden Point Fermin Light Station in San Pedro, California.

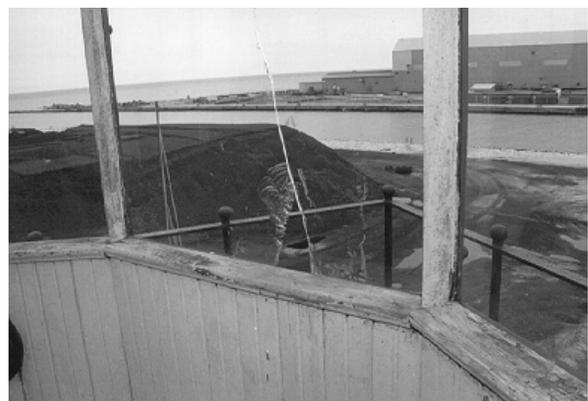
**Figure 5.** Storm glass with holes should be replaced as soon as possible to minimize water infiltration. If immediate replacement is not an option, the storm glass can be temporarily patched.

- **Lantern glass:** Lantern glass, frames, and roofs must be weathertight before mothballing (see Figure 5). Refer to the **Lantern** section for more information concerning the weatherproofing of the lantern components.
- **Built-in guttering systems:** All rainwater guttering systems (lantern roofs, or other tower roof forms) should be cleaned and checked for holes. Water entering the structure will cause premature deterioration of internal structural components. For more information refer to the discussion on roofing in the **Lantern** section.
- **Gallery decks:** In most wooden lighthouses gallery decks are wood covered in sheet metal. These decks are generally laid directly on top of

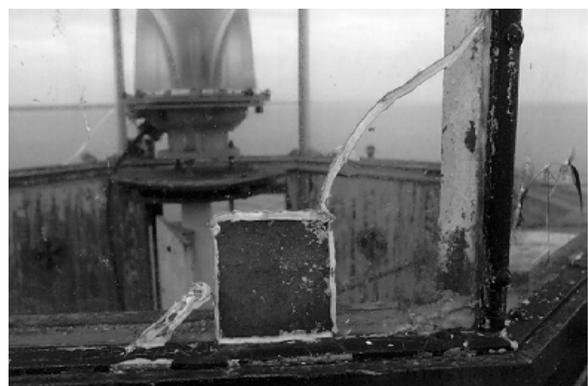
**Figure 6.** An acceptable temporary lantern glass repair made using a small piece of sheet metal and caulking.
