## Historic Lighthouse Preservation Handbook

The Historic Lighthouse Preservation Handbook was created through a cooperative partnership between the National Park Service, [U.S. Coast Guard](#), Department of Defense Legacy Resource Management Program, and U.S. Lighthouse Society. The 328-page preservation manual, released in August 1997, focuses primarily on the maintenance problems associated with the many different materials and construction techniques used in these unique structures. In addition to

sections devoted to preservation treatments, it includes a brief history of the U.S. Lighthouse Service and lighthouse construction types; existing historic preservation laws, standards, and guidelines; case studies for both lighthouse rehabilitation and restoration projects; related activities (interpretation, funding, safety management, etc.); and sources for more information.

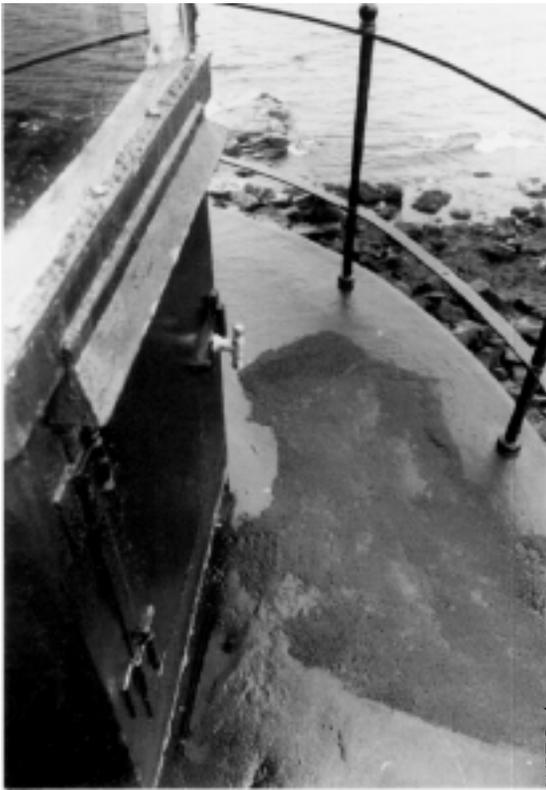
**Figure 7.** Ponding is occurring on this gallery deck near the base of the lantern parapet wall. This ponding has led to an active leak that occurs even during light rain conditions. A condition such as this should be remedied before the mothballing period.

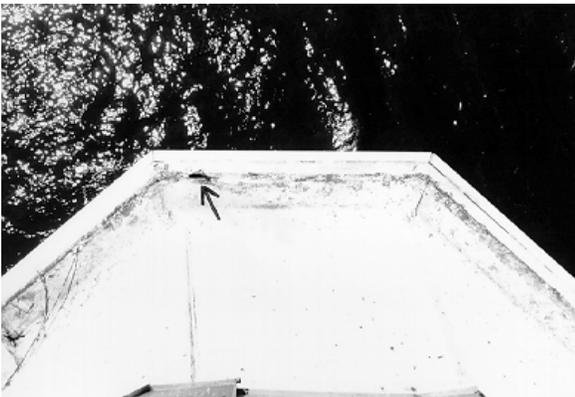
**Figure 8.** View of a wood-framed lighthouse roof; the arrow indicates where a large hole (approximately 2 by 4 inches) is present in the built-in gutter system. Water entering this hole has caused extensive damage to the interior wood framing members and wood interior wall paneling.

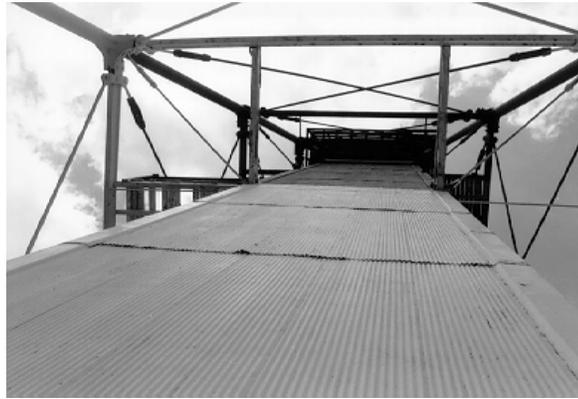
**Figure 9.** If the exterior of the wooden tower has been covered with another sheathing material like this corrugated metal, all joints in the exterior sheathing should be made completely weathertight; at this particular lighthouse, deterioration of interior wood framing members was caused by moisture infiltration.

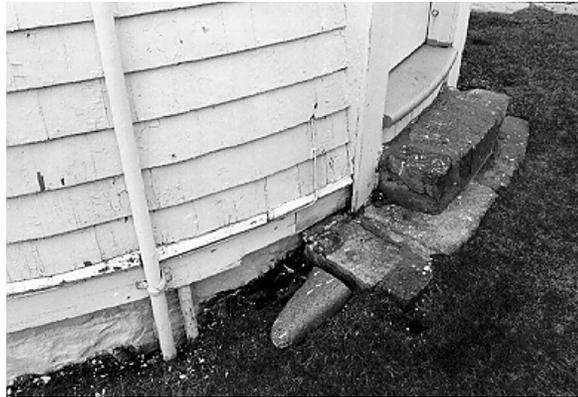
**Figure 10.** This door sill has a positive slope to ensure proper drainage; the joint where the door surround meets the shingles should be checked for gaps and recaulked if necessary.

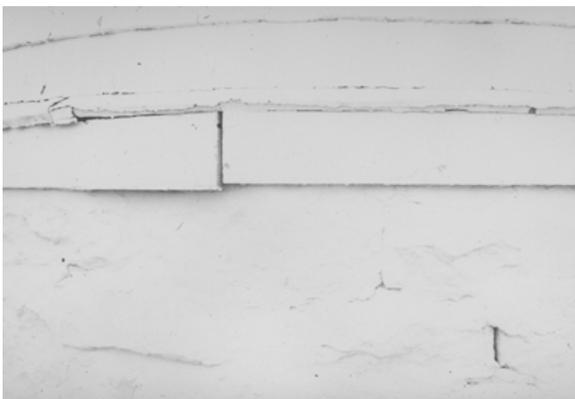
**Figure 11.** Open joints like those between these skirt boards must be properly primed, painted, and filled before mothballing the lighthouse.

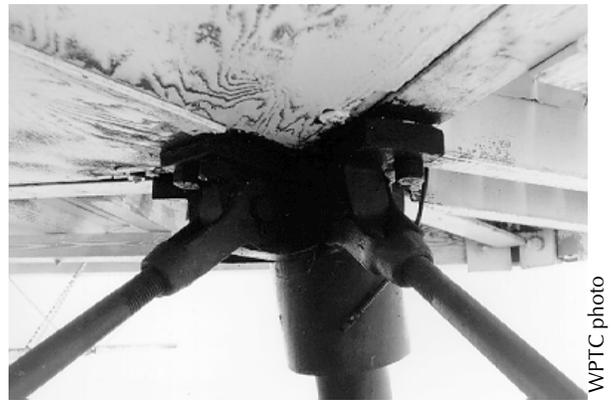
**Figure 12.** View of underside of a screwpile lighthouse. Although these bare wood surfaces are not directly exposed to rain, they are susceptible to mist and condensation moisture; and because there is no exposure to direct sunlight, the surfaces are seldom dry. For adequate protection during the mothballing period, these surfaces should be painted.

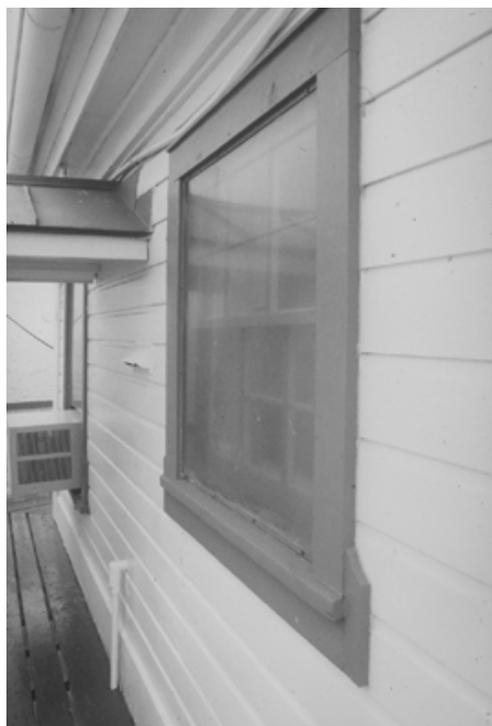
**Figure 13.** This image shows a Class I paint condition: virtually no deterioration, only some soiling and possible salt buildup resulting from the open-water location of the lighthouse.

**Class I:** Generally no paint removal—dirt, soot, pollution, chalking, mildew etc., (see Figure 13).

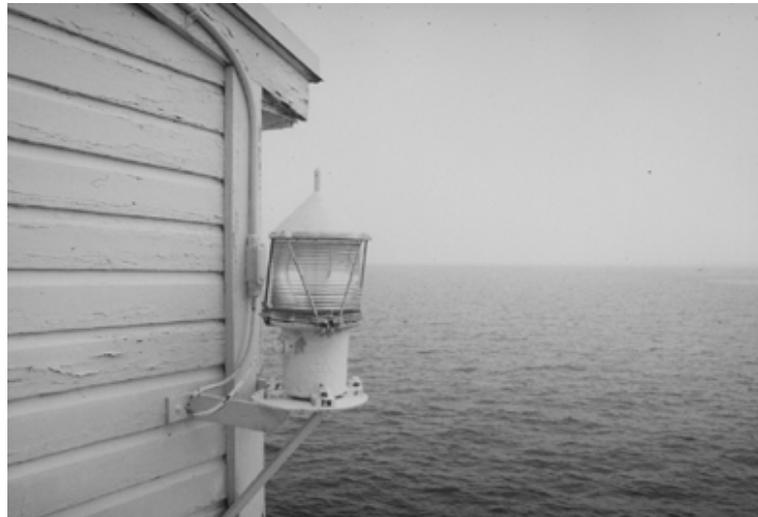
**Figure 14.** View of Class II paint condition: this example happens to be on the same lighthouse as the Class I condition shown in the previous image; multiple paint conditions can exist on the same lighthouse. In this example, only spot paint removal and repainting will be required to remedy the condition.

**Class II:** Generally limited paint removal—crazing, intercoat peeling, solvent blistering, wrinkling (see Figure 14).

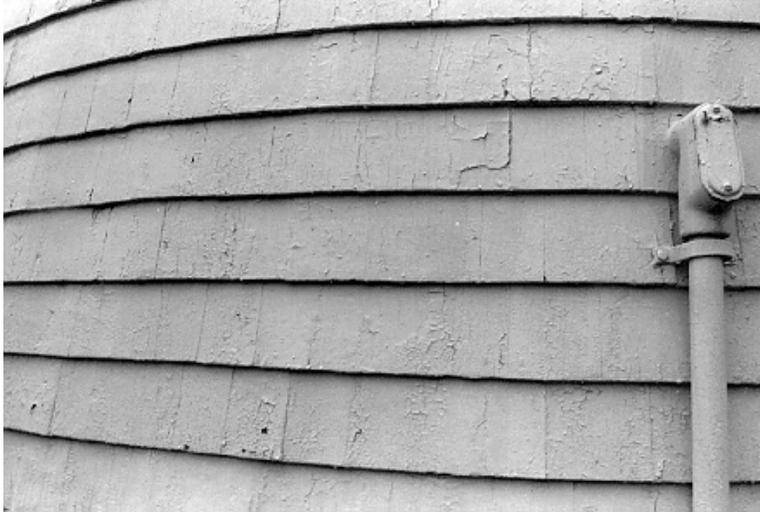
**Figure 15.** View of Class III paint condition: in this case the cracking, peeling, and alligoring have been caused by excessive paint layer build up.

**Class III:** Exterior surface conditions generally requiring total paint removal—peeling, cracking/alligating (see Figure 15).

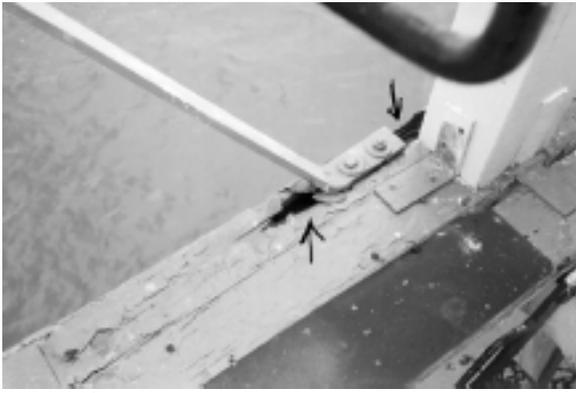
**Figure 18.** The wooden structural member that this bracket is attached to is extensively deteriorated. This condition is a prime example of deterioration that can be repaired by cutting back the rotted wood to a sound substrate, then fitting the void created with a wooden ‘dutchman’ or infill that matches as closely as possible the grain orientation and wood species as the existing member. Once the dutchman has been glued, and if needed, doweled in place, then the affected area should be properly primed and painted. This technique is affordable and incurs only minimal damage to the existing historic materials.

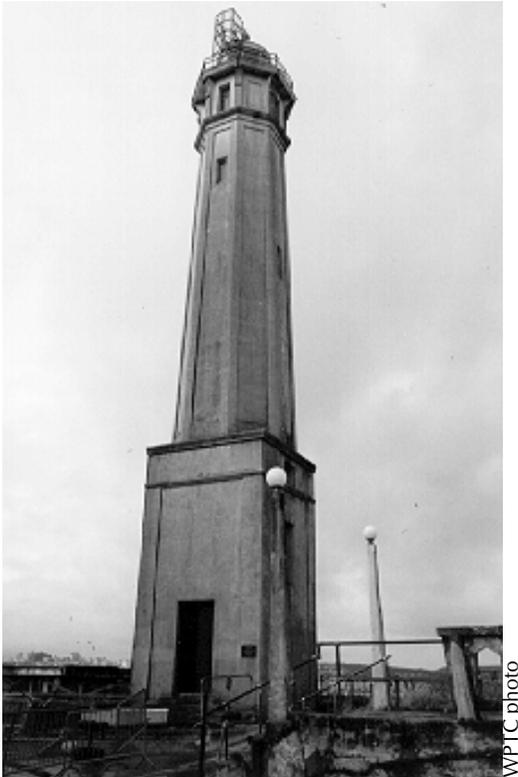
**Figure 2.** View of the Alcatraz Island Lighthouse. Reinforced concrete was chosen for this lighthouse location for its ability to withstand earthquakes.

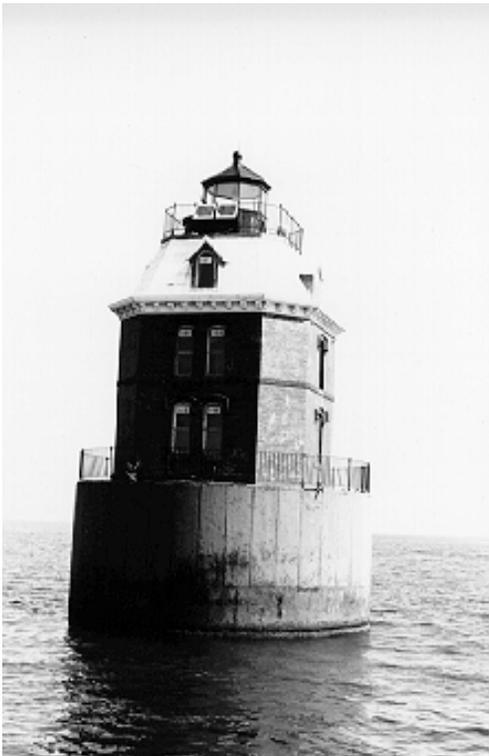
**Figure 3.** For the construction of this caisson-style lighthouse, unreinforced concrete was used as ballast to sink the cast-iron caisson foundation deep into the mud on the bottom of the Chesapeake Bay in Maryland.

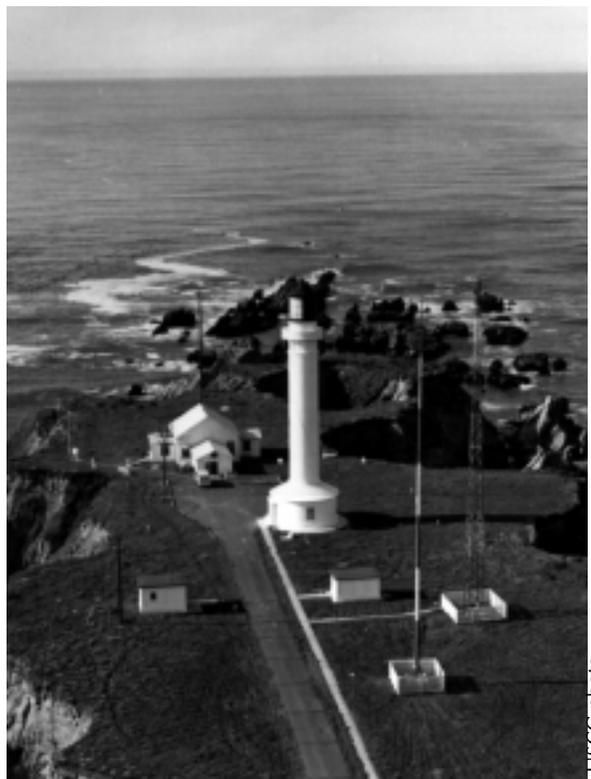
**Figure 4.** The first reinforced concrete lighthouse, Point Arena Light Station in California.

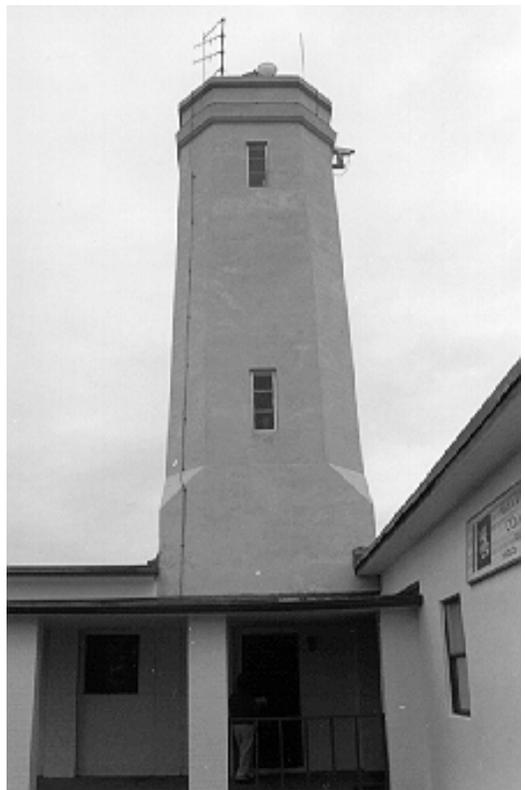
**Figure 5.** St. John's River Lighthouse, Mayport, Florida, was constructed of reinforced concrete for its economy and low maintenance.

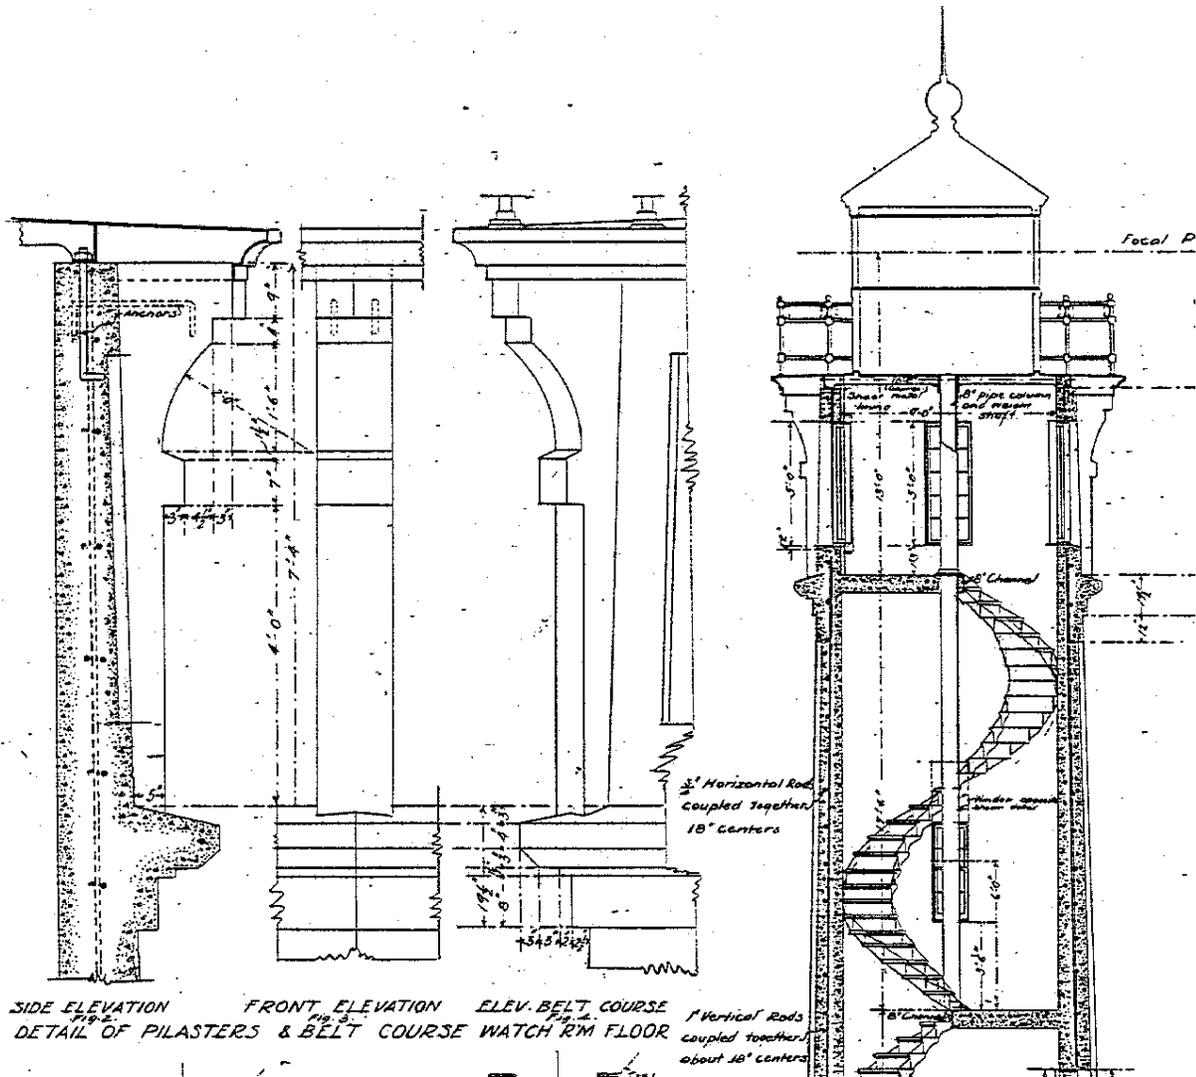
Figure 6. Image showing the placement of reinforcing bars in concrete lighthouse construction. (Image courtesy of CEU Oakland)

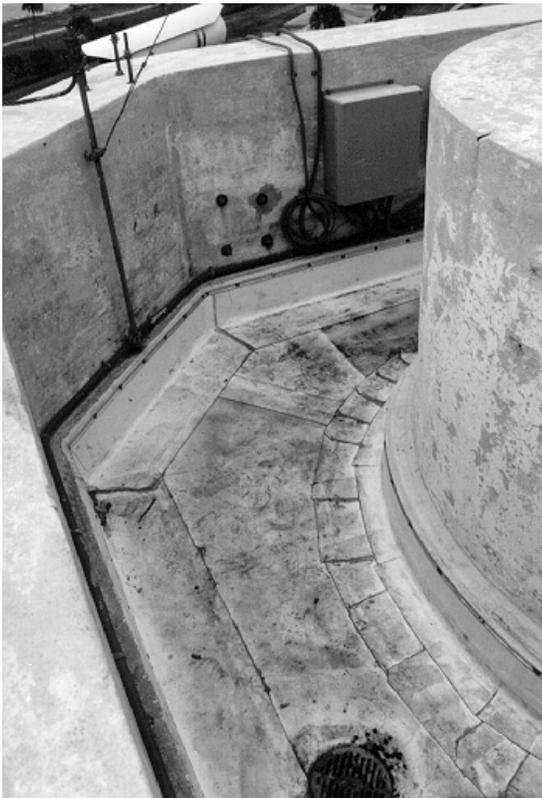
**Figure 7.** The concrete gallery deck on this concrete lighthouse has been covered with a rubber membrane. This covering should be checked regularly for leaks.

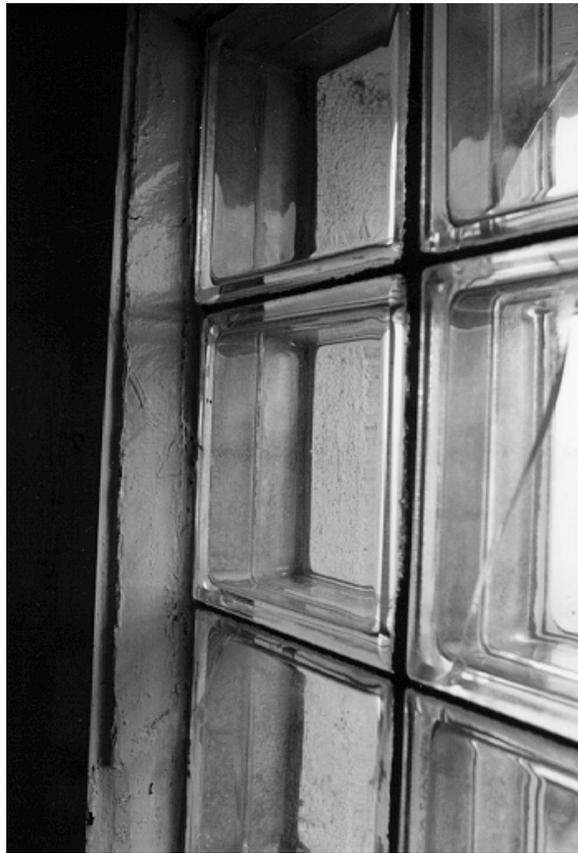
**Figure 8.** Close-up view of a glass-block window in a concrete lighthouse. The joint where the glass block meets the concrete wall should be caulked to prevent moisture infiltration.

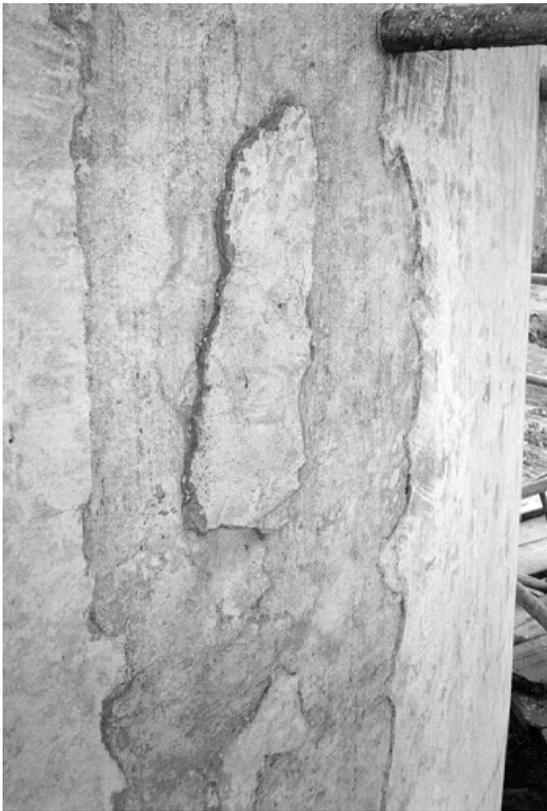
**Figure 9.** Patches of spalled concrete: familiar with lighthouse preservation the one pictured here should be repaired to protect the underlying concrete structure.

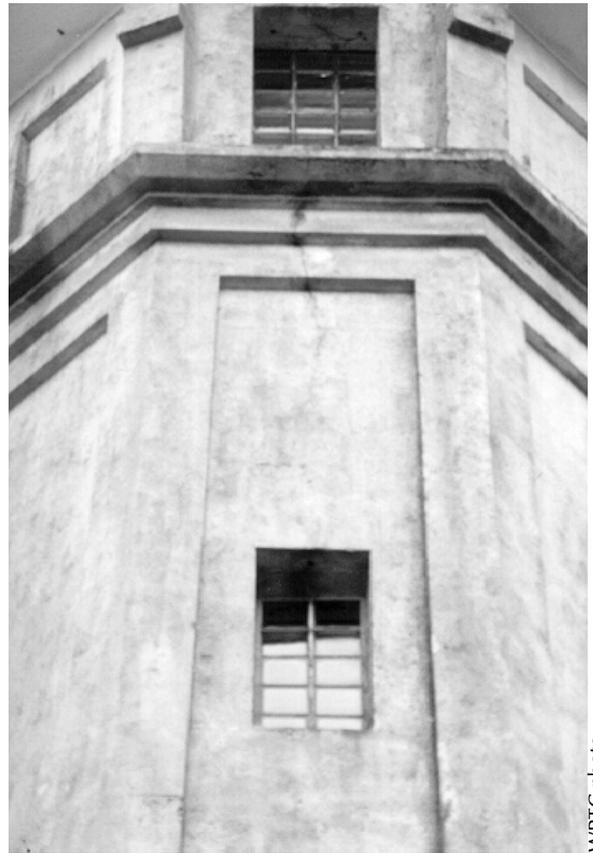
**Figure 10.** Cracks like the one here, extending down from the belt course of this concrete lighthouse, should be monitored for movement before any patching is performed.

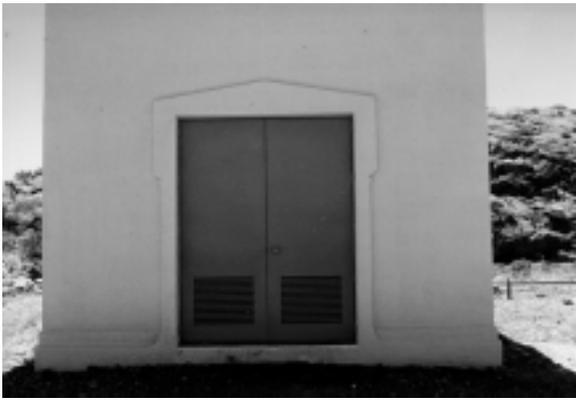
**Figure 11.** These replacement lighthouse doors have screened louvers that cover approximately 25% of the door opening to maximize air exchange.

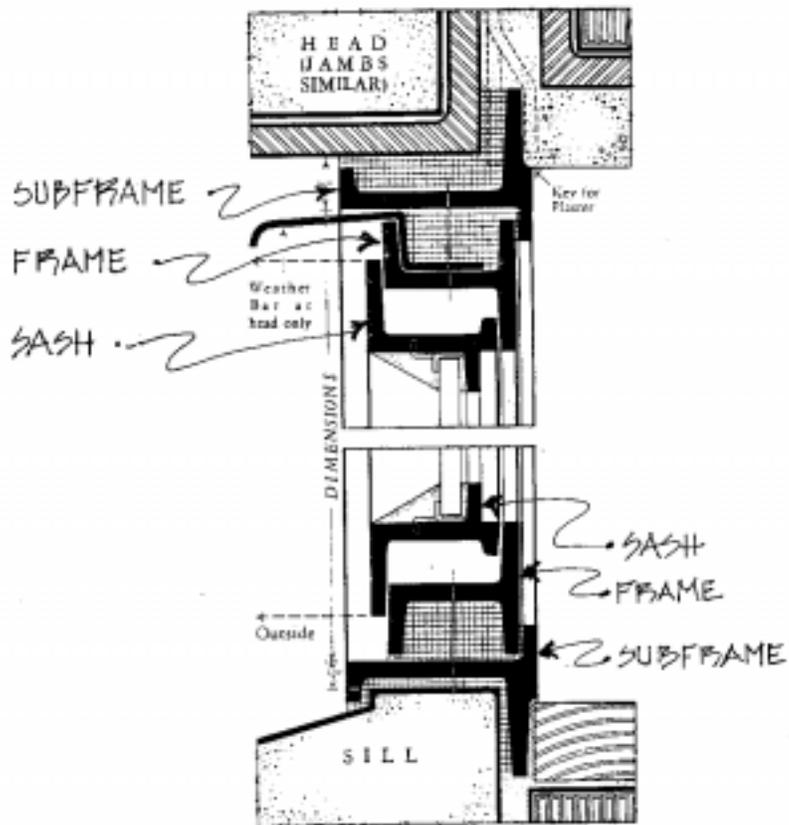
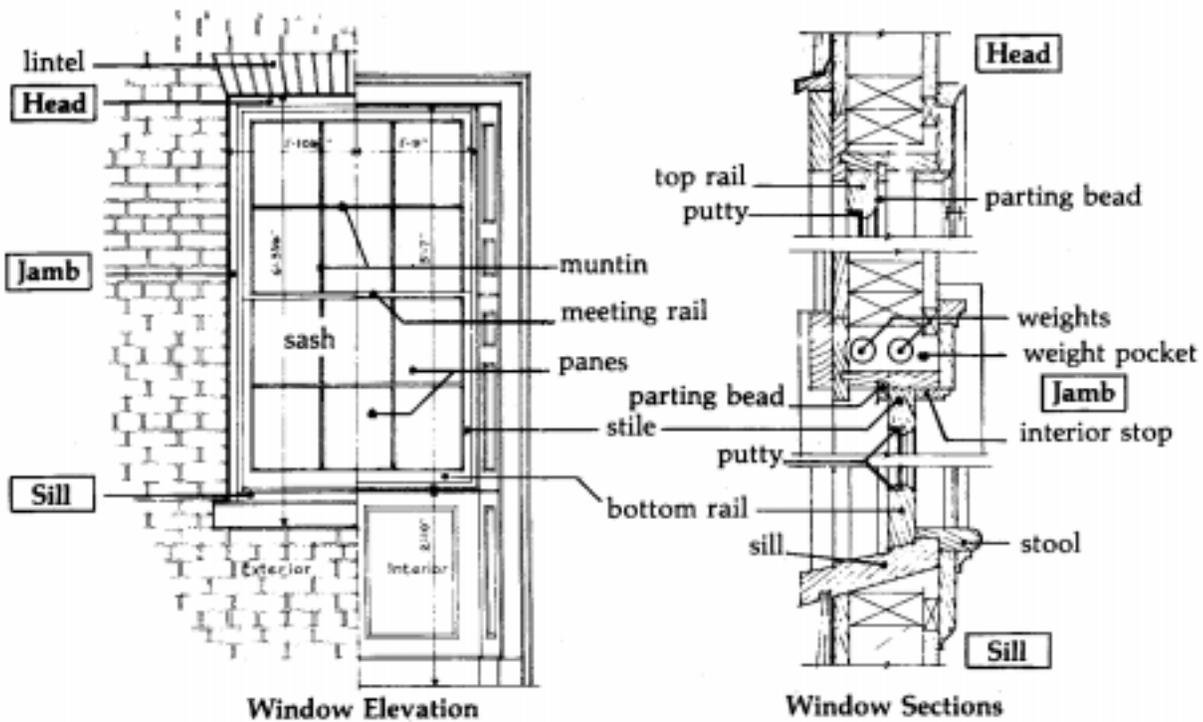
Figures 2 and 3. Wood and metal window details (source: *The Window Handbook*).

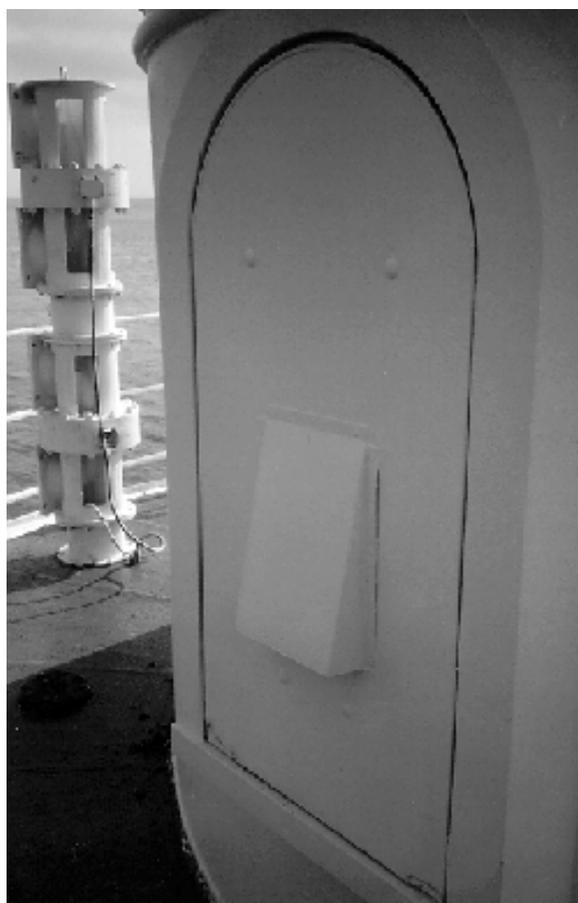
**Figure 4.** A good example of a blocked window using a metal panel fitted with a hooded vent. For more adequate ventilation, the vent should be larger.

- There are a number of ways to insert vented plywood panels into window openings to avoid damage to frame and sash. One common method is to bring the upper and lower sash of a double-hung unit to the midpoint of the opening and then to install pre-cut plywood panels on the inside face of the window using long carriage bolts anchored into horizontal wooden bracing, or strong backs (see Figures 4 and 5).

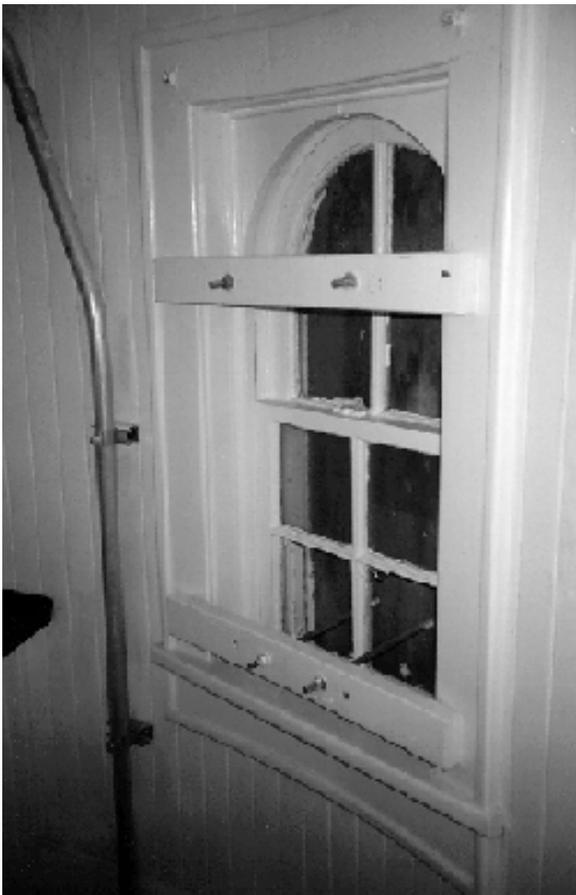
**Figure 5.** Interior view of the blocked window. If possible, a better solution would have been to raise the lower sash and lower the upper sash and pass the bolts through the openings.

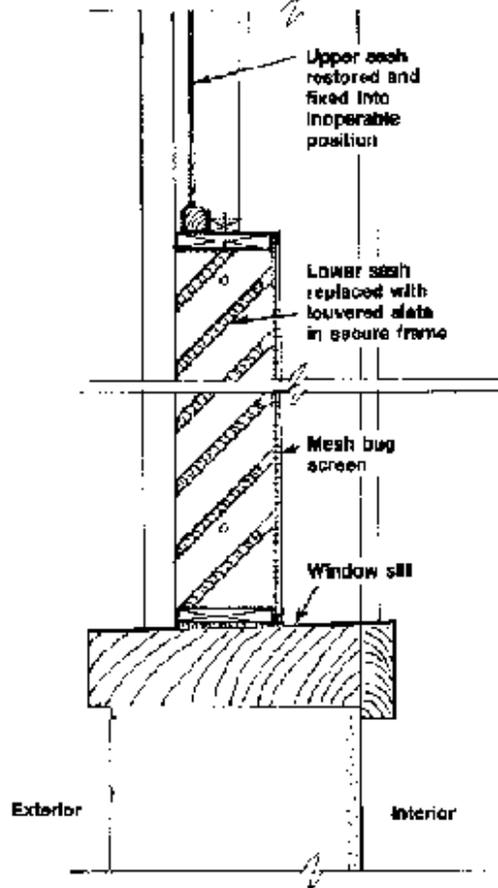
**Figure 6.** Detail of wood louver system designed to be inserted into lower sash opening after sash has been carefully removed. (Drawing by Thomas Vitanza, WPTC)

- The type of ventilation should not undermine the security of the building. The most secure installations use custom-made grills well anchored to the window frame, often set in plywood security panels. In upper-level windows vents formed using heavy millwork louvers set into existing window openings are another possibility (see Figure 6).

(To provide adequate ventilation, the louvered opening should have an area that is approximately half of the original sash opening.) When using this treatment, the sheeting must be ventilated to ensure that condensation, which could accelerate the deterioration of the window, does not build up between the panel and the window.

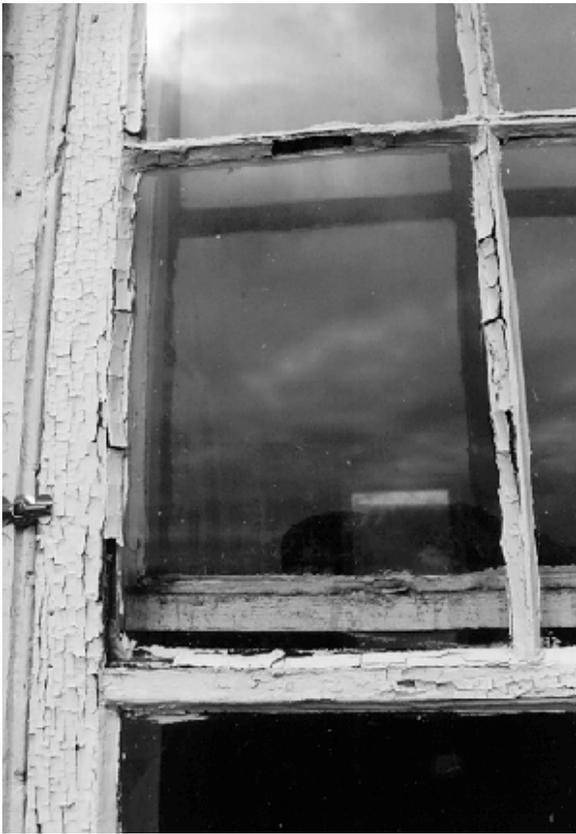
**Figure 7.** Deteriorated glazing putty and peeling paint on a multilite wood sash.

- Figures 7 through 9 illustrate forms of deterioration typical to lighthouse windows. All of these conditions are repairable and do not require total replacement. The following guidelines are intended to aid in the repair of such deterioration.

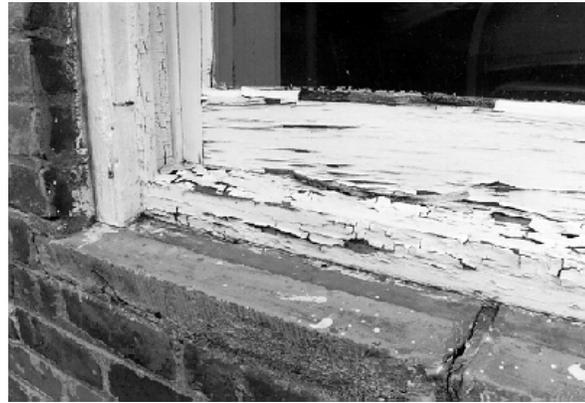
**Figure 8.** Deterioration of the bottom rail and sill on a wooden double-hung window.

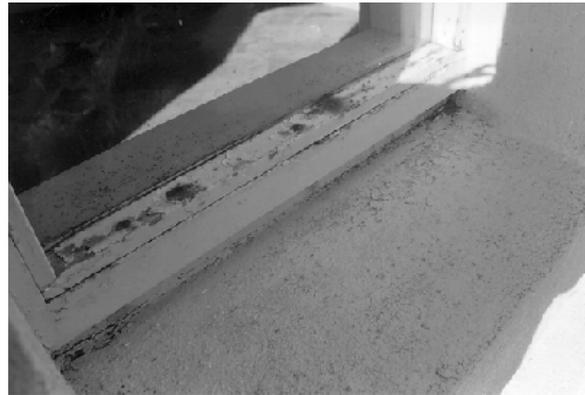
**Figure 9.** Rust occurring on the inside of the steel channel that forms the sill of this metal casement window.

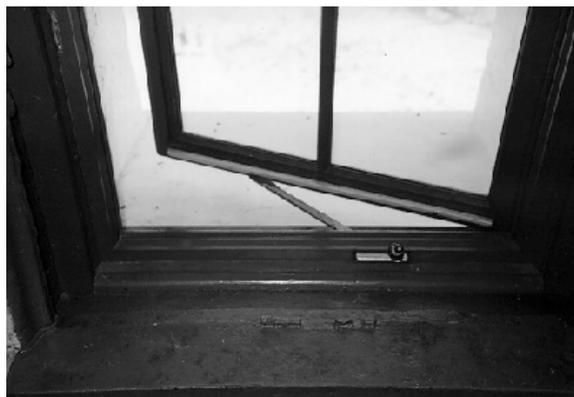
**Figure 10.** Close-up of a recently restored replacement metal window at Cape Hatteras Lighthouse. Now that the repair work is done, all that this window needs is the hardware lubricated and periodic maintenance to remain in operable condition for the next 50 years. At the time of this lighthouse restoration, it was discovered that the original windows were not repairable and funds were not available to replicate the original cast-iron frame design. The original windows were more like a shutter, constructed in two parts, hinged at both sides and meeting in the middle. The new landing windows were installed as a temporary measure until additional funds are available.

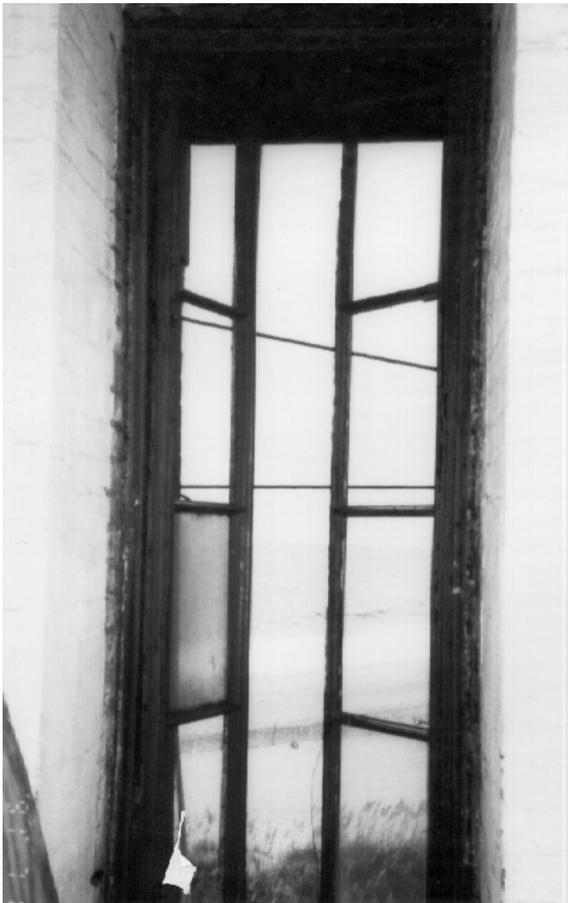
**Figure 11.** Example of a metal casement window in a lighthouse dating from the 1870s

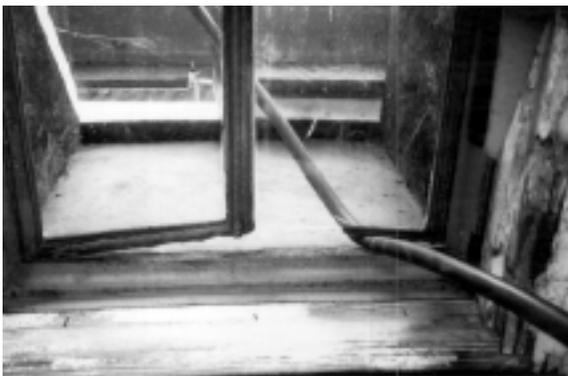
**Figure 12.** Close-up of severely deteriorated bottom rail of the same window in Figure 11. This condition can be repaired by splicing a new piece of sash

Deteriorated portions of wood windows can be effectively repaired using like-kind splices or dutchmen. Splicing of a wood member is required when a portion of the window, i.e., a frame rail, has been damaged or has deteriorated and only that portion needs removal and a new section attached in its place. All deteriorated material should be removed, and the end where the replacement member will be attached should be cut on a diagonal to increase the gluing surface area. The replacement member should match the existing members in grain orientation and in any existing shape or profile. The new member can even be made from matching salvaged stock. To attach the new member,

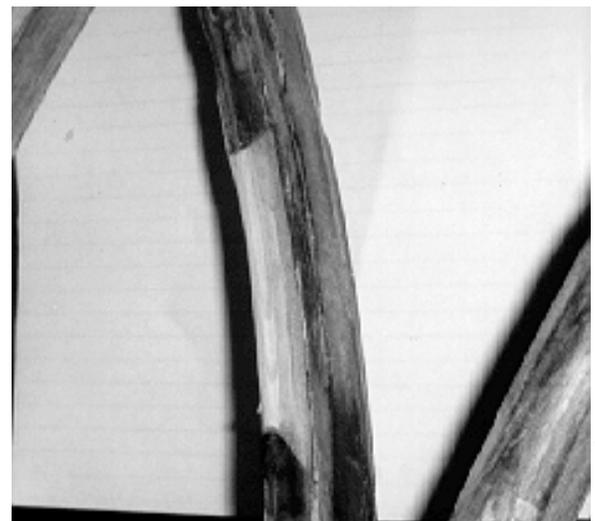
**Figure 13.** Close-up of a dutchman repair (light-colored wood used to mend a window muntin).

probe the deteriorated area to determine the approximate depth of the deterioration. Second, cut a wood patch or dutchman with its grain aligned with the existing member's. The dutchman can be rectangular or diamond shaped. Both shapes will work; however, a diamond shape is a little more difficult to fit but will provide more gluing surface and blend with the grain better if the window is finished with varnish instead of paint. Be sure the dutchman is large enough to cover the affected area and thicker than the deterioration is deep. Slightly bevel all of the edges of the dutchman so that the widest face is the top. This will ensure a tight cork-like fit. Next, trace the outline of the dutchman's narrowest face on the existing member over the deterioration. Using the outline as a guide, carefully remove all of the deteriorated wood with a chisel. Test-fit the dutchman, and trim the hole until the dutchman bottoms out and fills the affected area entirely; the dutchman should be slightly higher than the existing material. Glue and clamp the dutchman in place. Once the glue has cured, use a chisel or hand plane to make the dutchman flush with the surrounding material. Hand sanding can be used for the final leveling of the two surfaces.

A 'dutchman' is a fitted patch in a wood member that has only localized deterioration. To fit a dutchman, first

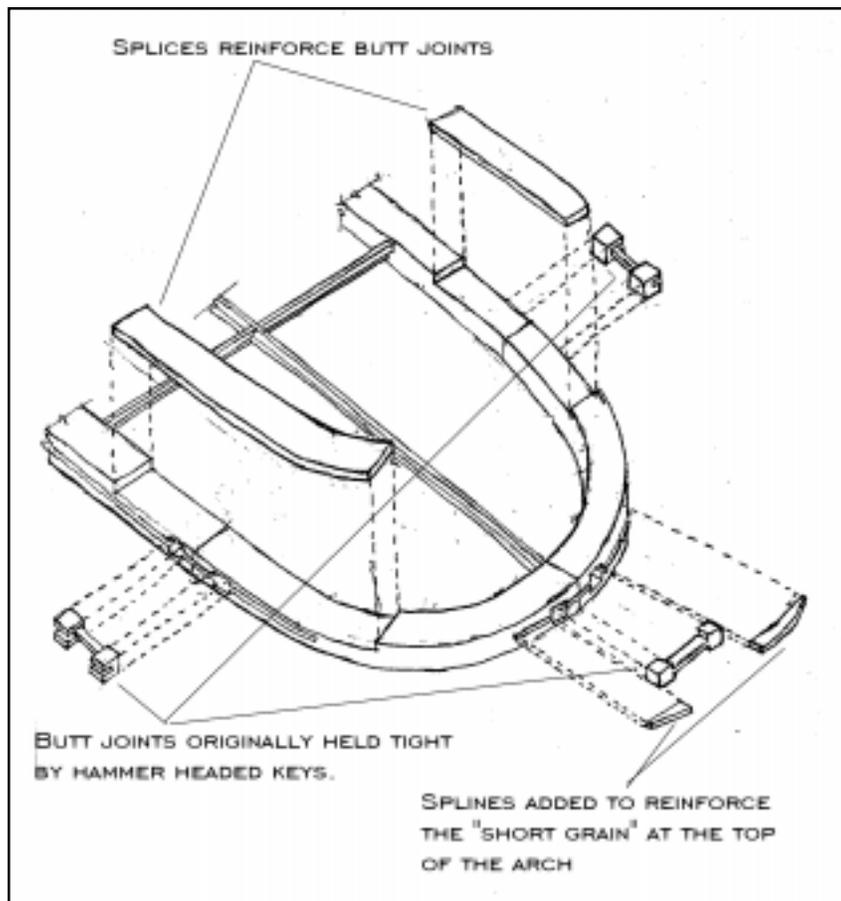
**Figure 14.** A wood window splice repair. (Illustration by Eric Ford, WPTC)

cut the end diagonally to match the existing member; then drill aligned holes in both members for reinforcing dowels.

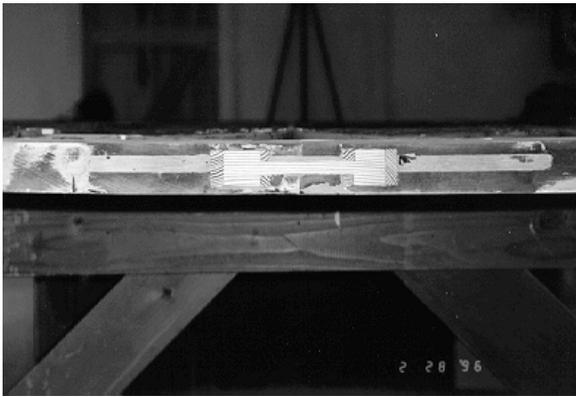
**Figure 15.** This window sash frame was repaired with traditional (replacement wood hammerhead key) and modern epoxy filler (material to left and right of the hammer head key) techniques.

In cases where a limited amount of rot has progressed well into the substrate, interior voids are filled in by saturating the wood with a penetrating epoxy consolidant formulated for wood. Surface voids, as well as decayed or missing ends near joints, are then filled or built up with an epoxy compound. When sash are in such poor

condition that they require consolidation, puttying and painting are typically also needed. Moreover, the joints connecting stiles and rails are likely to have become loose. After the glass and paint in affected areas have been removed, the sash is placed in a jig on a horizontal surface. Separated corners should first be repaired by pulling the joints together with a pipe clamp, drilling holes through adjacent stiles and rails, and securing each joint with a blind dowel. Rotted, missing, or eroded sections are then treated with the saturating epoxy, allowed to cure, and resurfaced with the epoxy paste. Surfaces are then sanded and painted as required.

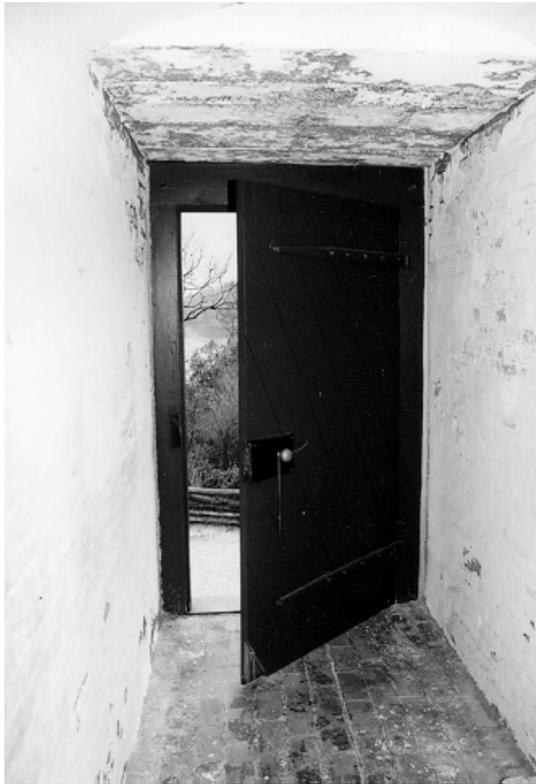
**Figure 5.** View of the large, single-leaf, wood-plank door at the Cape Henry Lighthouse (first tower), Fort Story, Virginia.

- **Wood plank door:** A door of one or two leaves that is constructed of two layers of tongue and groove wood planks that run vertically on the exterior side of the door, and typically run horizontally or diagonally on the interior. The planks are typically fastened by clinch nailing (nails that are driven through the outside of the door and bent over on the inside). The door is usually reinforced with horizontal 'battens' at the hinge locations: a diagonal batten may run from the top batten to the bottom batten. Such a door is typically hung on strap hinges; however, butt hinges may have been used. This construction method is used to limit the exposure of the end grain in the boards to the top and bottom of the door.

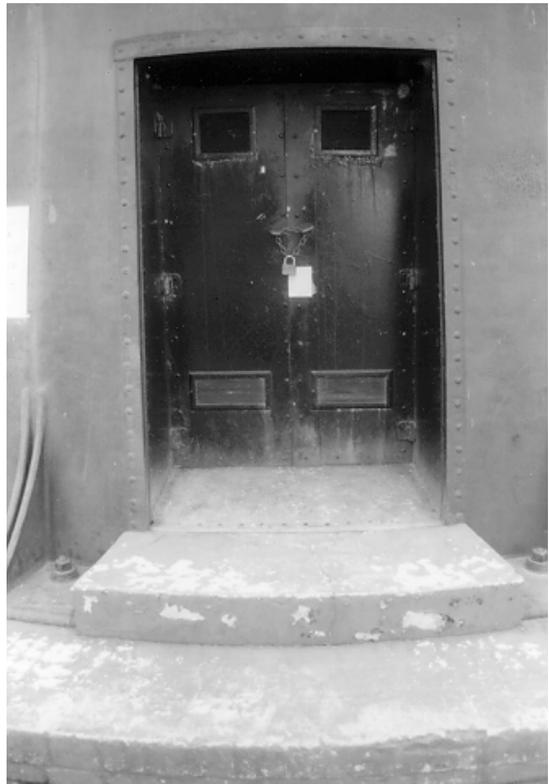
**Figure 7.** Another variation on the double-leaf, sheet-iron door configuration at the Cape Canaveral Lighthouse, Florida.

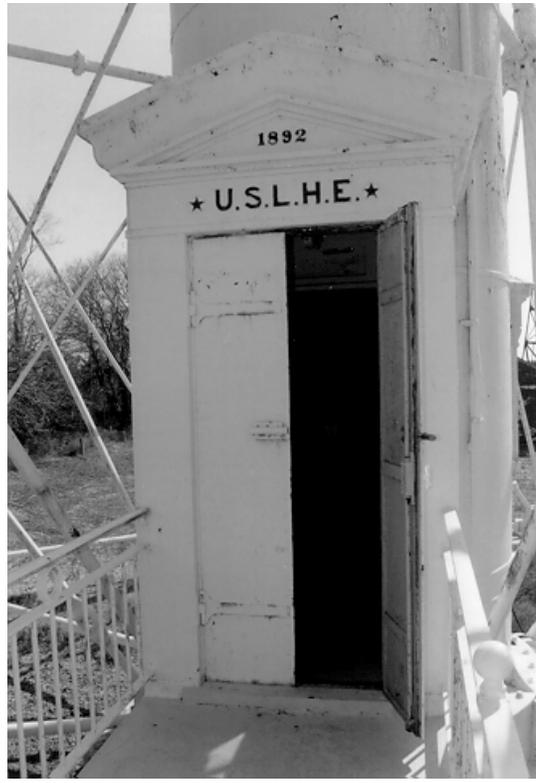
**Figure 6.** Close-up of the neoclassical, double-leaf, sheet-iron door at the Cape Charles Lighthouse, Smith Island, Virginia.

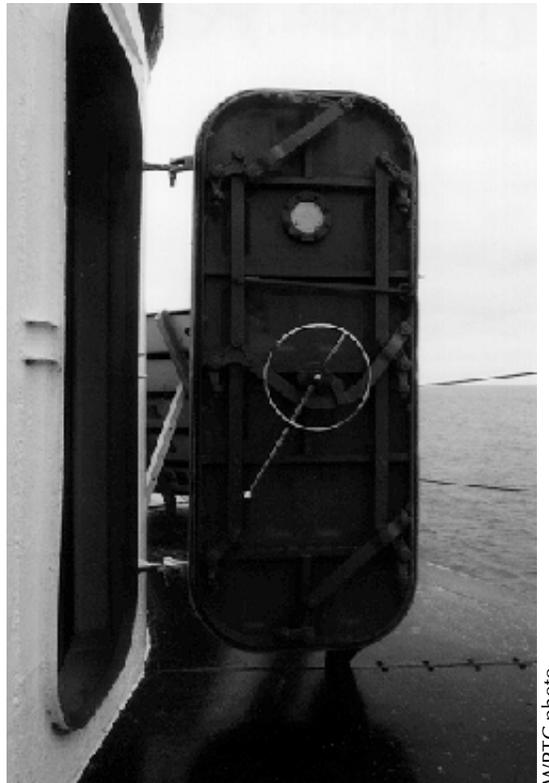
**Figure 8.** An example of a typical watertight 'ship' style door at Los Angeles Harbor Lighthouse, California.

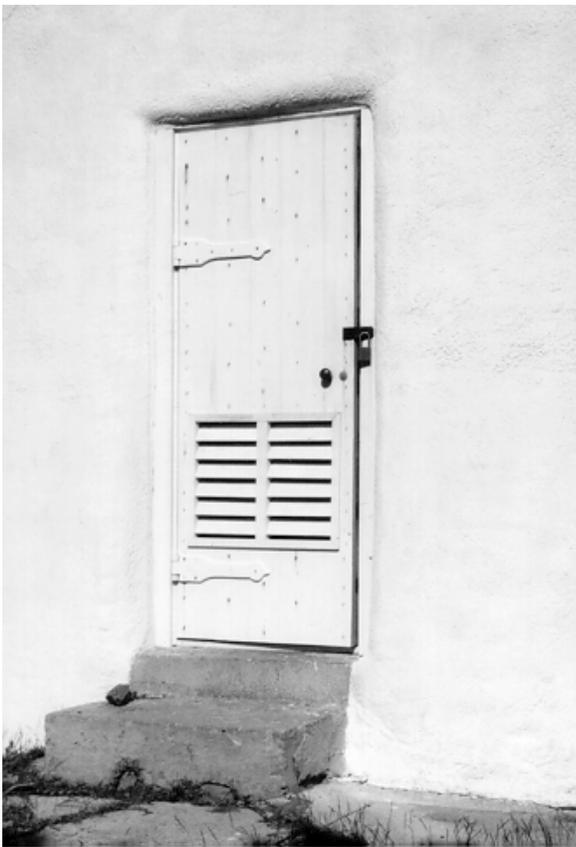
**Figure 9.** View of the Ocracoke Lighthouse five years after replacement; note rust streaks from nails. This condition indicates the paint coating has degraded to the point where moisture has permeated the surface.

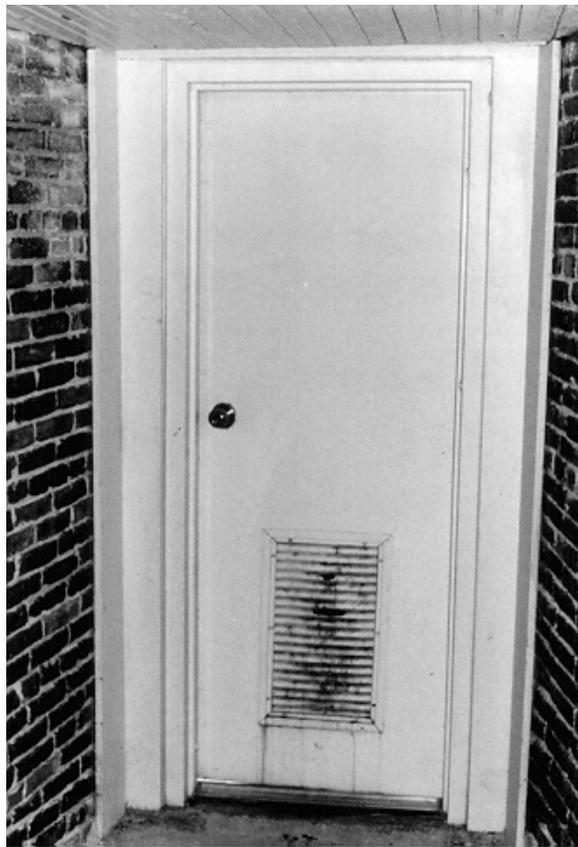
**Figure 10.** Interior view of the modern metal door at the Ocracoke Lighthouse before its replacement; corrosion like this should be removed and the affected areas treated with a rust-inhibiting coating system.

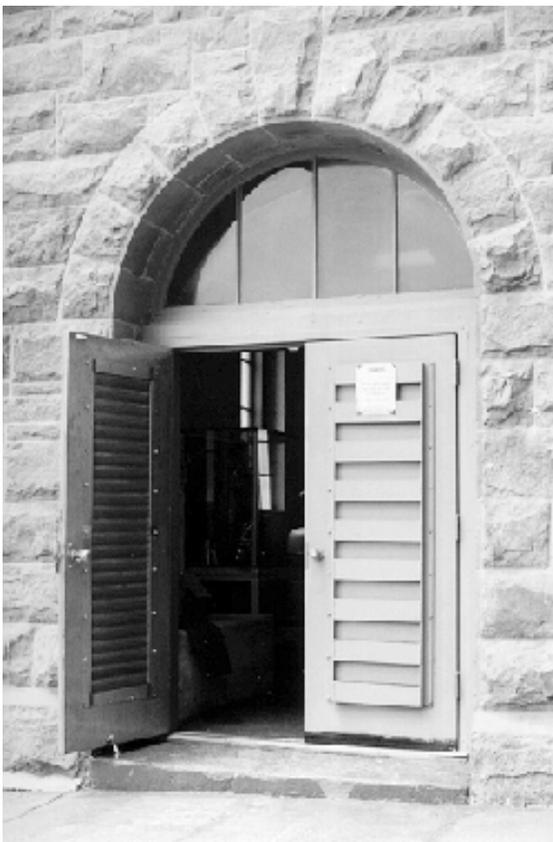
**Figure 11.** These louvered doors have been installed at Point Sur Light Station for security and ventilation. Note the baffles on the exterior and the screened louvers on the interior.

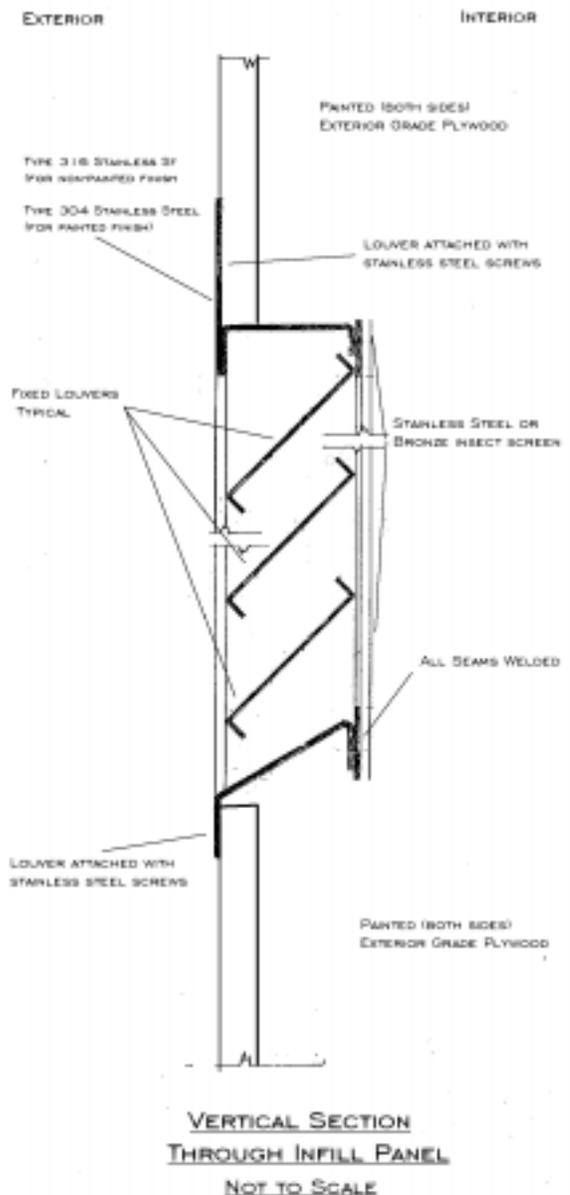
**Figure 12.** Typical detailing of a ‘storm proof’ louver for temporary lighthouse doors. (WPTC image adapted from drawing from USCG-CEU Oakland Archives)

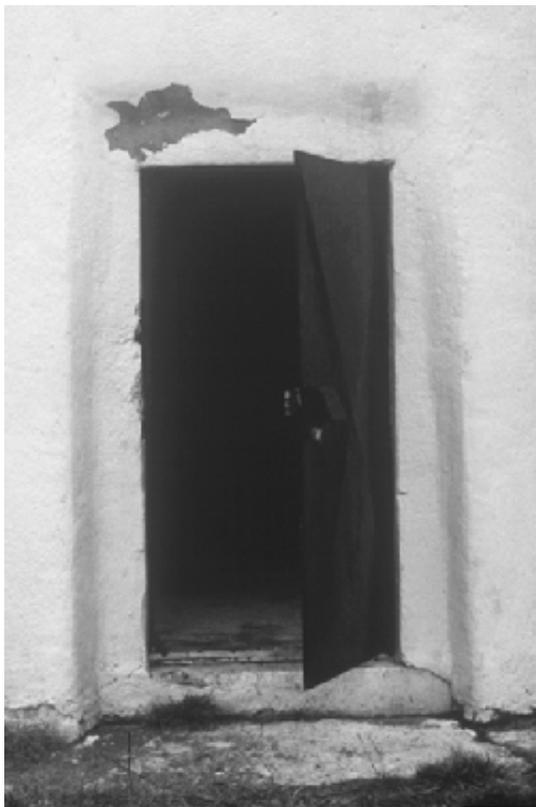
**Figure 13.** Site-built steel door at the Turkey Point Lighthouse; this solution was chosen because of the remote location and repeated break-ins. Note exterior stiffeners and shroud over the hasp and lock.

*Site-built, fabricated steel door:* This door consists of a steel 'C' channel frame set into the existing opening that is lag-bolted to the existing door frame. On the outside of this frame, the door leaf is connected by welding the hinges to both the frame and door leaf. The door leaf should overlap the opposite door frame to facilitate the installation of an eye that will pass through a slot in the door leaf to facilitate a lock. A steel shroud big enough to facilitate lock operation with a key, but prevent bolt cutters from reaching the lock, should be welded over top of the eye slot. If the lighthouse is not in an area that is to being wave swept (i.e., if the lighthouse is located on a breakwater or pier), the door should be fitted with screened louvers that are approximately 25 percent of the total door area. The louvers
