## Historic Lighthouse Preservation Handbook

The Historic Lighthouse Preservation Handbook was created through a cooperative partnership between the National Park Service, [U.S. Coast Guard](#), Department of Defense Legacy Resource Management Program, and U.S. Lighthouse Society. The 328-page preservation manual, released in August 1997, focuses primarily on the maintenance problems associated with the many different materials and construction techniques used in these unique structures. In addition to

sections devoted to preservation treatments, it includes a brief history of the U.S. Lighthouse Service and lighthouse construction types; existing historic preservation laws, standards, and guidelines; case studies for both lighthouse rehabilitation and restoration projects; related activities (interpretation, funding, safety management, etc.); and sources for more information.

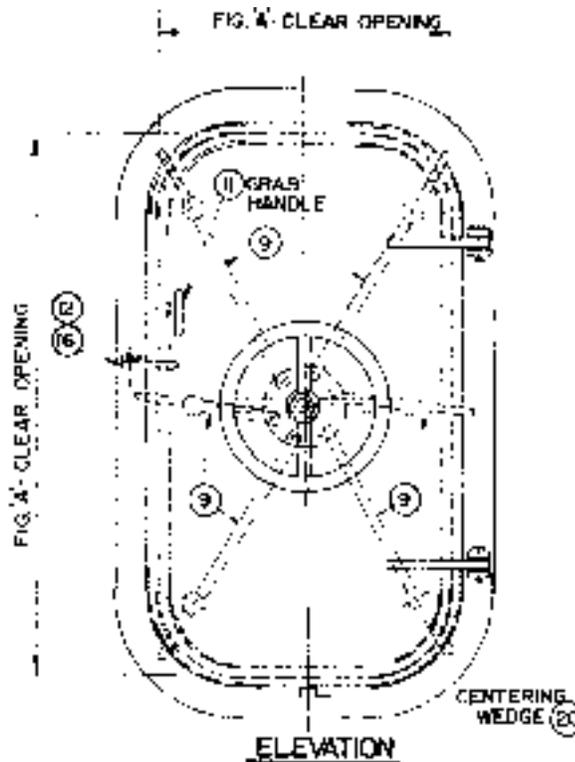
**Figure 14.** A shop drawing depicting the parts of the watertight 'ship' style door. (Drawing courtesy of Cen-Tex Marine Fabricators)

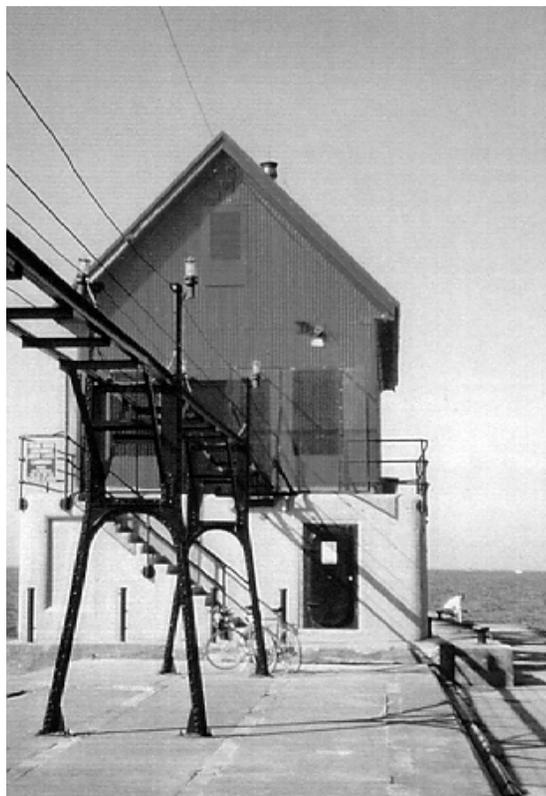
**Figure 15.** View of wwatertight 'ship' style door installation on the Grand Haven South Pierhead Front Range Light, Grand Haven, Michigan.

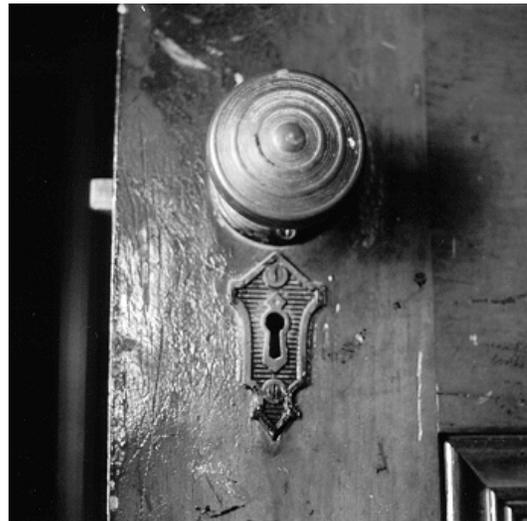
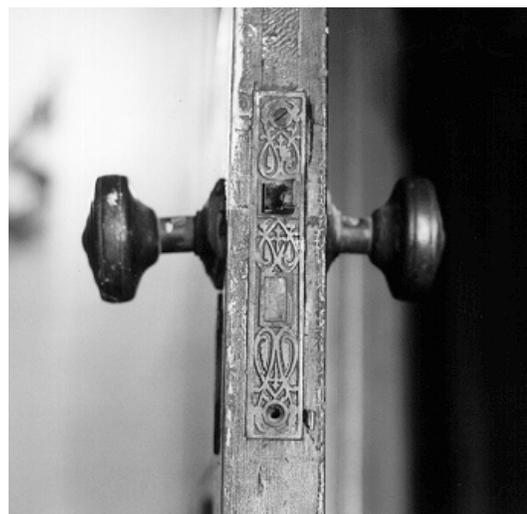
**Figures 16 and 17.** Examples of decorative door hardware found in late 19th-century lighthouses.

Historic lighthouse door hardware is not only functional but also significant in defining the character of the historic door. Lighthouse door hardware such as door knobs, hinges, keyhole escutcheons, and even strike plates were often decoratively detailed with motifs of the architectural style of the lighthouse. When preserving historic lighthouse doors, the existing hardware should be retained. When repairs are made to the door, the hardware should be removed for protection or protected in place to avoid any damage that may be incurred during the repair process. If the hardware is removed, label each piece to

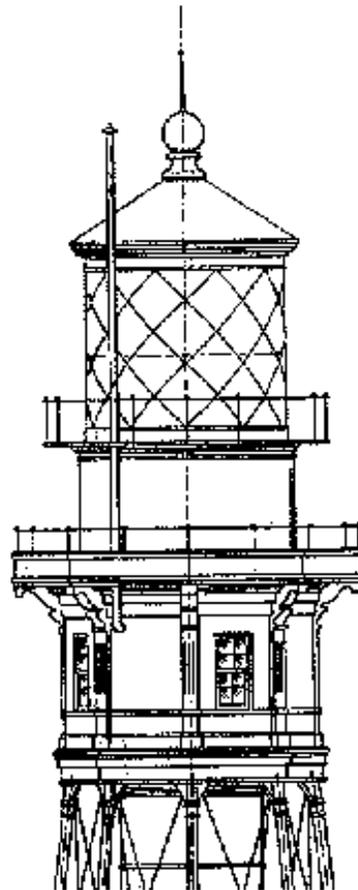
National Archives

**Figure 2.** Original construction drawing of the first-order Cape Fear Lighthouse showing the lantern above the service/watch room.

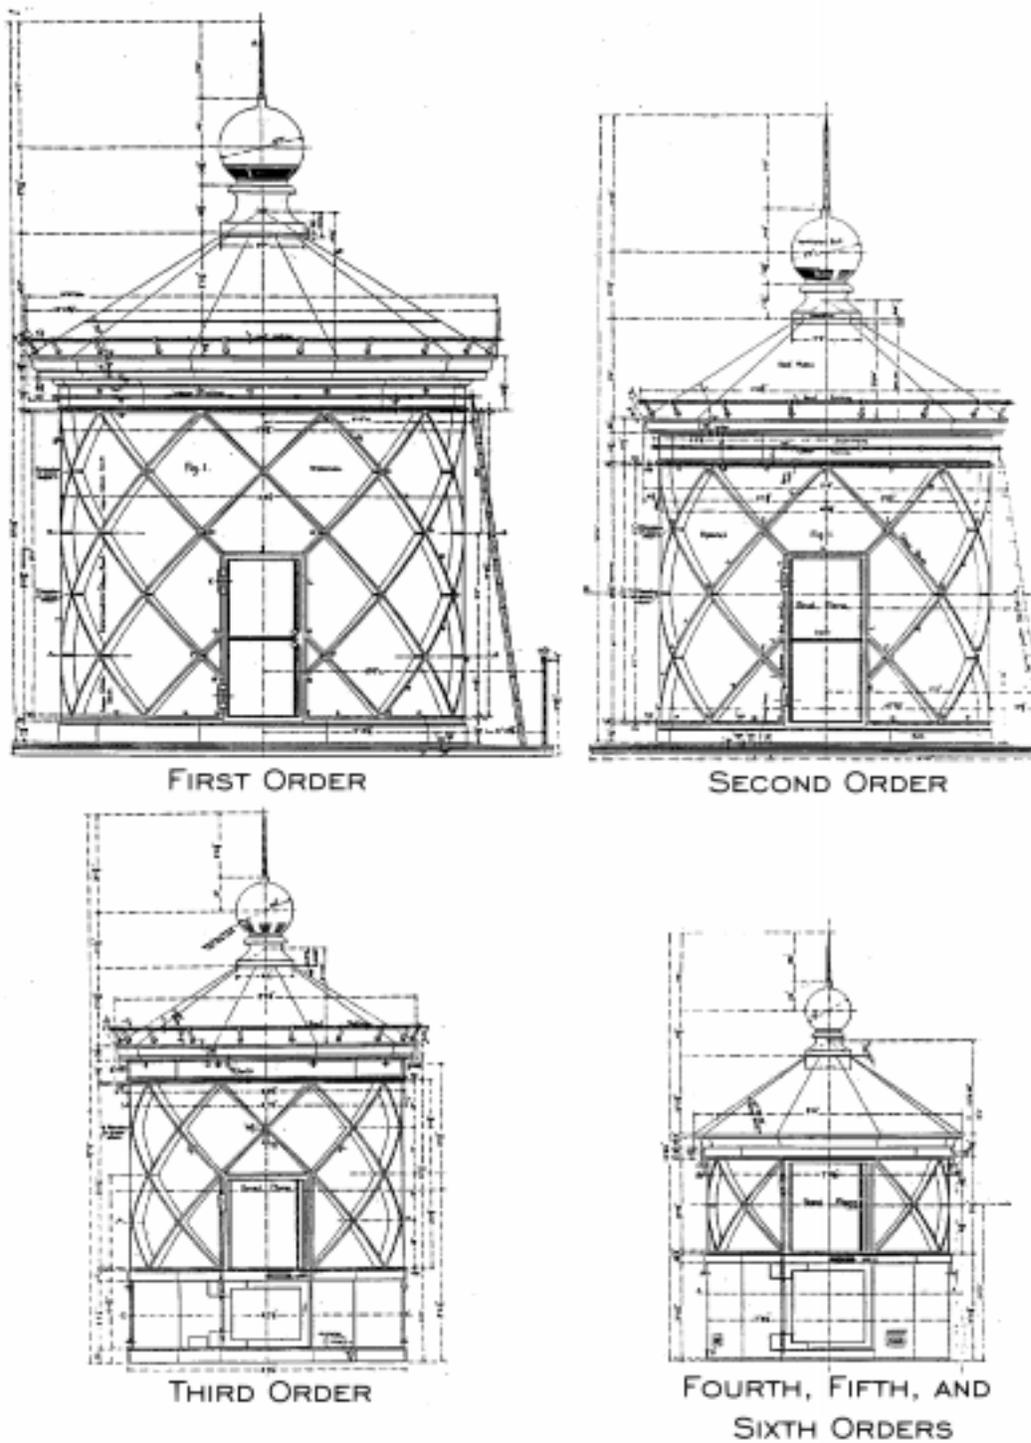
**Figure 3.** Illustration of the four standard lantern sizes used by the U.S. Lighthouse Establishment in the first half of the 20th century. Drawing assembled by WPTC from images dated 1898 and 1903 courtesy of USCG CEU Oakland.

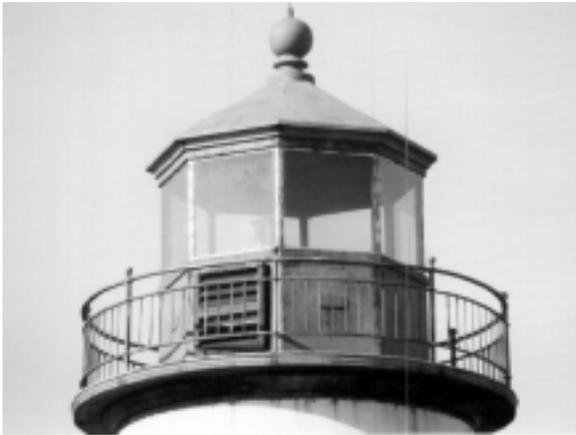
WPTC photo

**Figure 4.** Close-up of the fourth-order lantern at Coquille River Lighthouse in Oregon.

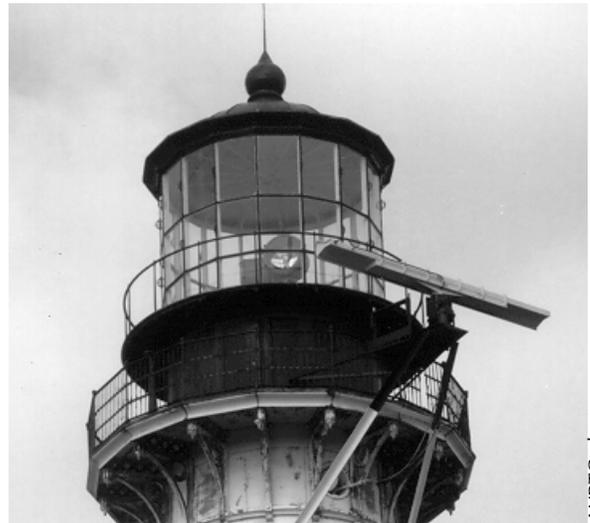
WPTC photo

**Figure 5.** Close-up of the first-order lantern at Cape Canaveral in Florida.

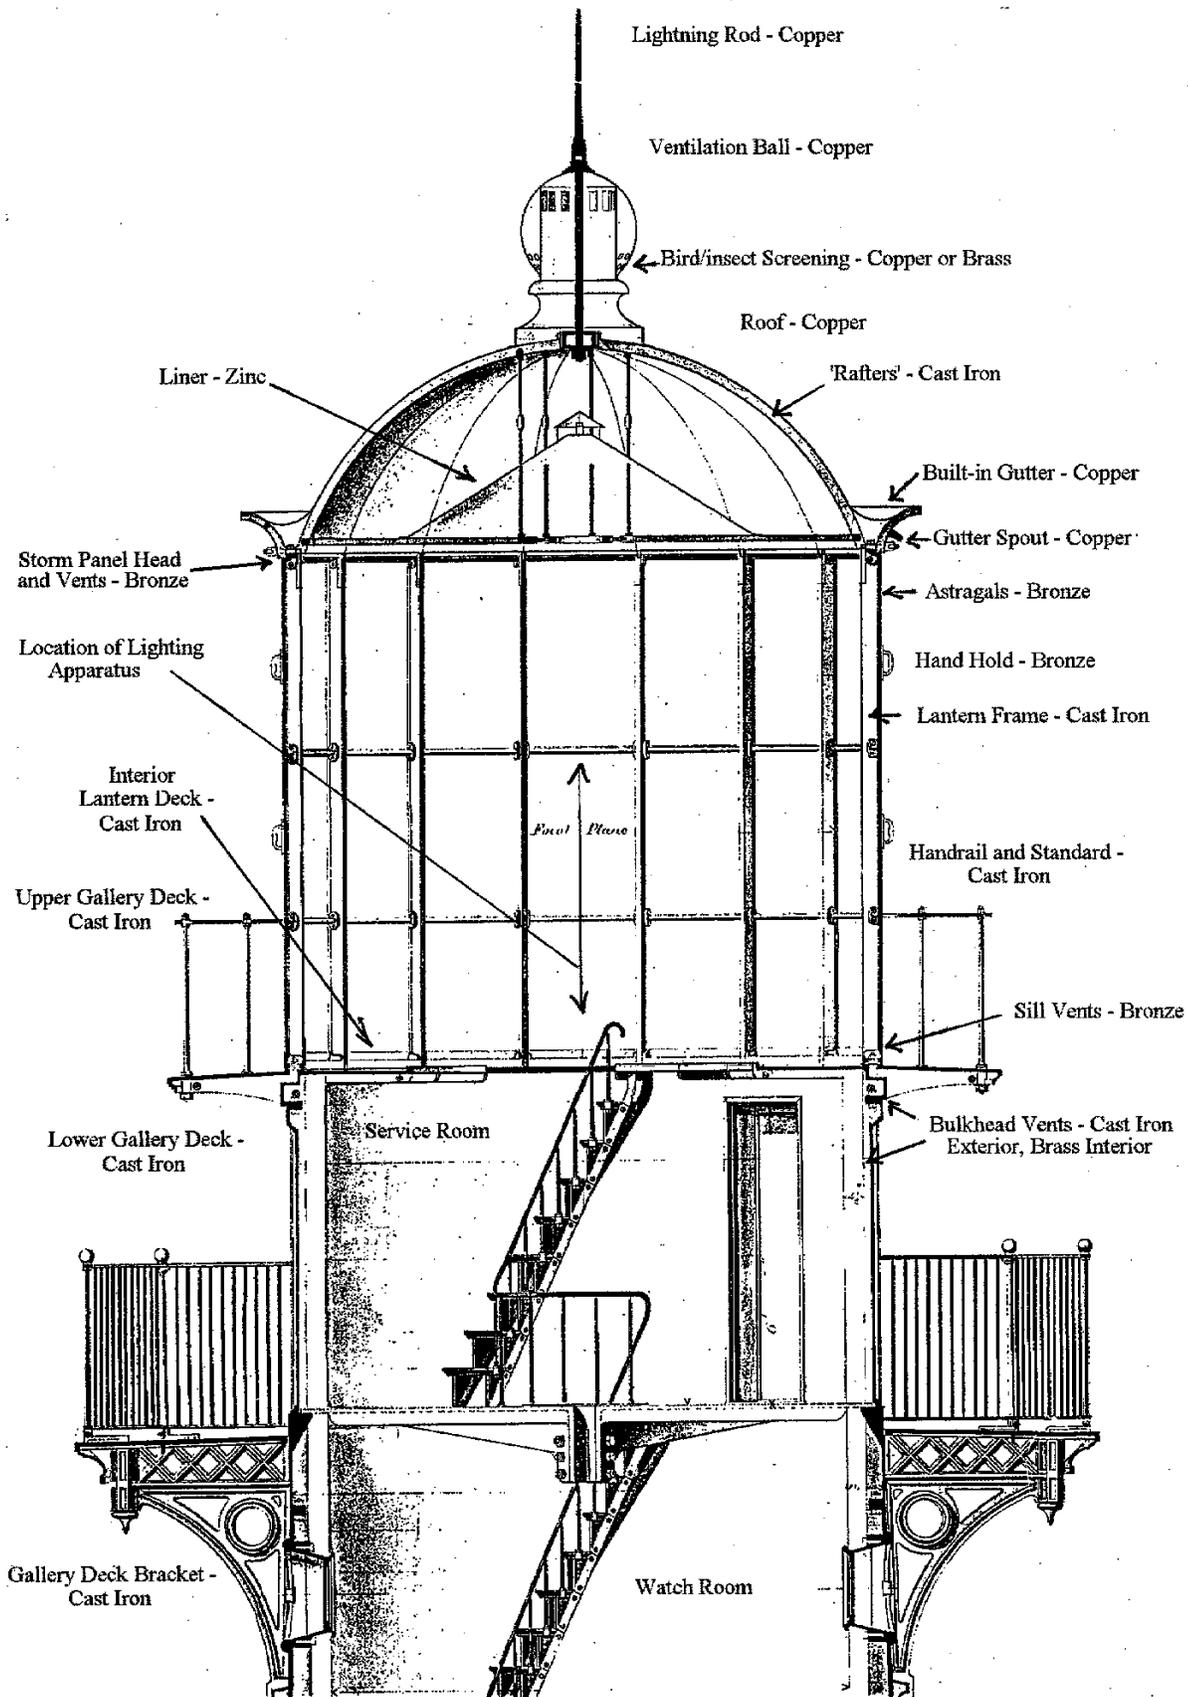
Figure 6. Diagram of a typical first-order lantern; the parts are similar to second- and third-order lights. (Diagram based on USLHS drawing in the National Archives)

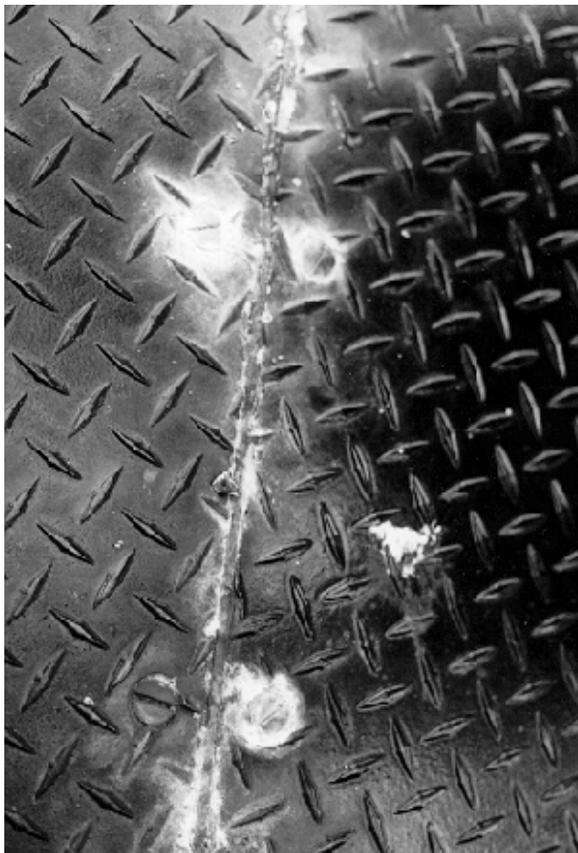
**Figure 7.** The white chalky residue around the steel bolt heads on this aluminum deck is the by-product of the corrosion occurring at these connections.

An example of an undesirable situation that permits galvanic attack is the use of steel or aluminum fasteners to hold together a copper-covered lantern roof. Since the more noble metal is in contact with a small area of a more base metal, galvanic attack would corrode away the fastener with nothing to hold the copper cover to the lantern should the coating system fail and allow water (the electrolyte) to facilitate the galvanic corrosion.

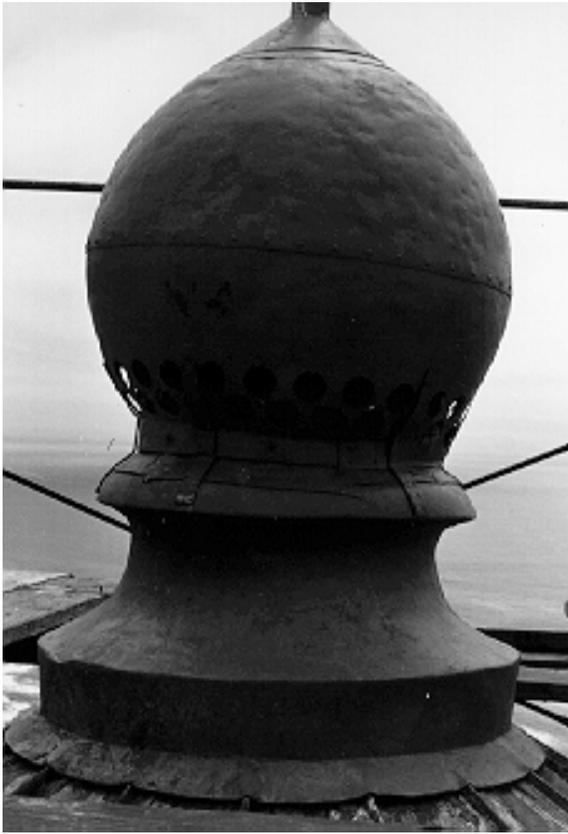
Point Reyes National Seashore

**Figure 8.** Despite the fact that this first-order lantern ventilation ball has been repaired several times, it still provides adequate lantern ventilation.

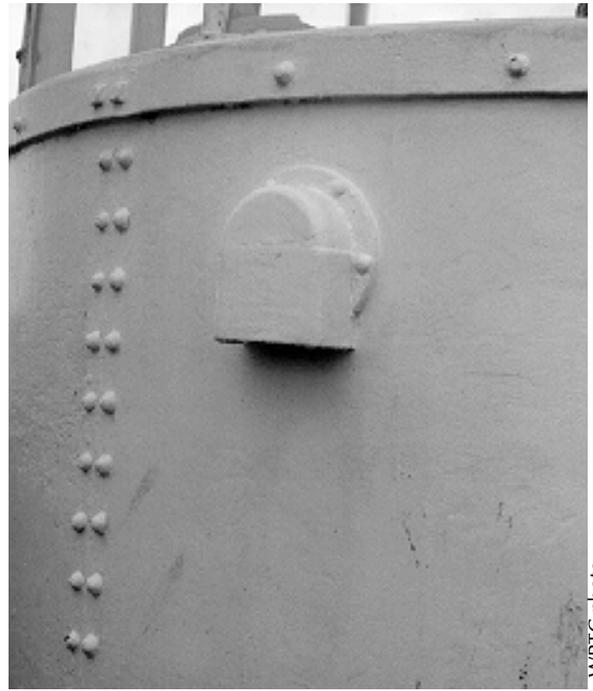
WPTC photo

**Figure 9.** An example of a parapet-wall-mounted vent on a fourth-order lantern.

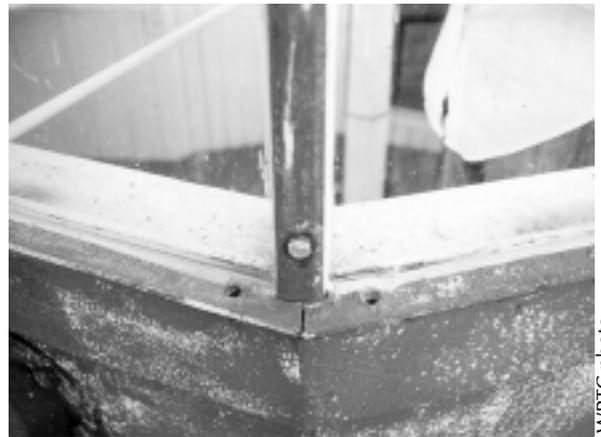
WPTC photo

**Figure 10.** Close-up of missing clamp bolts; these bolts should be replaced to keep this area weather tight.

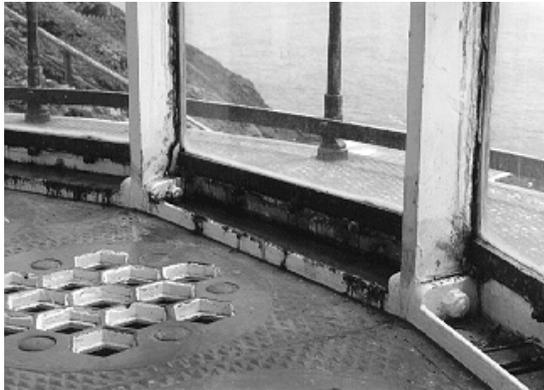
**Figure 11.** The water that has collected in this lantern sill is causing the iron lantern glass frame (the vertical members in the center of the photo) to rust and corrode.

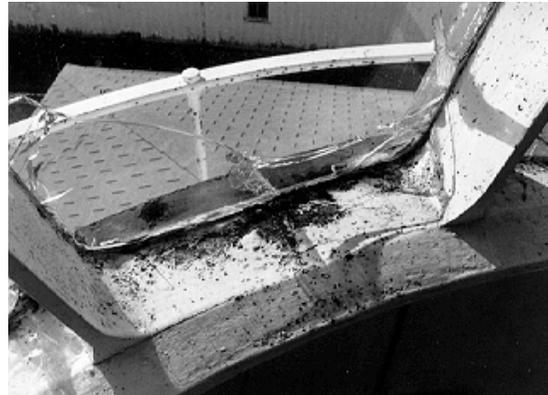
**Figure 12.** The glass in this lantern has been cracked by the rust-jacking that is occurring along the iron frame.

Rust-jacking threatens any iron or steel component. In lantern glass, the condition can cause severe damage. When moisture enters the channel that retains the glass, the iron frame may begin to rust. As the iron rusts, it expands and in turn cracks the glass. This phenomenon can occur anywhere a ferrous metal (iron or steel, etc.) is in direct contact with another material. The pressure created by the exfoliating rust (iron oxide) may damage the adjacent material. (For more information concerning prevention of rust-jacking refer to the repair treatment in this section of the handbook.)

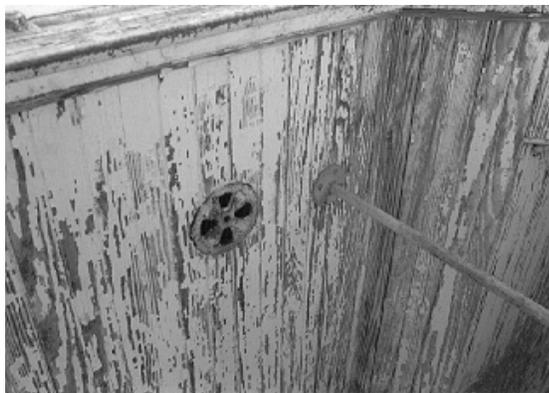
**Figure 13.** The paint coating that once protected this lantern parapet wall has failed.

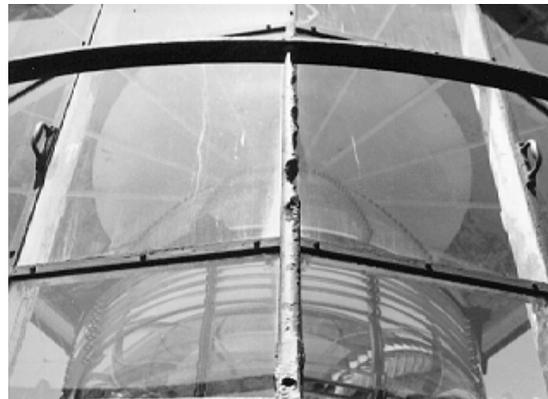
**Figure 14.** Wind and airborne sand have accelerated the deterioration of this lantern gallery deck handrail

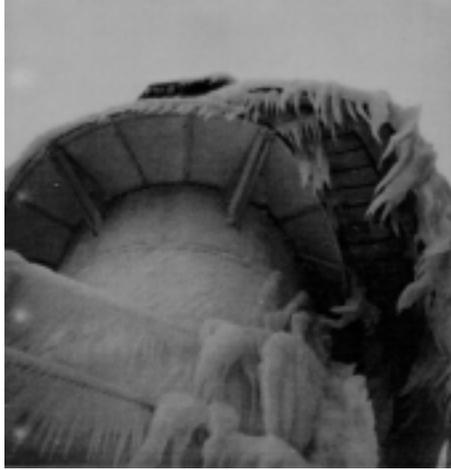
USCG Group Grand Haven, Michigan

**Figure 15.** Close-up of ice on St. Joseph North Pier Lighthouse causing damage to gallery deck and handrail.

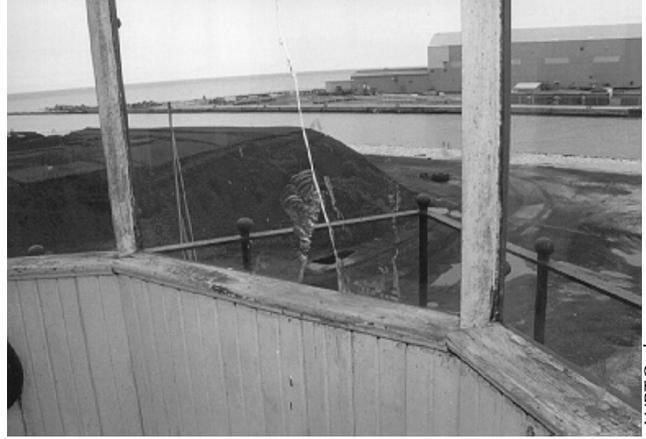
WPTC photo

**Figure 16.** This lantern glass has been damaged by rock-throwing vandals. The resulting hole is allowing rain and insects to enter the lantern.

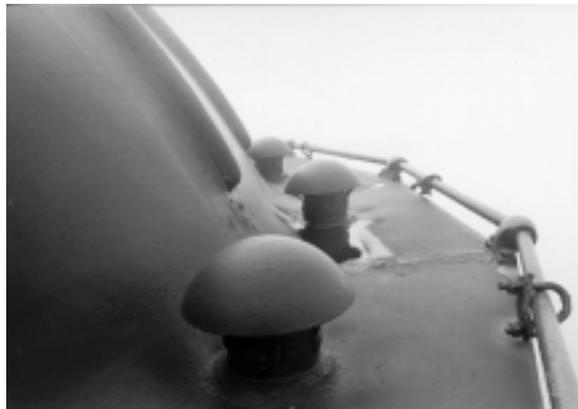
**Figure 17.** Roof vents such as these should be inspected for leaks and maintained during the mothballing period. This shroud-style vent allows air to pass while preventing rain from entering.

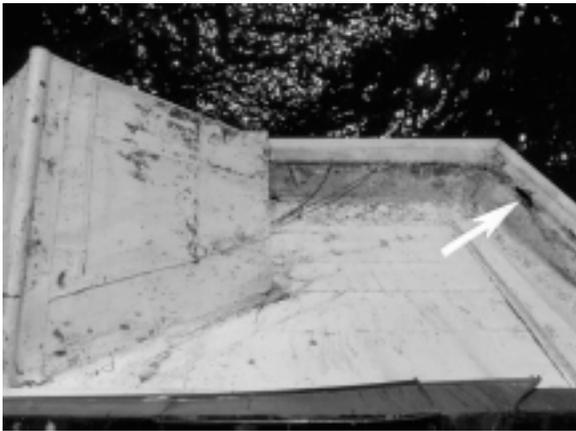
WPTC photo

**Figure 18.** View of built-in gutter on a caisson lighthouse; arrow indicates fist-size hole. This condition must be treated before mothballing.

- **Built-in guttering systems:** All rain water guttering systems (lantern roofs, or other tower roof forms) should be cleaned and checked for holes. All holes and non-functioning gutter system components should be repaired. Holes in sheet-metal, built-in gutters, should be properly soldered to ensure the soundness of the repair (see Figure 18). Caulking should be used only for temporary repairs until a proper soldered repair can be made. (For more information refer to the lantern roof discussion later in this section.)

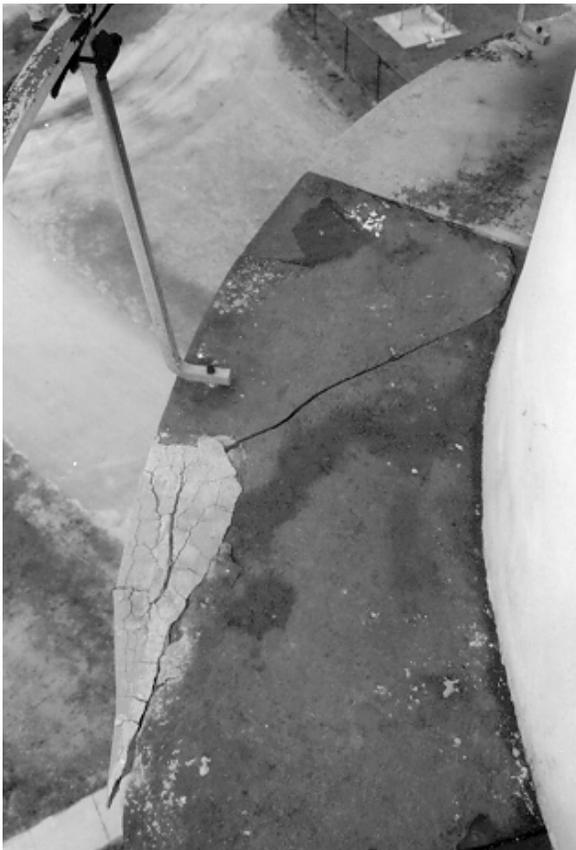
WPTC photo

**Figure 19.** The repair made to this stone gallery deck has begun to deteriorate; moisture penetration is occurring. This condition should be addressed before mothballing.

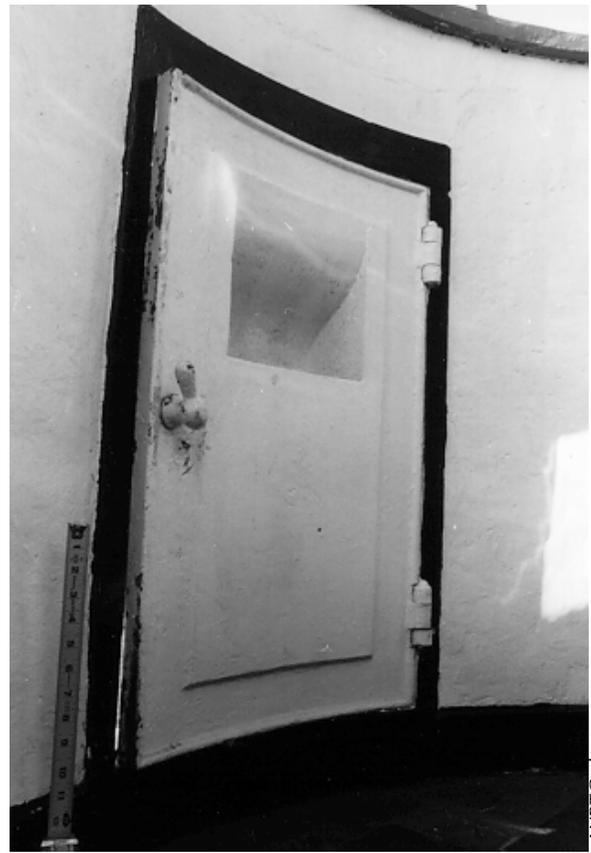
WPTC photo

**Figure 20.** Close-up of a vented parapet hatch in a fourth-order lantern. The hatch should have a good seal and still remain operable. The built-in vent should also be kept open to maximize ventilation of the lantern and tower.

- **Parapet hatch, service room door:** Regardless of the size of the lantern, it will have a hatch or door of some form in the lantern itself or in the service room that provides access to the exterior of the lantern. This opening must be made weathertight. To achieve this, the latch and hinges must be lubricated and in working order. The opening should be fitted with a gasket material such as neoprene that is both readily available and long lasting. The flashing that protects the door opening must also be in working order so that it diverts water away from the door or hatch opening.
- **Service room windows:** For more information on window treatment, refer to the **Windows** section.
- **Protective coatings:** As a protective measure and for daymark purposes, lanterns were

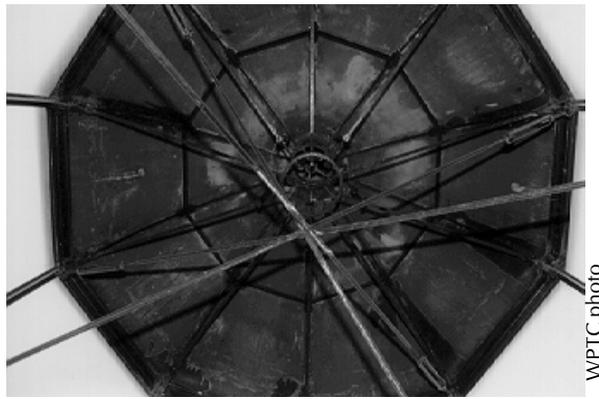
**Figure 21.** The diagonal tension rods in this empty lantern were installed to brace the lantern against lateral loading caused by high winds.

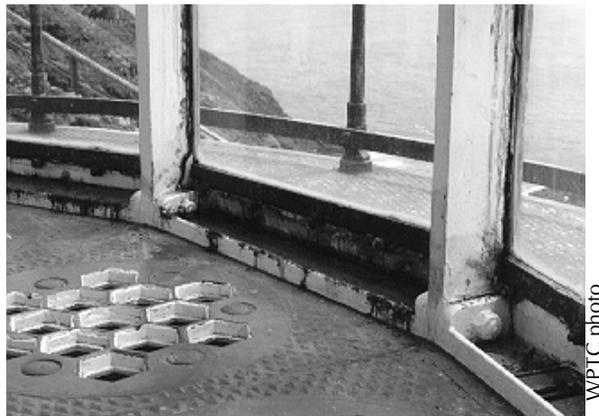
**Figure 22.** Close-up of sill vents in a first-order lantern. The vents should be kept open during the mothballing period to maximize lantern and tower ventilation.

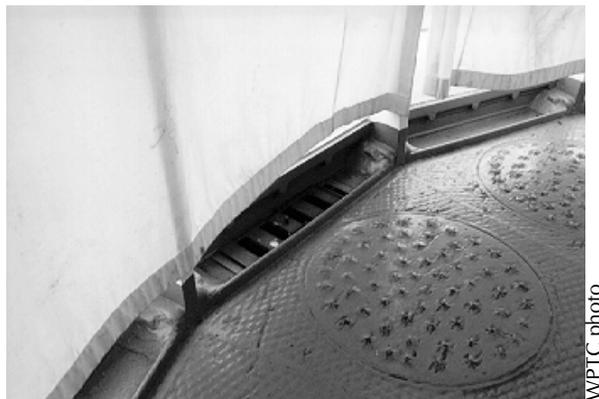
**Figure 23.** As part of the lantern mothballing treatment the lantern glass sill vents should be kept open (except in extremely damp climates) to allow for the free flow of air through the lantern.

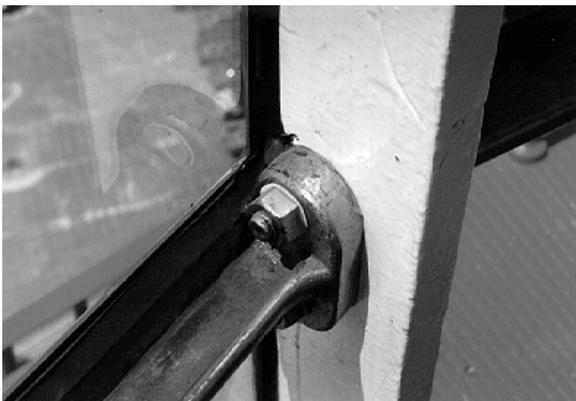
**Figure 24.** The stainless steel through bolts used to join this bronze sash bar to the vertical lantern post is isolated from the bronze using a nylon washer as a barrier.

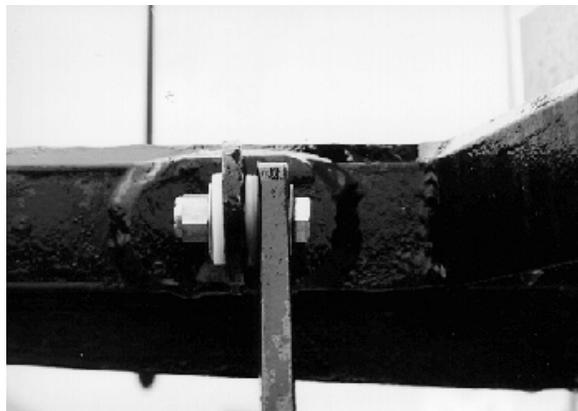
**Figure 25.** This is a view of a typical dissimilar metal isolation solution; the steel ladder post (vertical member in the center of the image) is isolated from the aluminum lantern gallery deck with nylon washers. The bolt chosen for this application is made from Type 316 stainless steel.

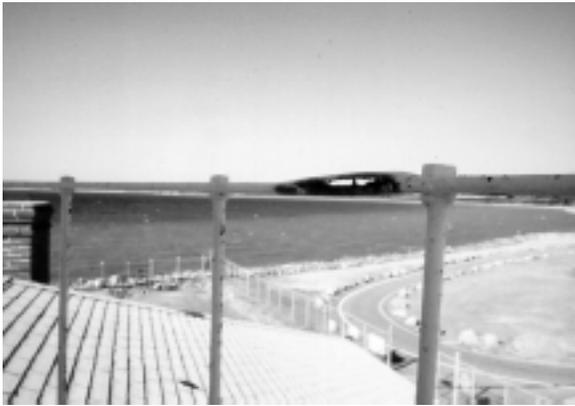
**Figure 26.** Detail of handrail that is being deformed by rust-jacking.

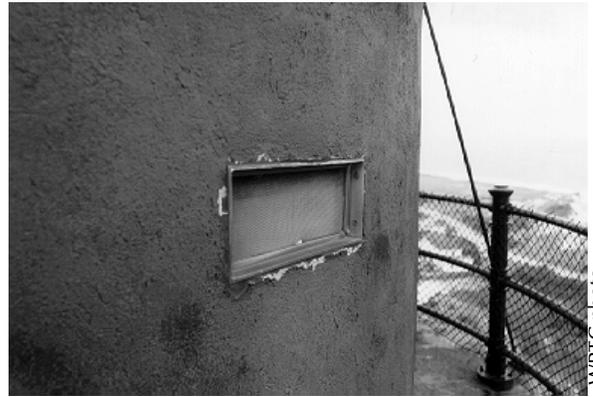
**Figure 27.** This lantern vent opening has been covered with a fine stainless steel screen that prevents insect infiltration while maximizing air movement through the vent and into the lantern.

During any preservation treatment the vents should remain operable to allow the maximum amount of air flow through the lantern. To prevent pest infiltration, the exterior openings of the vents should be screened with fine brass or stainless steel screen. When vents are kept open, natural convection caused by sunlight heating the

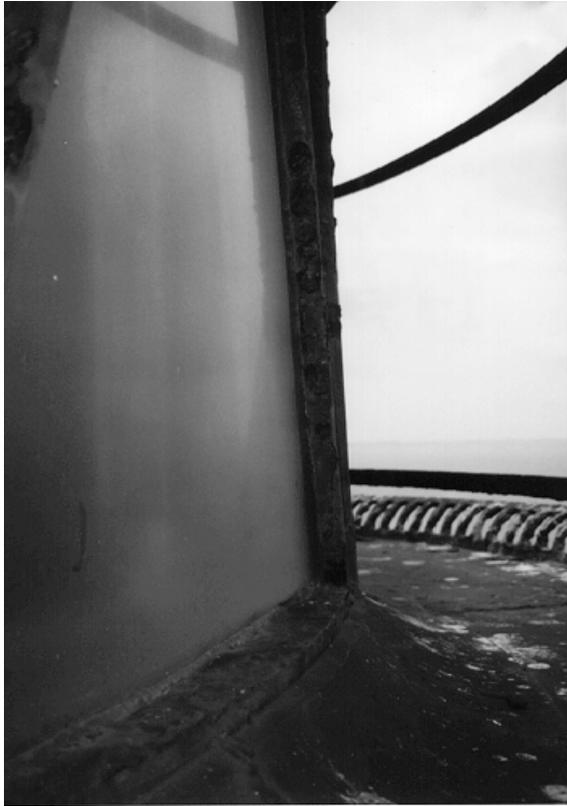
**Figure 28.**

**Figure 28 (top left).** Close-up view of severely hazed Lexan replacement panel. Note the limited visibility caused by only ten years of sunlight and salt air exposure.

In 1986 the wire-glass in the lantern of the Sombrero Key Lighthouse was replaced with Lexan (plastic) panels. A 1996 site visit found the Lexan panels hazed by sunlight and salt air exposure. This condition greatly reduces the transmission of light and therefore reduces the effective range of the aid to navigation. The inability of the Lexan panels to withstand the conditions of the marine environment gives the panels a short life expectancy when compared to glass. With these inherent limitations, Lexan or other plastic panels should only be used as a temporary repair and not be relied upon as a long-term lantern glass material.

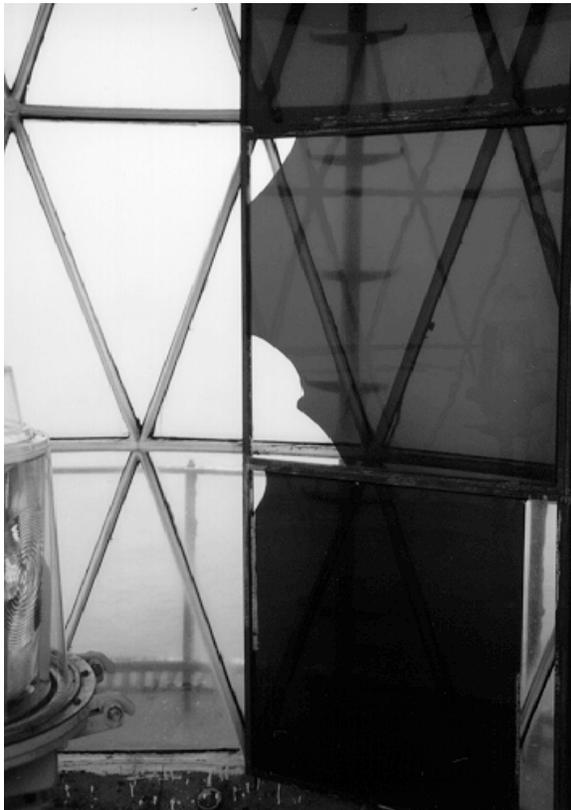
**Figure 29.**

**Figure 29 (bottom left).** Looking out through severely hazed Lexan panels, note the limited amount of light transmission; this greatly hinders the effectiveness of the aid to navigation. If the panels are not replaced, the degradation may continue and diminish the light transmission, ultimately rendering the aid to navigation ineffective.

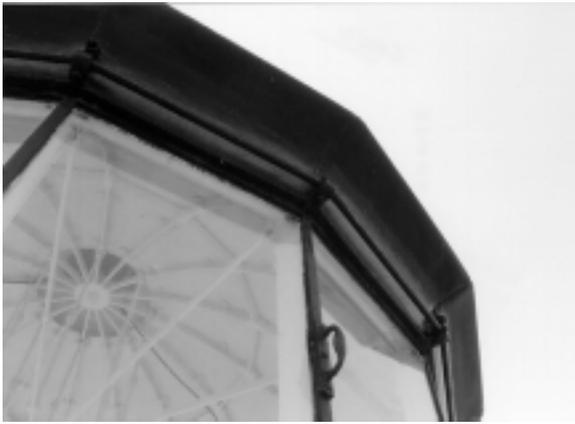
**Figure 30.** Close-up of a first-order lantern that retains its lantern glass; note the clarity.

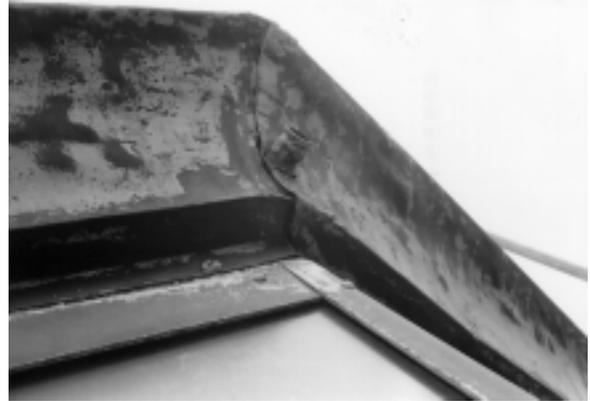
**Figure 31.** View of built-in gutter spout on a copper roof.

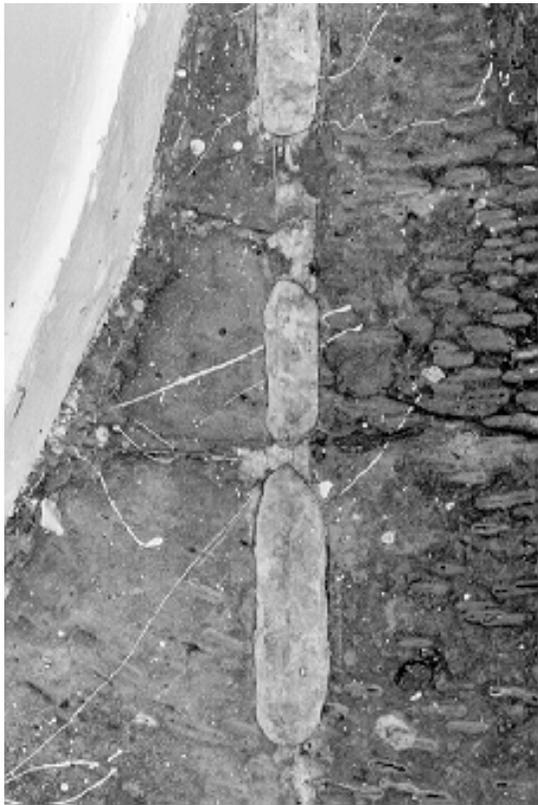
**Figure 32.** This sheet-copper-covered lantern gallery deck has been repaired several times by soldering sheet copper patches over the holes. This method of repair, if performed properly, greatly increases the life span of the roof covering.

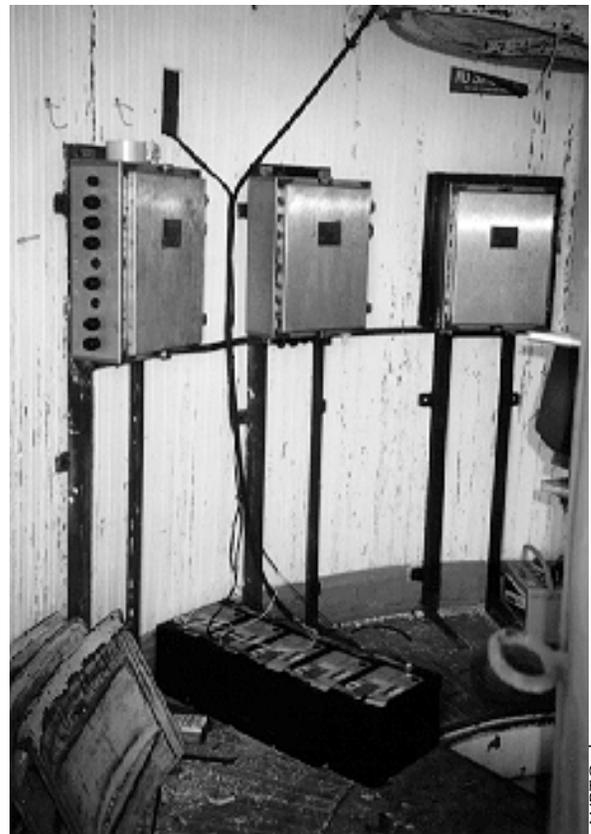
**Figure 33.** To minimize damage to historic wood beadboard panelling, these new panels should have been installed on a sheet of plywood attached to the historic wood beadboard panelling in four locations. These batteries stored on the floor should be in containment boxes in case the batteries leak.

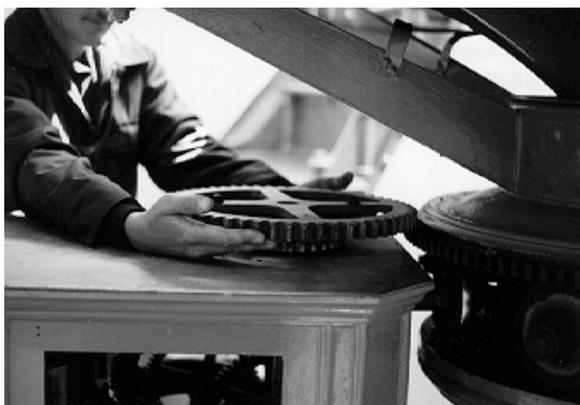
**Figure 34.** When this first-order classical lens was converted to AC power, the original drive gear (pictured here) was the crank used to wind the clockworks.

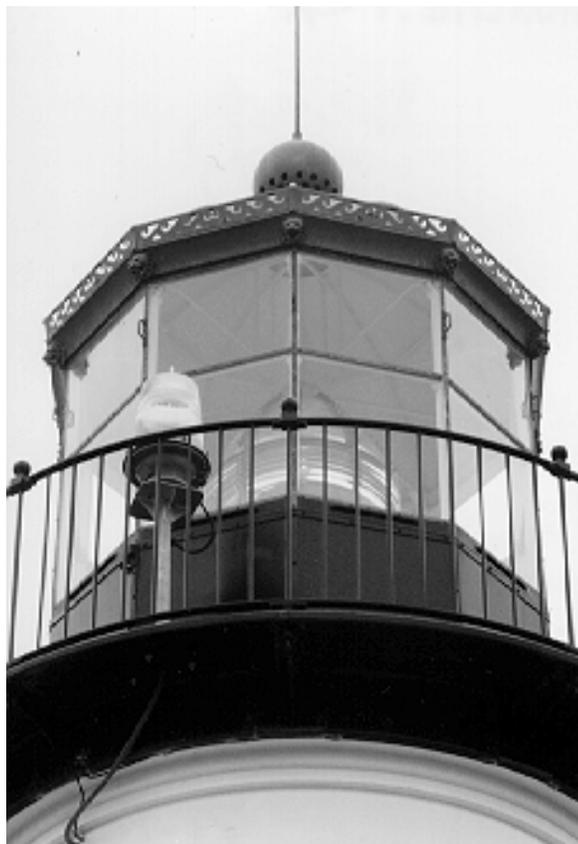
**Figure 35.** This is an acceptable auxiliary light installation. The light is mounted on an aluminum pedestal that has been bolted to the replacement aluminum deck.

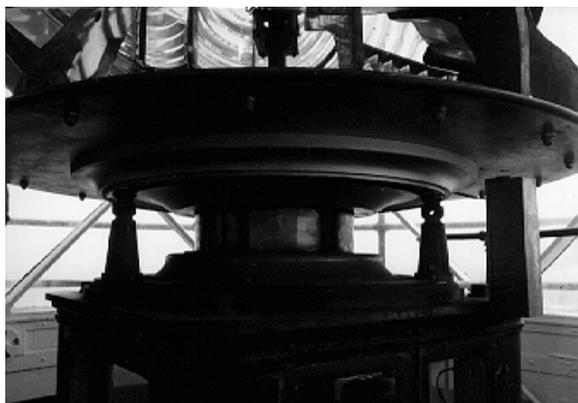
**Figure 36.** This c. 1926 lens was designed to be AC powered; the original lens jacks are still in place. The three jacks (the third is obscured by the brass bearing cover) were used to lift the lens assembly so that bearings could be serviced.

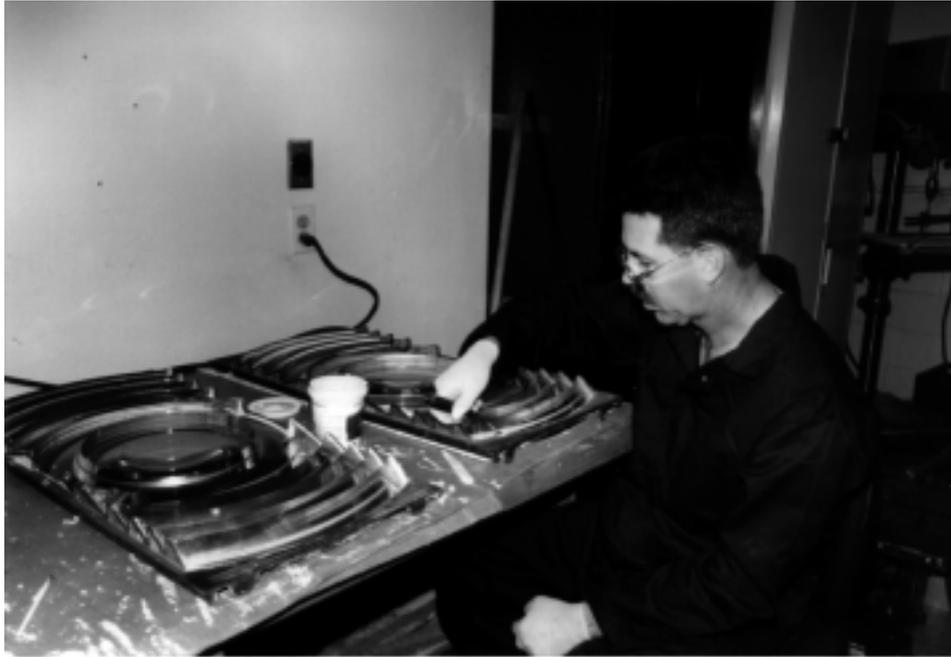
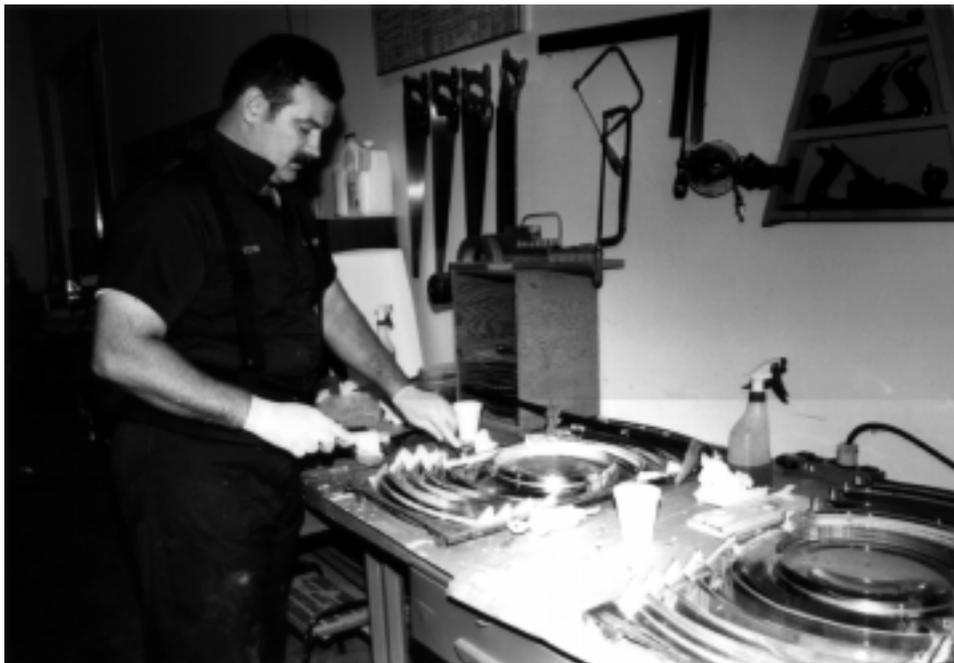
**Figures 37 and 38.** Joe Cocking (above) and Nick Johnston (below) restore a classical lens at the U.S. Coast Guard Exhibit Center.

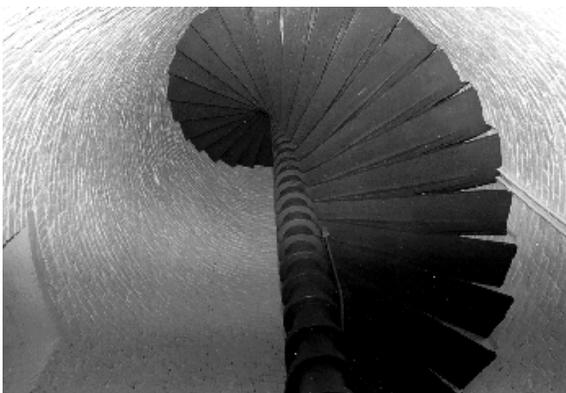
**Figure 2.** Utilitarian light tower interior at Cove Point Light Station, Maryland.

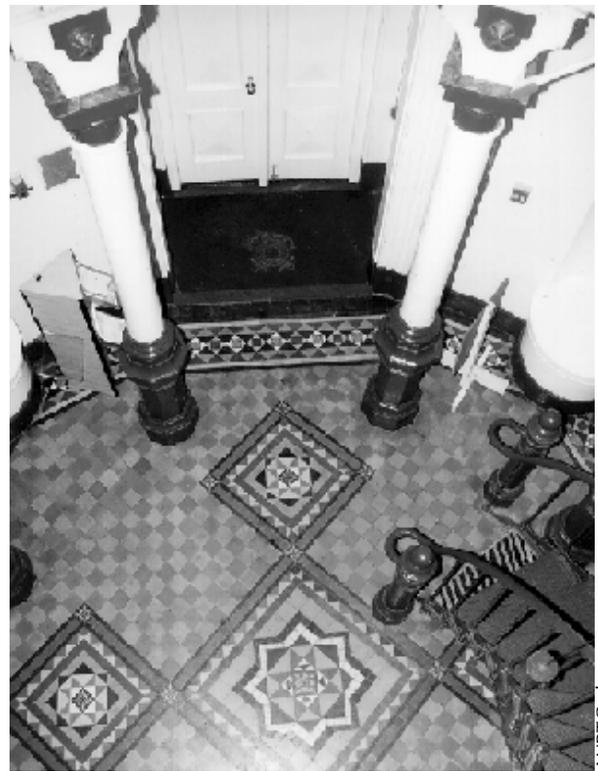
**Figure 3.** Highly decorated interior of the Cape Henry Light Station (second tower), Fort Story Virginia

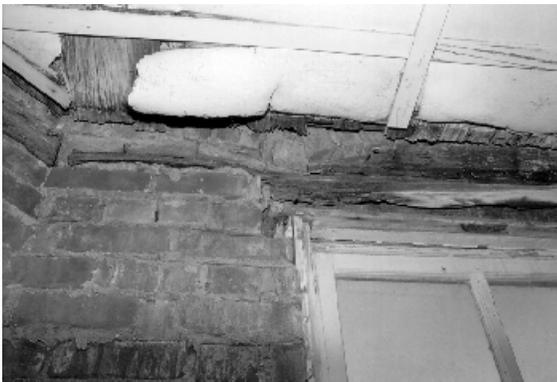
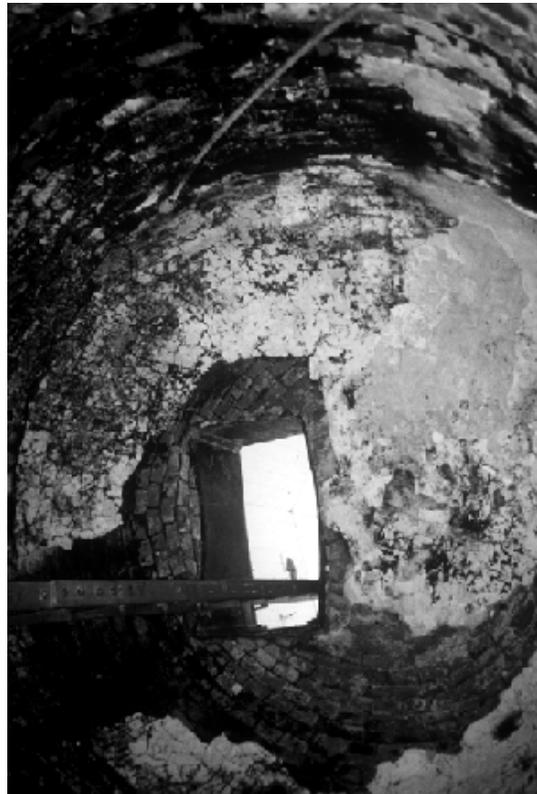
**Figure 4 (left).** Extensive interior finish deterioration in a lighthouse that had holes in the roof which were not repaired.

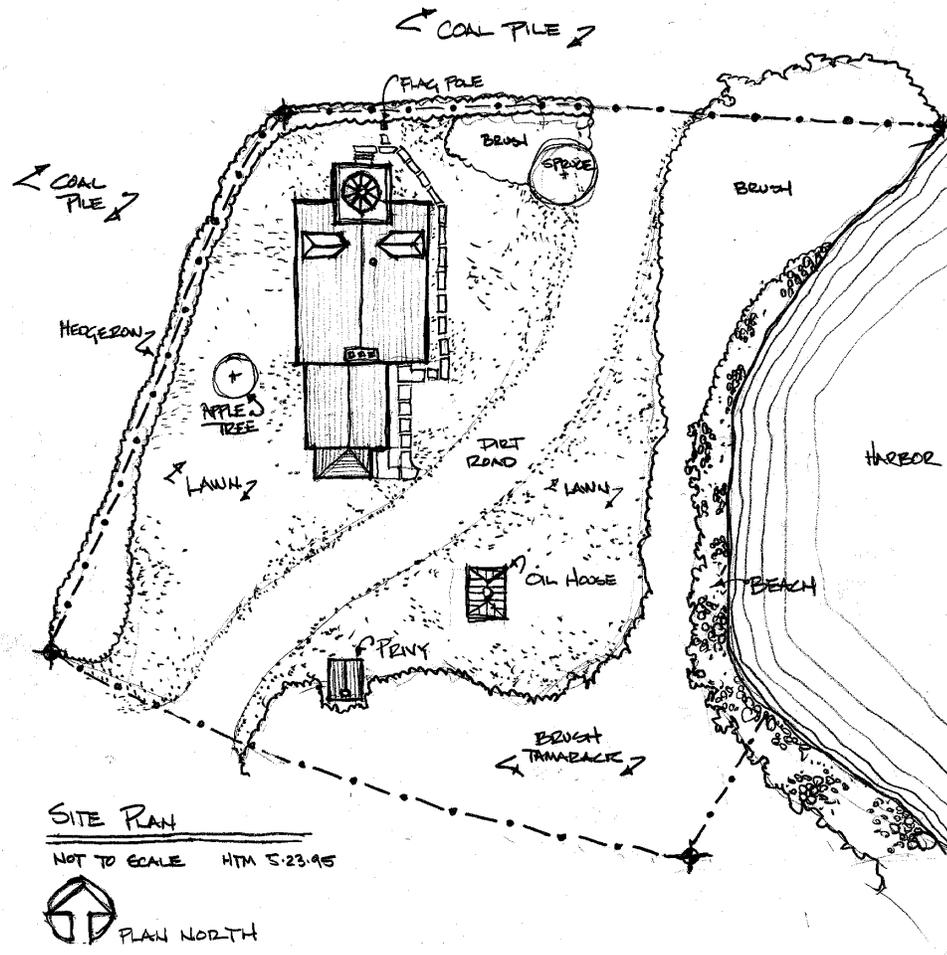
**Figure 5.** A simple sketch site plan records the relationship of a light station's buildings and features. This type of recordation should be dated and filed with the lighthouse maintenance records. (WPTC drawing by H. Thomas McGrath)

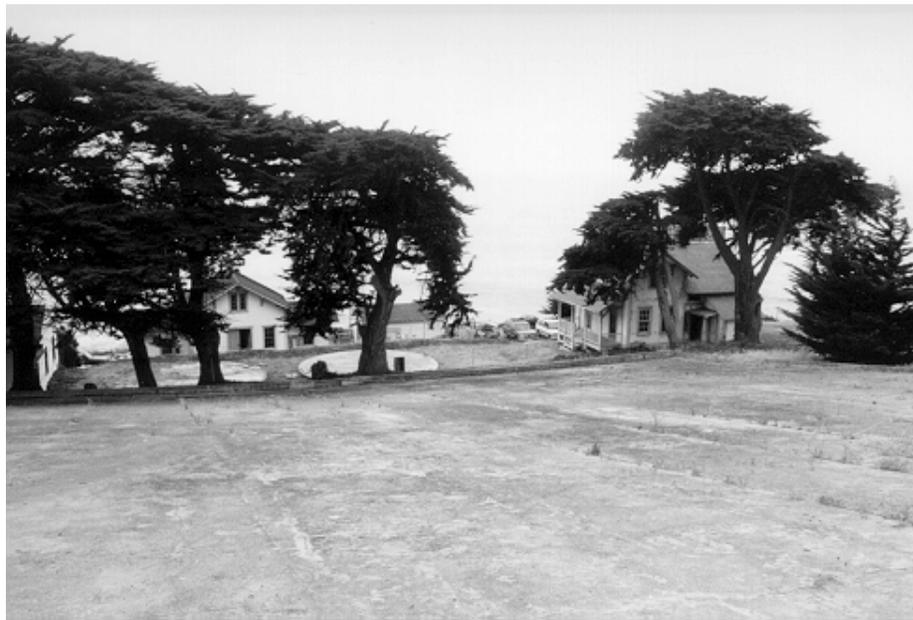
**Figure 9.** View of a highly intact historic light station in California. All principal structures that made up the light station are intact including the large concrete rain water catchment (in the foreground) and the below-grade wood cisterns (just the lids are visible in the center of the photo) used to store the rainwater to produce steam for the fog signal. The preservation of a site at this level of integrity is essential to understanding the relationship of the light station buildings and their contribution to the station's overall operation.
