## Historic Lighthouse Preservation Handbook

The Historic Lighthouse Preservation Handbook was created through a cooperative partnership between the National Park Service, [U.S. Coast Guard](#), Department of Defense Legacy Resource Management Program, and U.S. Lighthouse Society. The 328-page preservation manual, released in August 1997, focuses primarily on the maintenance problems associated with the many different materials and construction techniques used in these unique structures. In addition to

sections devoted to preservation treatments, it includes a brief history of the U.S. Lighthouse Service and lighthouse construction types; existing historic preservation laws, standards, and guidelines; case studies for both lighthouse rehabilitation and restoration projects; related activities (interpretation, funding, safety management, etc.); and sources for more information.

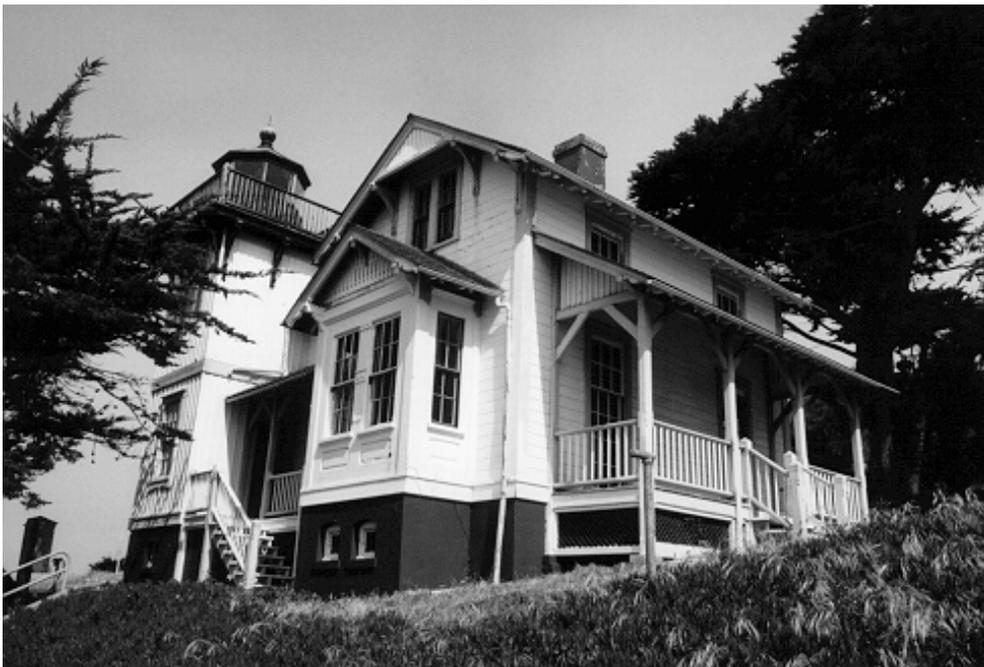
**Figure 12.** Historic plantings, such as this ice plant (the ground cover at the bottom of the image) planted as a fire break around the light station structures, are part of the light station’s cultural landscape and should be preserved.

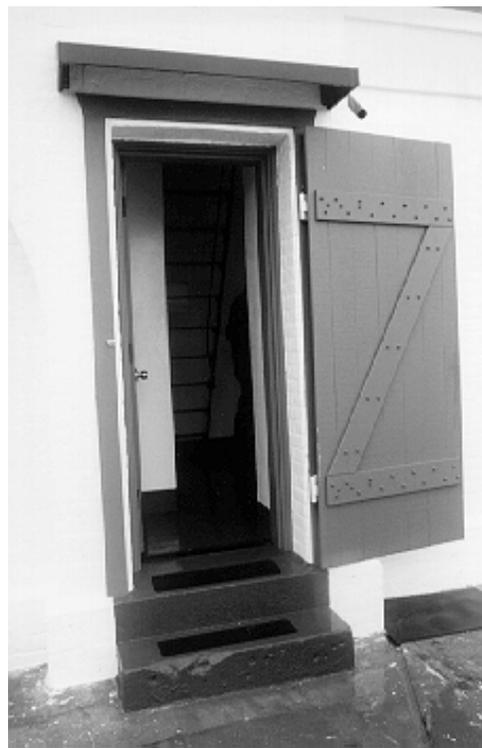
Figure 7.

**Vertical wood plank door:** The design for the door in Figure 7 was based on the information in the historic photographs. The materials used during the construction of this door were chosen for their durability. The wood chosen was fir, which was primed before assembly to ensure all surfaces would be coated to deter rot caused by damp wood. The planks were joined to the 'z' batten with stainless steel screws to decrease maintenance and eliminate the possibility of rusting fasteners. The hinges are salvaged bronze strap hinges that will also require minimal maintenance. The copper hood or awning above the door is another traditional protective measure for historic lighthouse doors.

Figures 6 through 9 are examples of successful replacement door designs. The solutions displayed here can be easily adapted to most historic lighthouse door designs. The wood replacement door design in Figure 6 was based on wood-frame and panel-construction-style doors commonly used when this lighthouse was constructed in 1928. The only difference made to the c. 1928 design was the upgrade of the hardware to stainless steel components. This door design was based on information from historic photographs from the U.S. Coast Guard archives and

evidence found during the rehabilitation of the lighthouse. Historic photographs showed a vertical plank door on the exterior.

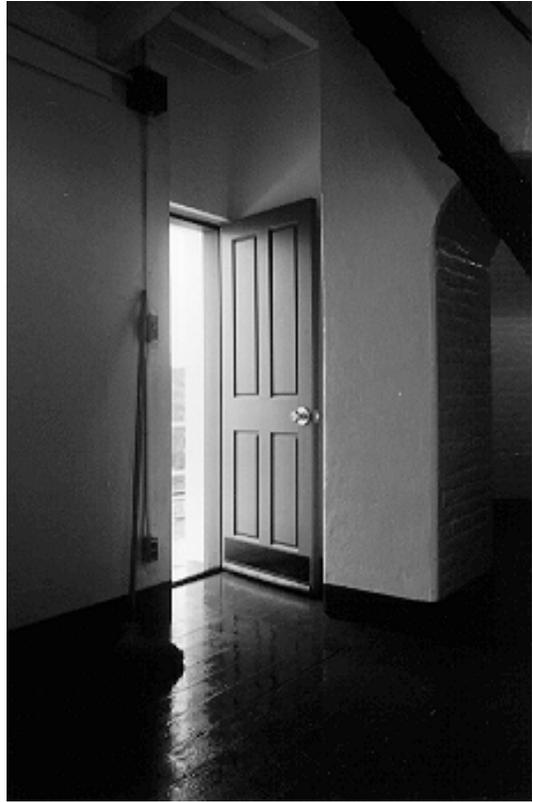
Figure 8.

**Wood frame and panel door:** Partial remains of a wood frame and raised panel was found inside the structure during rehabilitation. This evidence was used in conjunction with historic construction drawings to develop this design. The door shown in Figure 8 was made by a local mill from Douglas fir. The hardware is all stainless steel to minimize maintenance and to extend the serviceable life of the door. As an added weather protection measure, a traditional drip edge has been installed along the bottom of the door to shed water away from the door opening.

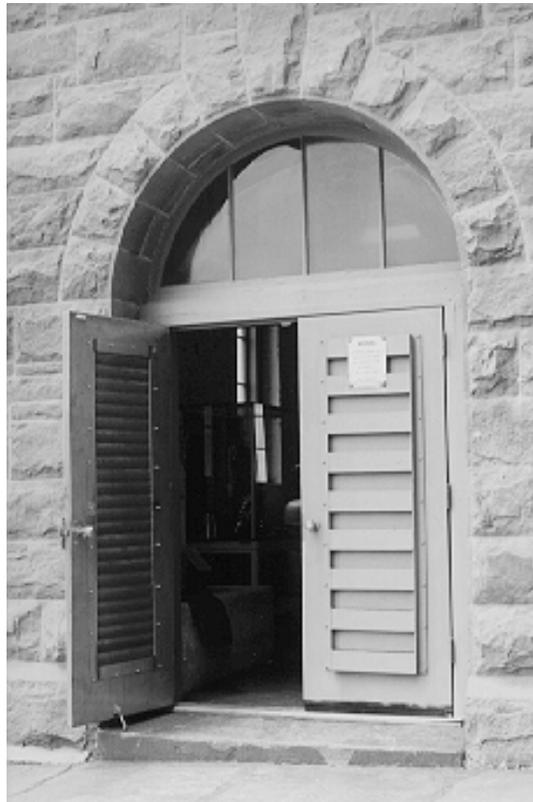
Figure 9.

The door in Figure 9 is designed to minimize the problems at a lighthouse that does not see regular visitation because of its remote location. Four factors took precedence over historical correctness: weathertightness, ventilation, security, and maintenance. The door had

The solution to the problems associated with the mothballing of this lighthouse was to use high-quality materials and sound design. The doors are made of Type 304 stainless steel. The louvers are baffled to allow for more than adequate air exchange, which will minimize interior condensation buildup, while at the same time preventing water infiltration. The louvers are also screened to prevent animal infiltration. The locks and hinges are also stainless steel to prevent corrosion and ensure long-term use. The installation of this type of door should not permanently affect the historic door frame.

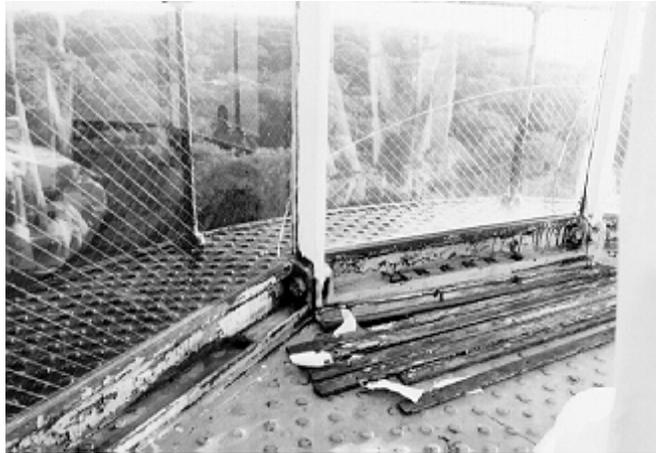
**Figure 10.** Oblique of the interior of the lantern room with exterior bronze astragals stored in the foreground before cleaning and removal of the extent wire-glass panels.

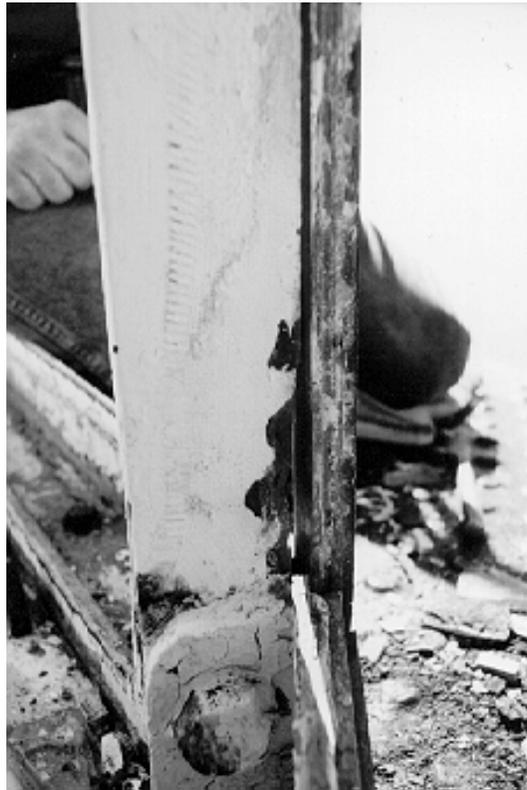
**Figure 11.** The extent of the damage to the cast-iron column through exfoliation can be seen in profile after the removal of loose rust and the lower bronze mullion.

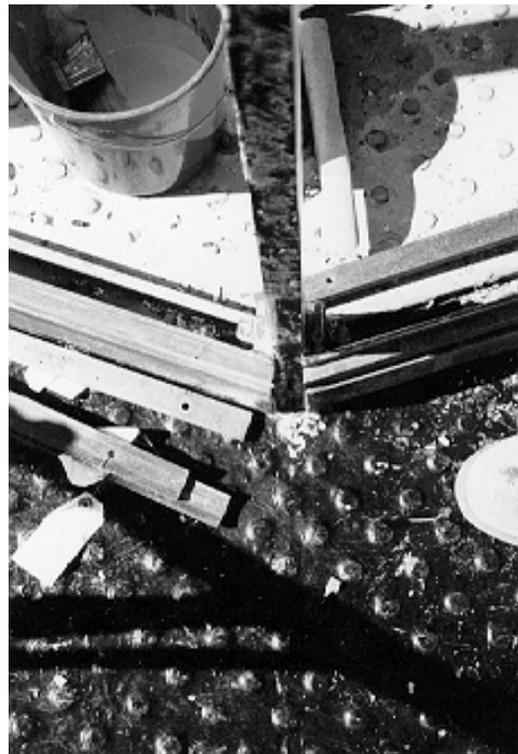
**Figure 12.** Detail of the bronze sill when the lower mullion is removed; the fastener is re-tapped and the cast-iron column is treated with a rust converter. Note that the bronze astragals have been cleaned and are ready to accept the glazing system.

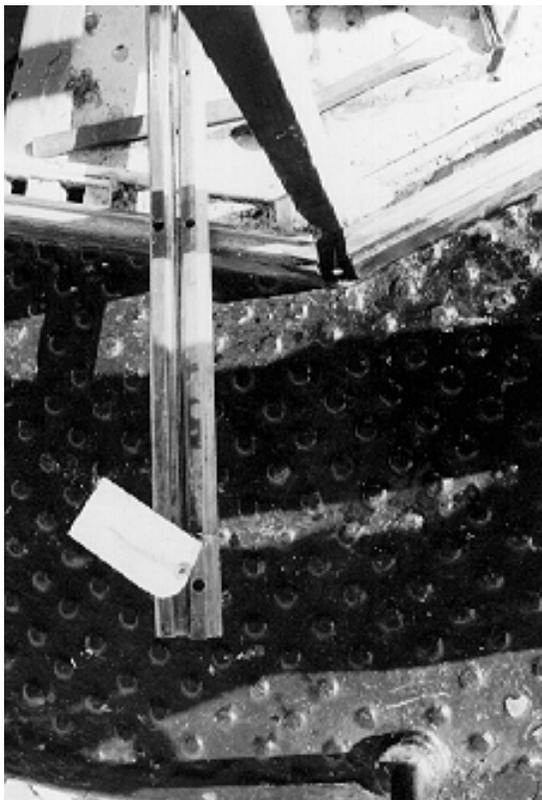
**Figure 13.** This detail of the bronze sill shows the location of the new lower fastener before its removal and resetting with the lower bronze mullion.

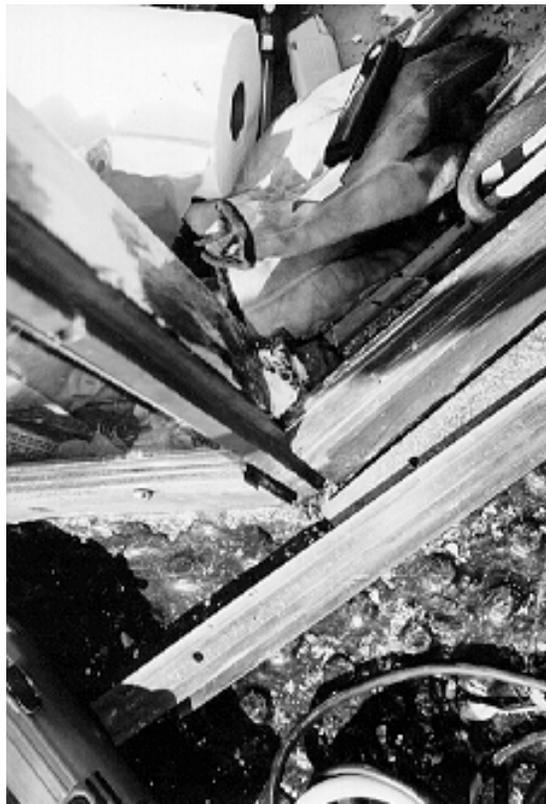
**Figure 14.** Following placement of the restored bronze mullion, the fenestration is ready to receive the new glazing system.

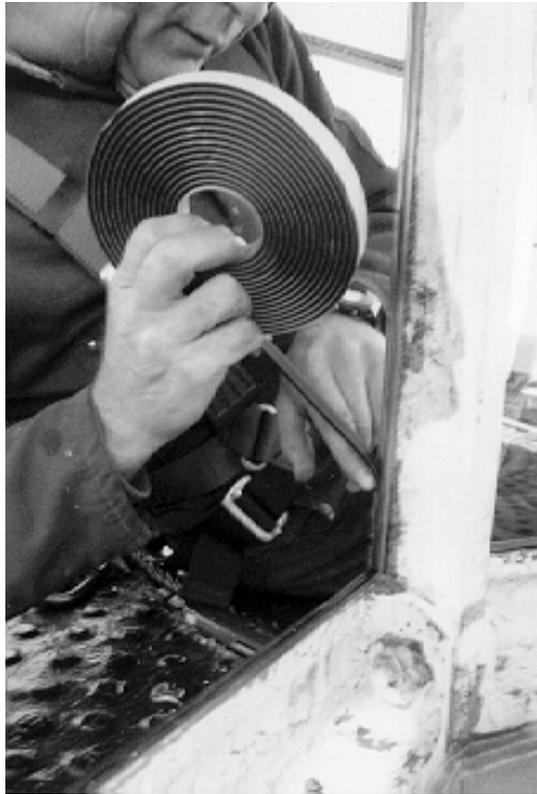
**Figure 15.** The polybutyl sealant tape was placed on all receiving surfaces on the plane of the interior face of the glass and on the inside faces of the exterior astragals.

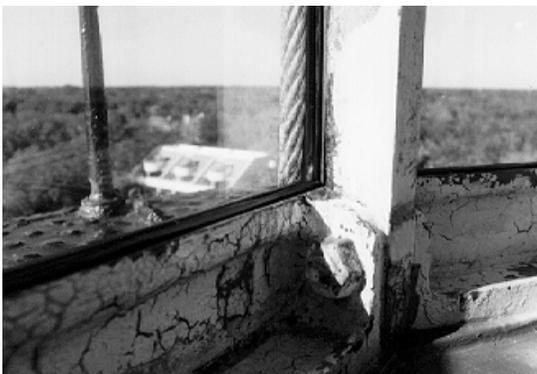
**Figure 16.** This detail shows the new glazing system in place with associated cast-iron post and bronze sill available to receive additional cleaning and paint removal.

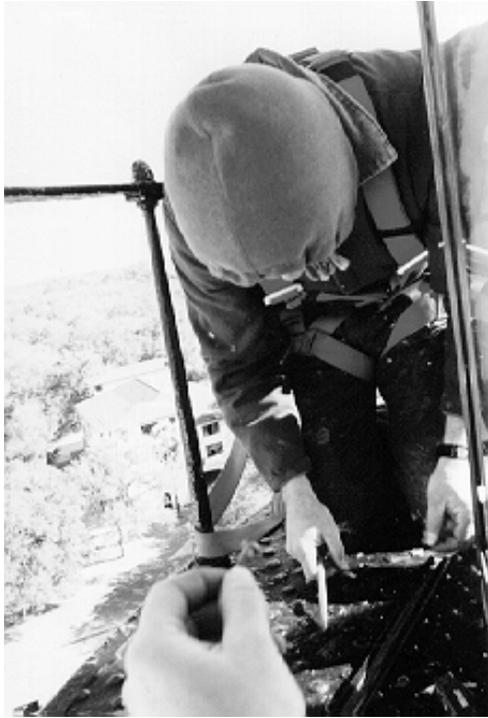
**Figure 17.** Note the detailing of the finished exterior astragal in place and the polybutyl sealant tape visible in profile.

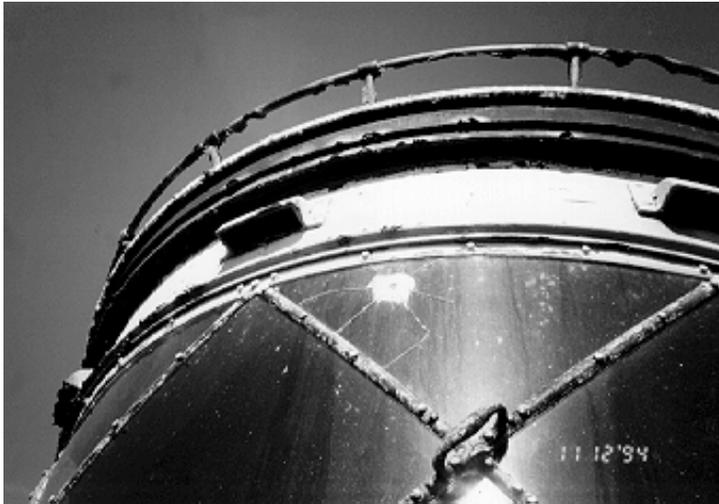
**Figure 18.** Close-up of the deteriorated conditions of the Anacapa Island Lighthouse before rehabilitation.

Civil Engineering Unit Oakland's Facility Inspection Team originally identified the need for this rehabilitation during an inspection of the lighthouse in 1992. The entire lighthouse was in such poor condition that it was labeled the worst lighthouse on the West Coast (see Figure 18). The inspection team initiated the paperwork that identified both the need for the rehabilitation and funds. Although most large Coast Guard projects normally take five years before being funded, Anacapa was in such poor condition that it was given a high priority; design work started within two years. In late 1994 the architect assigned to the project made his first site visit. The architect determined that the best way to repair the badly deteriorated cast-iron lantern house was to remove it from the concrete tower via heavy-lift helicopter and transport it to the mainland for overhaul. Further investigation, however, disclosed several insurmountable obstacles; he was forced to consider a more conventional but far from easy onsite rehabilitation of the entire lighthouse. The following scope of work was identified and budgeted for \$325,000:

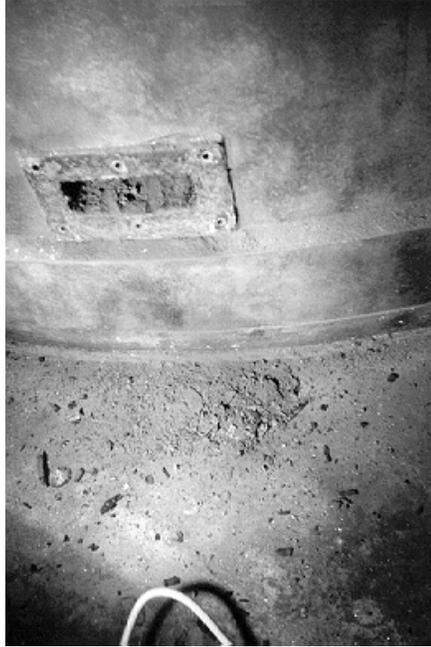
**Figure 19 (left).** Buildup of rust in parapet wall vents.

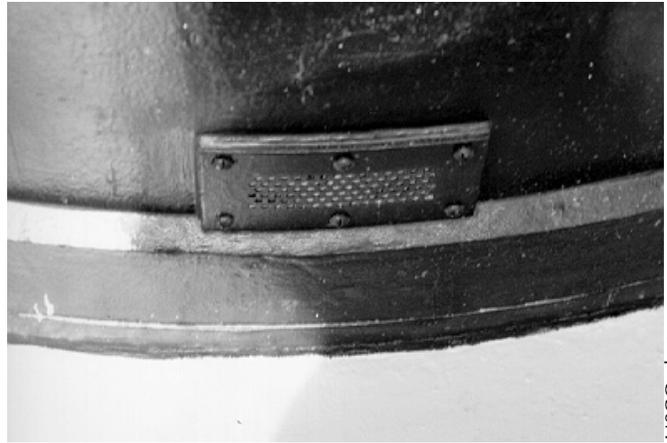
**Figure 20 (above).** The finished vent installation: 15-lb. roofing felt was placed between the bronze vent grill and the cast-iron parapet wall.

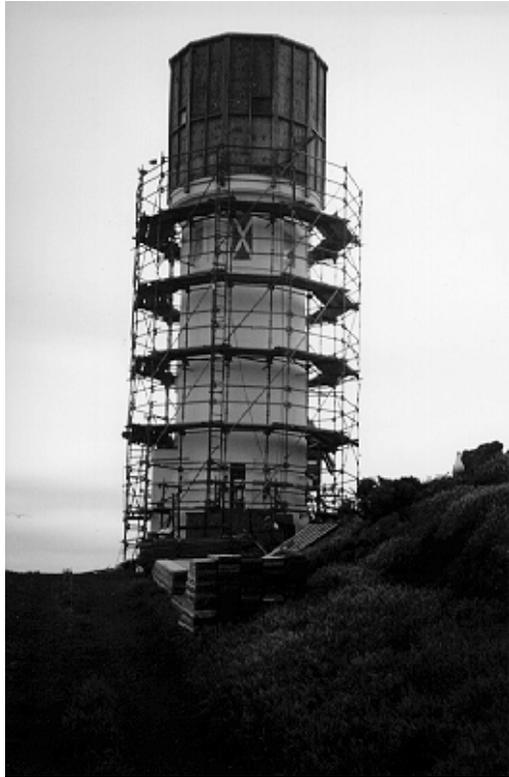
**Figure 21.** View of the plywood lantern enclosure and scaffolding.

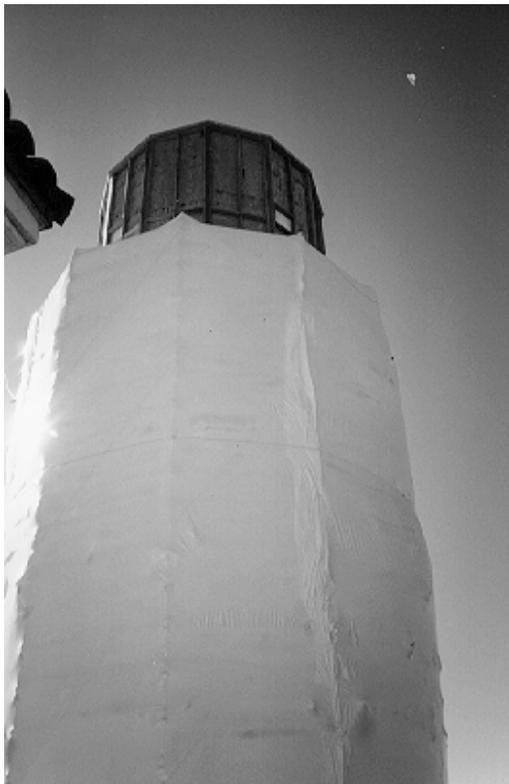
**Figure 22.** View of the lighthouse scaffolding covered with shrink wrap to contain all hazardous materials and protect workers from severe weather.

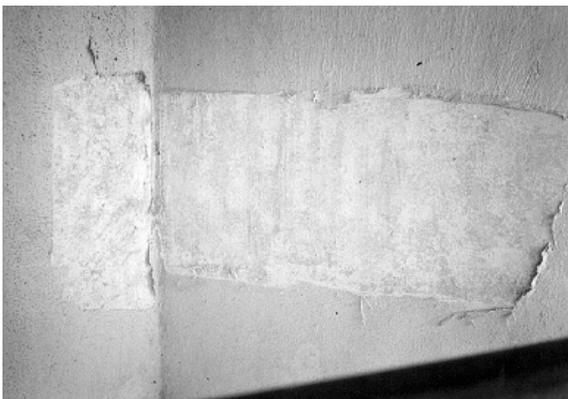
**Figure 23.** The water-based paint stripper was very effective in removing the many layers of paint from the exterior of the tower.

windows. The stripper was water-based and applied by brush and airless sprayer. After soaking for at least 1 1/2 hours, it was scraped off (see Figure 23). The stripped area was then neutralized with water and finished with power sanding where necessary. The interior lead-painted walls which were originally only to be lightly scraped and painted were causing problems. The paint was so old and brittle it continually flaked off. The abatement contractor asked for a change order to completely remove the paint because the current finished product was proving to be unacceptable. Chemical stripping of the interior walls had been selected over light blasting to save on the costs of transporting more blasting media to the island. Air-driven needle gun scalers using low pressure air, however, proved to be a more cost-effective method. The paint was so brittle, it shattered when struck by the needles, leaving the concrete virtually paint free (see Figure 24). There was no damage to the concrete and only lead-paint chips were left to be swept up and disposed of. This method could not be used on the exterior concrete because of the 3/8-inch white mortar skim coat that had been applied as a finish coat when the light was built in 1932.

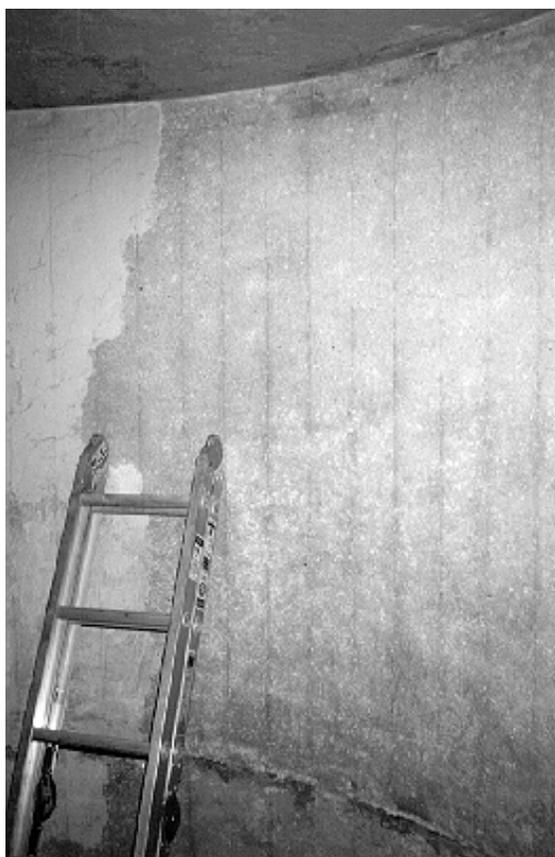
**Figure 24.** The interior paint was effectively removed using needle gun scalars, without damaging the concrete as evidenced by the visible impressions of the formwork boards.

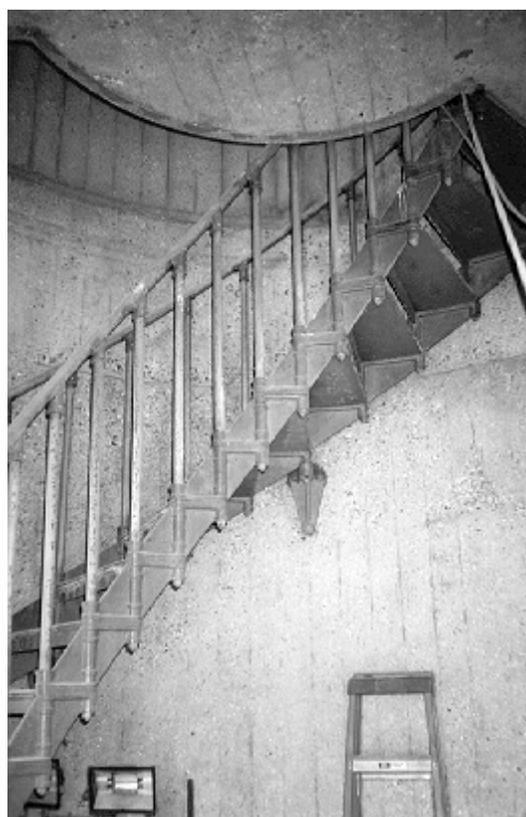
**Figure 25.** After the cast-iron stairs were blast-cleaned, they were rinsed to remove all traces of lead dust; flash rust immediately formed (as seen in this photo). Before painting, this light rust was removed with wire brushes.

expected and did not pose a problem (see Figure 25). All surfaces were then wire brushed, prepped, and primed by a three-man team who only prepped what they could prime within an hour. Although the primer used was designed for use over flash-rust, we did not want to chance a coating failure.

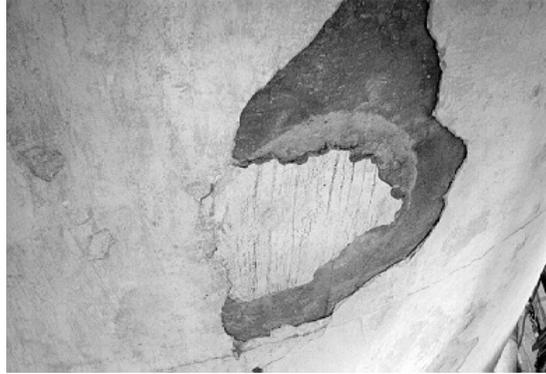
**Figure 26.** Once the scaffolding was erected, areas of the delaminated white mortar finish coat were removed.

The 3/8-inch white mortar finish coat that had been applied over the exterior concrete when the light was built in 1932 was not identified in any of the original drawings. As a result, no one looked during the work site visit for signs of delamination. After the scaffolding was in place, however, several areas were found to be loose between the 10- and 30-foot elevations. The foreman became concerned that other unidentified delaminated areas would fall out after the job was complete and ruin his work. The foreman inspected the entire tower and found an additional 100 square feet of delaminated mortar. After receiving approval to repair any bad mortar, he personally chipped away all the loose mortar and applied a two-part masonry patch material. The repair work was of such high quality that the patches were unnoticeable when the tower was repainted (see Figures 26 and 27).

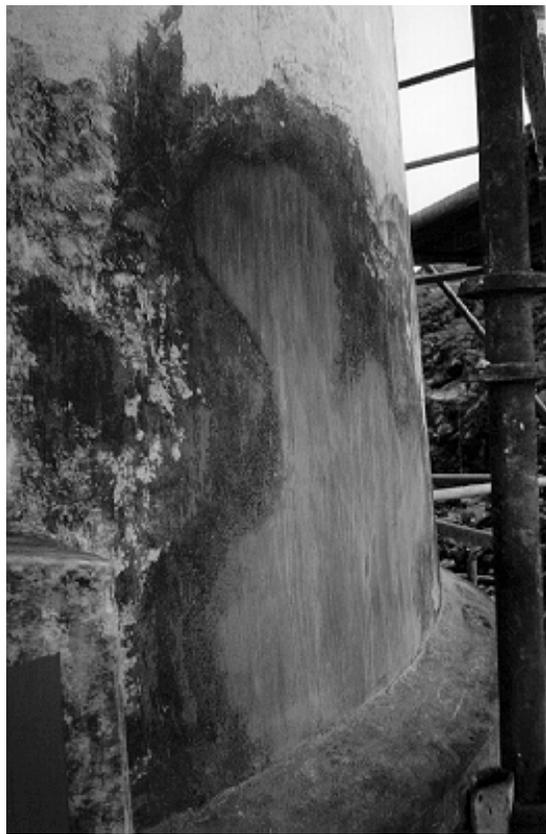
**Figure 27.** The areas where the loose mortar finish coat was removed were repaired with a two-part mortar patch. The final texture on the patch was tooled to match the historic wall surface. The patch was completely invisible after the tower was painted.

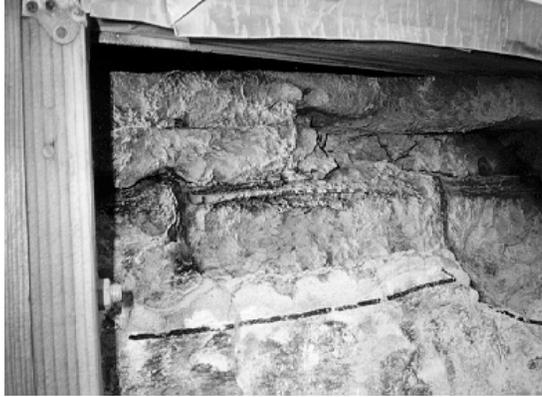
**Figure 28.** Close-up of the damaged concrete gallery deck after the loose concrete has been removed and before the damaged concrete was repaired using pressure-injected epoxy grout.

One major area of concern was the concrete gallery deck located outside the lantern. This deck had considerable damage in two areas without any evidence of the cause. The outer rebar showed signs of corrosion but the damage went 18 to 24 inches deeper into the concrete. Since freezing was not an issue, the cause of the damage was at first unknown. Closer examination revealed signs of an explosion inside the concrete, and we noticed bolt patterns for two old antenna mounts directly above the area. We determined lightning to be the cause. There was no practical way to dig out the

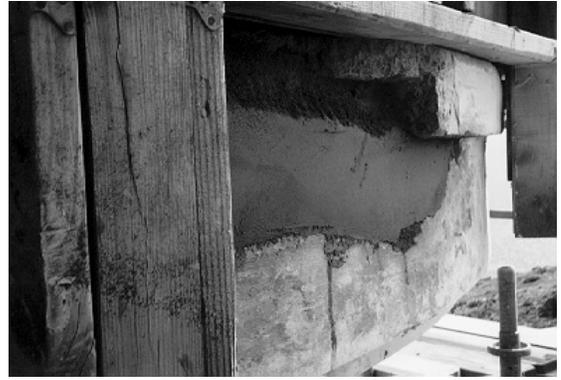
**Figure 29.** The first application of the mortar patch material to the damaged concrete.

broken concrete; the project was already over budget. We decided to do a pressurized epoxy injection and fill all the voids. The area was prepped and pumped full. The outer three inches were left unfilled so the two-part mortar patching compound could be used to restore the damaged area (see Figures 29 and 30).

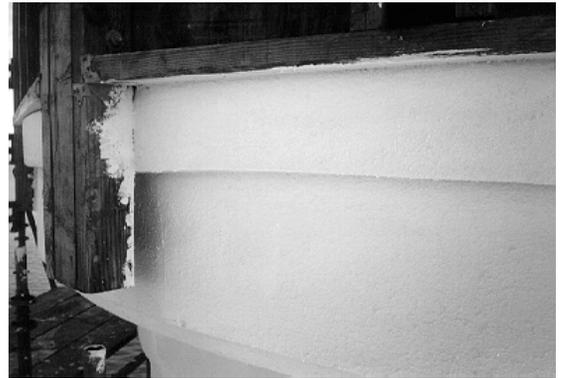
**Figure 30.** The finished concrete repair is virtually invisible after the surface has been painted.

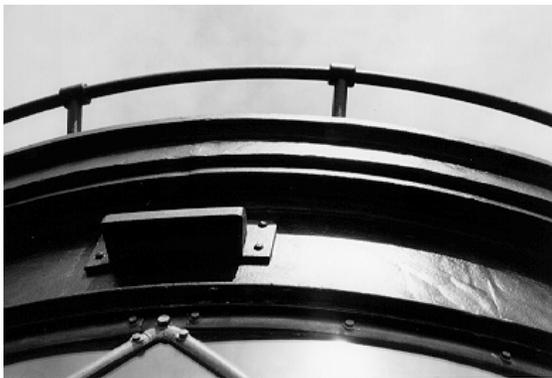
**Figure 31.** Close-up of the finished metal work on the lantern.

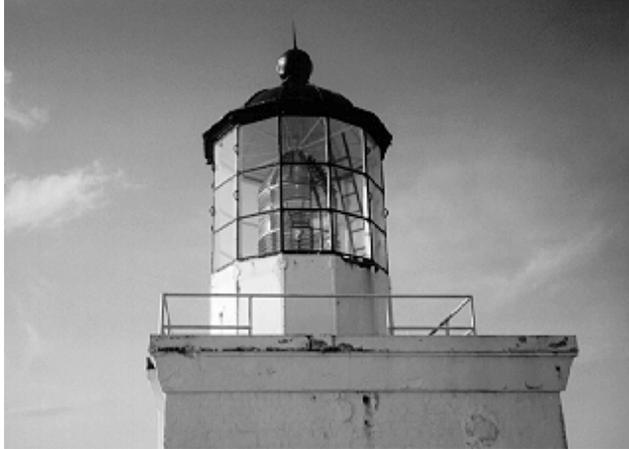
**Figure 33.** Point Bonita Lighthouse before rehabilitation; note missing gallery deck and holes below between the bottom of the lantern glass and top of the service room wall.

The poor condition of Point Bonita was first noted by the Officer in Charge of the San Francisco Aids to Navigation Team (ANT). His request prompted a site visit to Point Bonita in January 1993 to conduct a facility assessment and provide advice on how to repair the structure (see Figure 33). The original plan was to stop the water from entering the lighthouse and let Civil Engineering Unit (CEU) Oakland do the overall renovation in a couple years. But further investigation indicated the need for more immediate repairs, using self help-funding and the ANT personnel. The project soon grew into a full renovation that took six months and \$75,000 to complete.

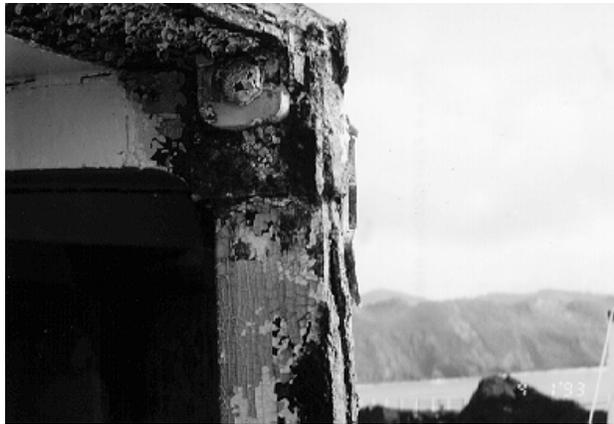
**Figure 34.** Close-up showing what remained after the gallery deck brackets were cut off with a torch. Note the heavy rust and paint failure caused by exposure.

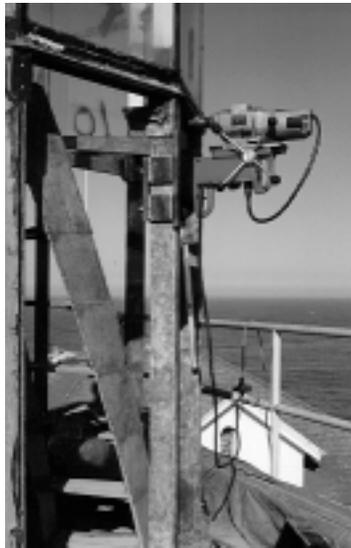
**Figure 35.** Jig used to bore holes in the gallery bracket tenons.

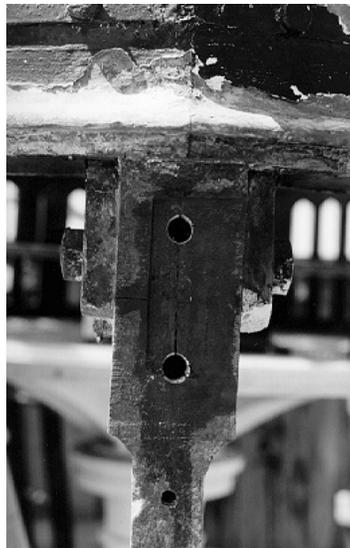
**Figure 36.** View of the gallery bracket tenons after the holes have been drilled. The tenon on the right connected to the exterior gallery; the tenon on the left is part of the interior gallery deck bracket. The 'v' that has been stamped in the end of the left tenon is an assembly identification mark.

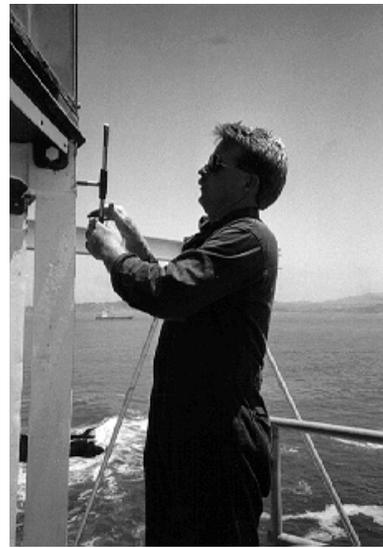
**Figure 37.** After drilling, threads were cut into each hole using a hand-operated tap.

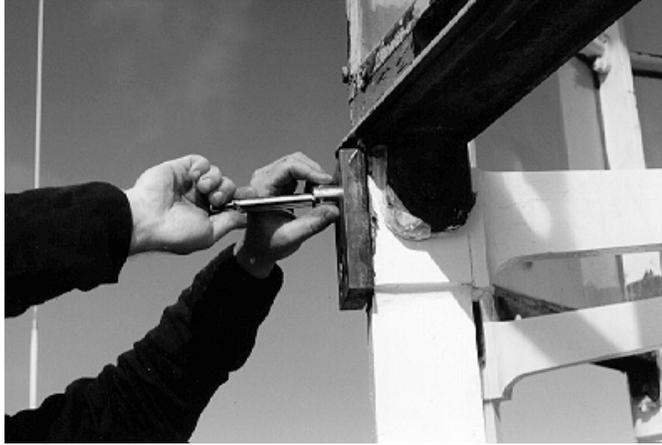
**Figure 38.** To provide a plumb mounting surface for the gallery deck, each mounting surface was covered with Belzona (a two-part metal paste); then the mounting plates were installed and tightened until they were plumb. The excess Belzona can be seen oozing near the middle of the plate.

Investigative demolition followed. The original gallery deck had been removed in the 1960s, but no details were available on how it was performed. First removed was the fiberglass cloth that sealed the watchroom panels to the lantern room and covered the areas of the original gallery deck brackets. Fortunately, the old brackets had been cut off above the wide base flange with a torch, leaving the tenons from the original brackets intact inside the cast-iron lantern frame (see Figures 34 and 36). Removal of the remaining tenons from the frame and fabrication of new gallery deck brackets duplicating the originals proved impractical because the tenons were rusted tight and pinned in place. The tenon was therefore used as an anchor. The old base flange flush with the frame was cut using a portable metal-cutting bandsaw and the area ground flush. A special jig was designed for the magnetic drill press; two holes were then drilled and tapped directly between each set of tenons (see Figures 35, 36, and 37). A one-inch-thick mild steel mounting plate consisting of two recessed bolt holes and four tapped holes was then put in place. (304 S/S might have been an even better choice; the mild steel is holding up well, but may become a maintenance problem if the lighthouse isn't properly maintained.) The two recessed holes allowed the plate to be bolted to the lantern frame and the new bracket bolted directly over the two base bolts. The area beneath the plate was covered with a 1/8-inch layer of Belzona Metal filler to ensure there would be no voids and to act as a leveling compound (see Figure 38). The bolts as well as the plate were covered with a releasing compound (Vaseline)

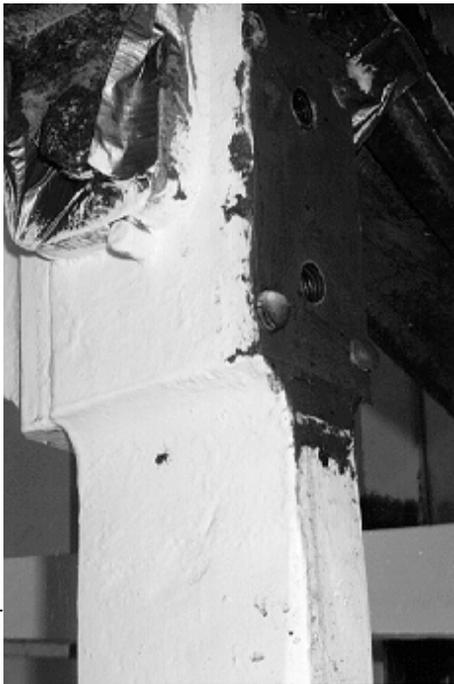
**Figure 39 (left).** View of the mounting surface after the Belzona had cured and the mounting plate had been removed. The 'knobs' or protrusions on the surface are where the Belzona was squeezed through the holes in the mounting plate. These were ground off along with the excess Belzona that squeezed out around the plate.

and then slowly tightened until the plate was plumb. The Belzona was then allowed to dry before all excess Belzona was ground off (see Figure 39). This procedure worked very well and took no more than three days to accomplish. The base plates were then primed, painted, and caulked before being torqued in place.

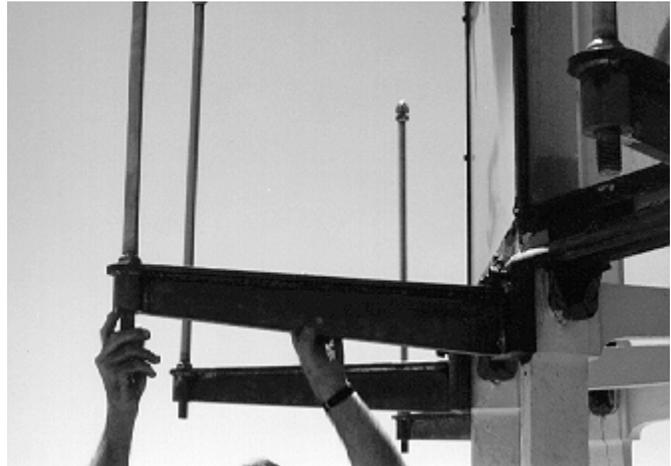
**Figure 40 (above).** The new gallery deck brackets after installation.

fabricated to match the original cast-iron brackets details. (This is another area where 304 S/S might have been better.) The stanchions were made of 1-inch 304 S/S round stock and 1-inch 316 S/S bolts. The bolts had a 1-inch diameter and 1/4-inch-deep recess machined in the head to ensure the bolts were properly aligned during welding. Custom 1-inch 316 S/S acorn nuts were then purchased to secure the stanchion to the brackets and the handrails. With the brackets and stanchions in place, the 3/8-inch flat bar handrails were then drilled, scribed, and fitted (see Figure 40).

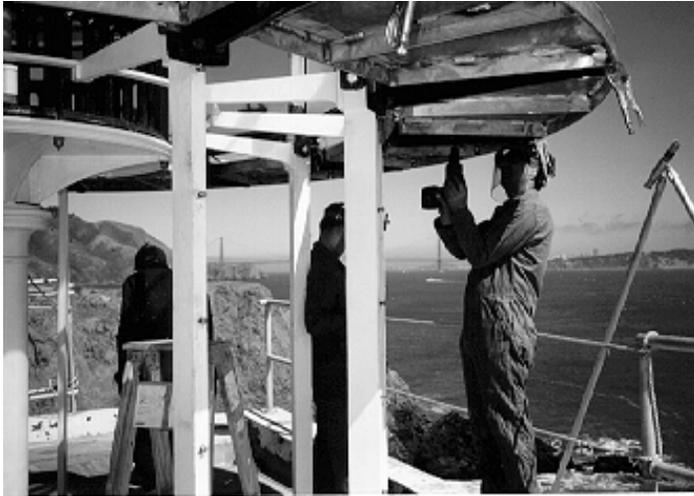
**Figure 41.** Final fitting and installation of the new aluminum deck plate.

with no signs of dissimilar metals reacting. S/S diamond plate, might however, avoid any future problems (see Figure 41).)

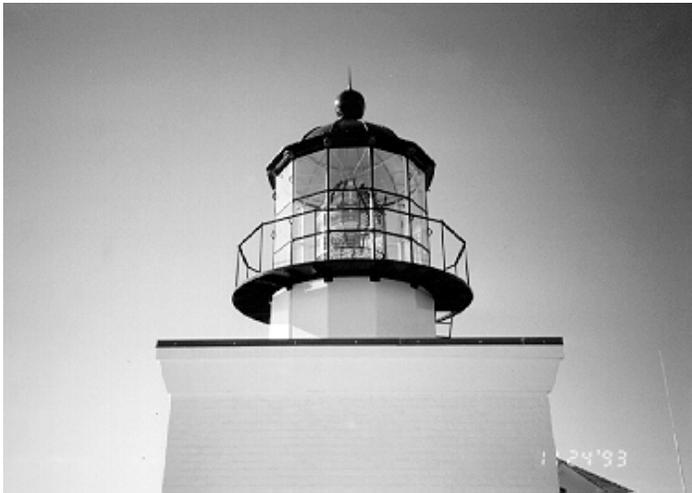
**Figure 42.** View of the Point Bonita Lighthouse after the gallery deck replacement.

on lighthouses understands dissimilar metals or even how to ensure that materials are properly reinstalled (see Figure 42).

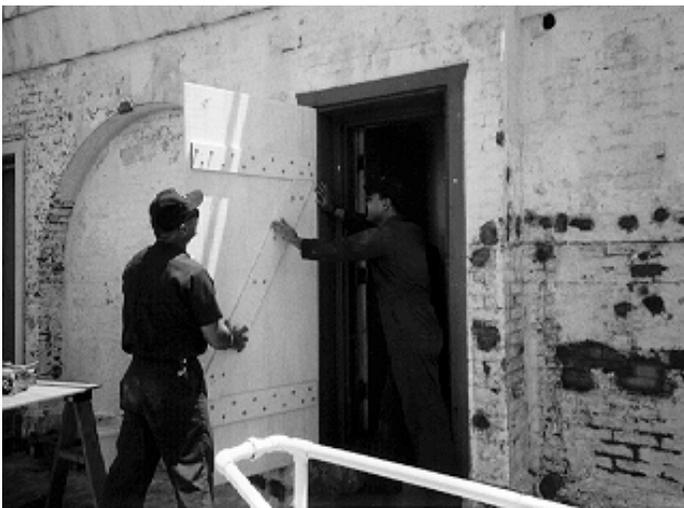
**Figure 43.** Installation of the new exterior wood storm door.

The exterior storm doors were also easy to duplicate. The pictures were clear and showed one door open and one closed. Both exterior doors were made of 1- by 6-inch tongue-and-groove redwood and fastened together using S/S carriage bolts, nuts, and washers. After the doors were test fitted, they were disassembled, primed, painted, and reassembled. These doors have held up extremely well and have given no trouble (see Figure 43).

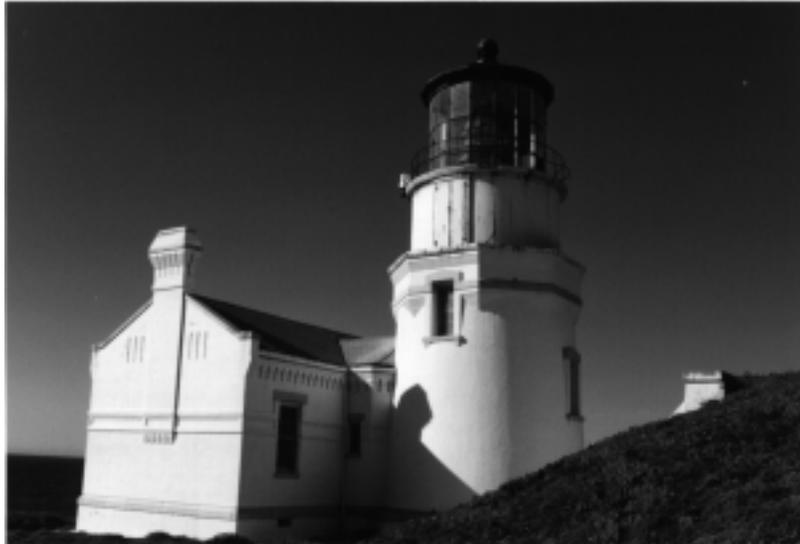
**Figure 44.** *Before the rehabilitation.* Note the doors at the watch room. A new louvered panel will be installed for added ventilation.

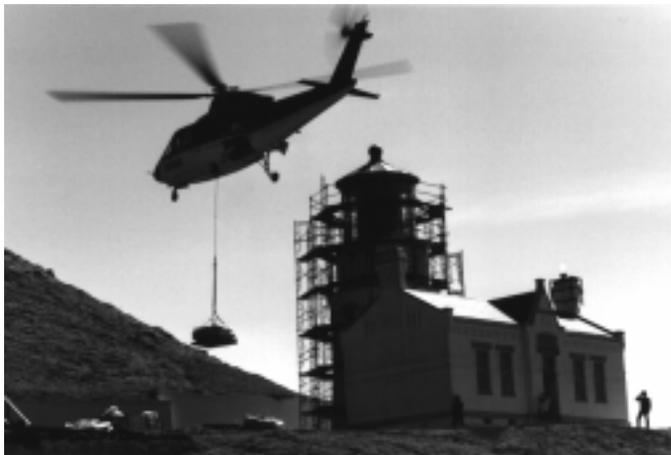
**Figure 45.** *Staging the work.* Note the temporary location of the auxiliary light on the fog signal building chimney.

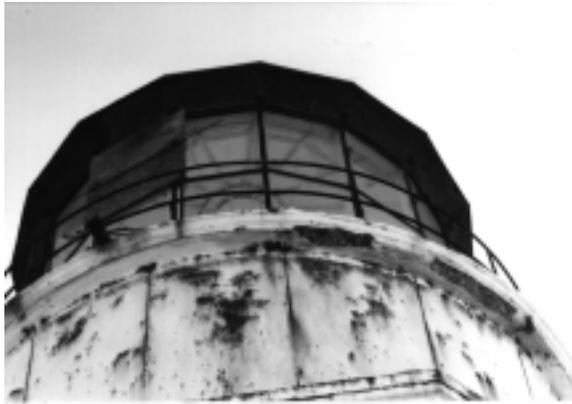
**Figure 46.** *Lighthouse lantern before rehabilitation.* Note the missing ladder rails and the severe rust on the lantern cornice and lower watch room panels. The badly spalled concrete gallery deck was installed in 1947 and is not original.

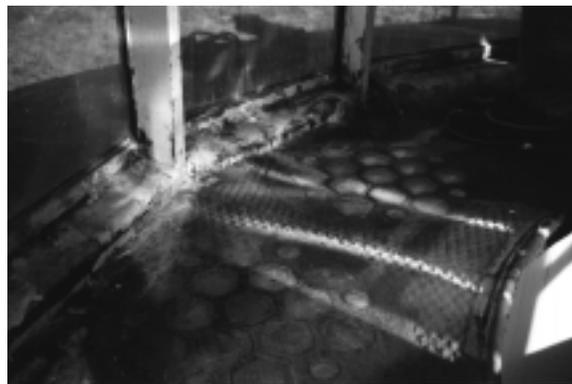
**Figure 47.** *Lantern room before rehabilitation.* Note the lower sill channels filled with concrete. This shortsighted ‘repair’ method blocked the ventilators and caused condensation to spill out on the deck, effecting rust and further damages below.

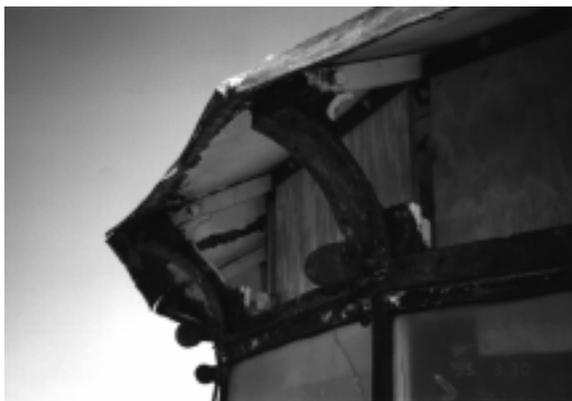
**Figure 48.** *Reconstructing the cornice.* The cornice plates were removed to expose the corroded cast-iron brackets and top channels. New brackets were cast in bronze, and the top sill channels were fabricated in stainless steel. Note the plywood ‘curtain’ erected for weather protection and shoring the lantern roof during reconstruction.

heavy rain washed out portions of the road, which cut off access for over a week. A special plywood ‘curtain’ was erected in the lantern room with clamps to protect the classical lens from the weather and shore up the lantern structure during reconstruction.

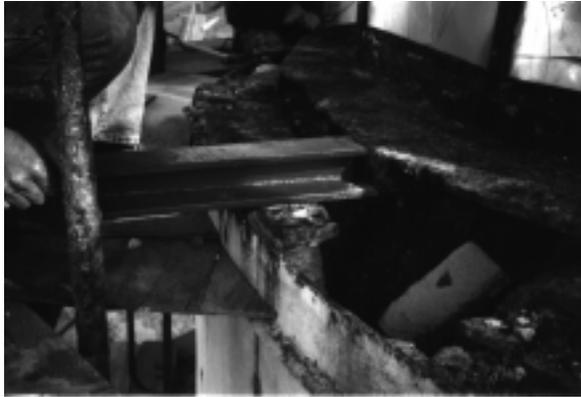
**Figure 49.** *Reconstructing the gallery deck.* After removing the existing concrete, remnants of the original cast-iron deck were found.

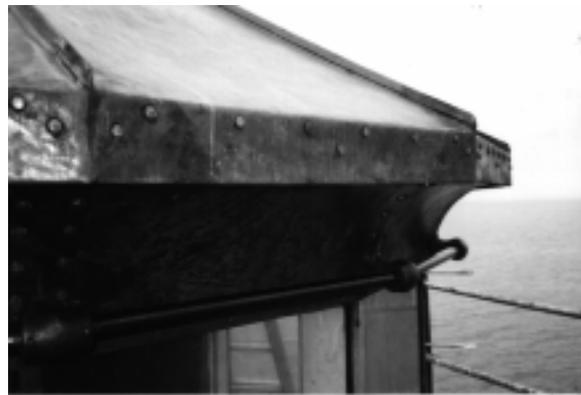
**Figure 50.** *Lantern cornice after rehabilitation.* Replacing the original steel cornice plates with copper eliminated the dissimilar metals problem.

Although surface rusting was the main problem at the lantern, some of the deterioration was caused by galvanic reaction between dissimilar metals. Dissimilar metal problems were eliminated by replacing the original deteriorated cast-iron cornice plates and brackets with copper and bronze. The original copper roof dome was then stripped of its paint and allowed to naturally patina. Besides low maintenance, the other advantages of copper are its flexibility to withstand strong winds, building movement, and wide temperature changes. In other areas, neoprene gaskets, felt or teflon tape, thick epoxy primers, and bituminous paints were used between dissimilar metals to prevent future corrosion.

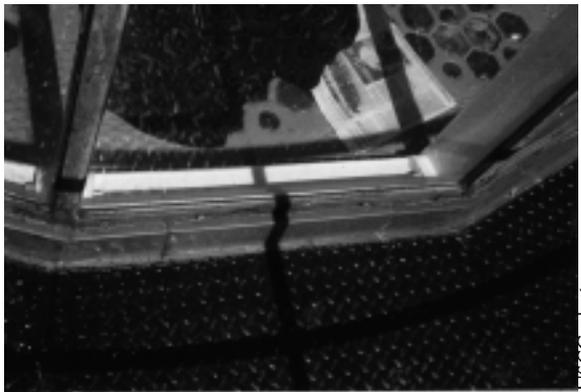
**Figure 51.** *Lantern galley deck after rehabilitation.* The new gallery deck was fabricated with stainless steel diamond plate and carefully flashed with copper at the lantern room. The interior lower sill channels were rebuilt to catch condensation from the glass.

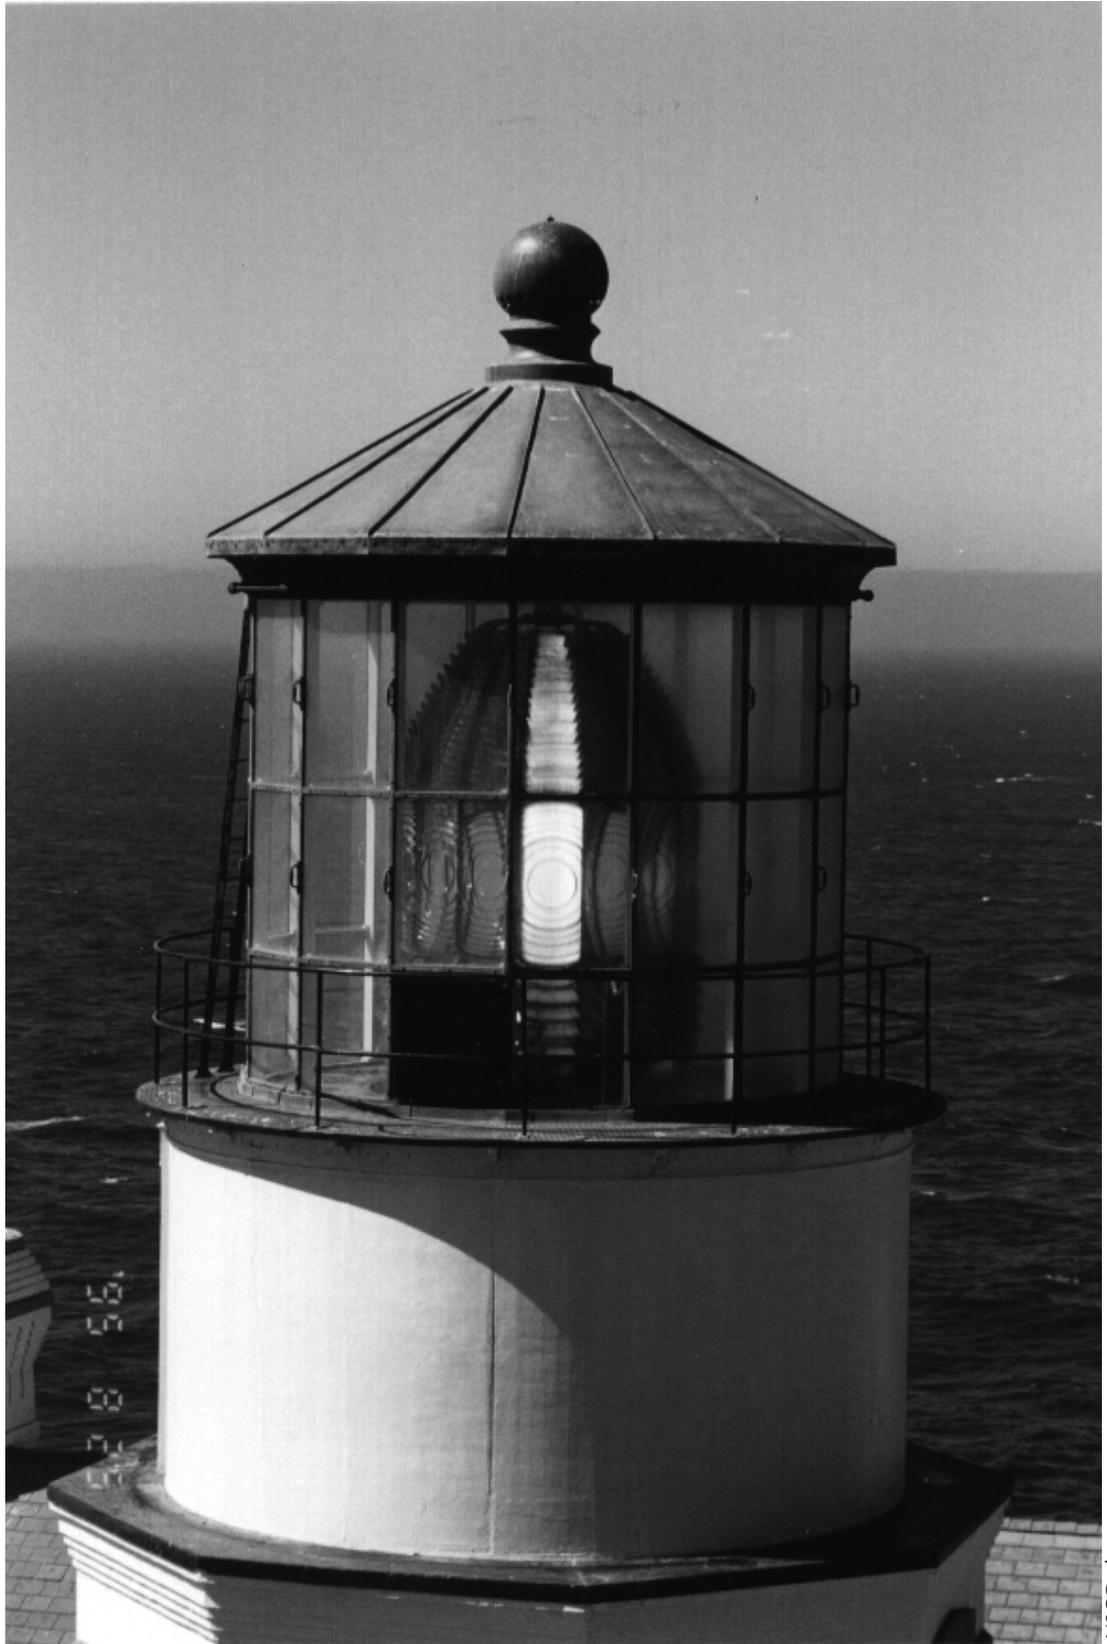
**Figure 52.** *Light tower lantern after rehabilitation.* The nonferrous metalwork at the lantern room is left unpainted and allowed to naturally patina, thus saving maintenance costs.

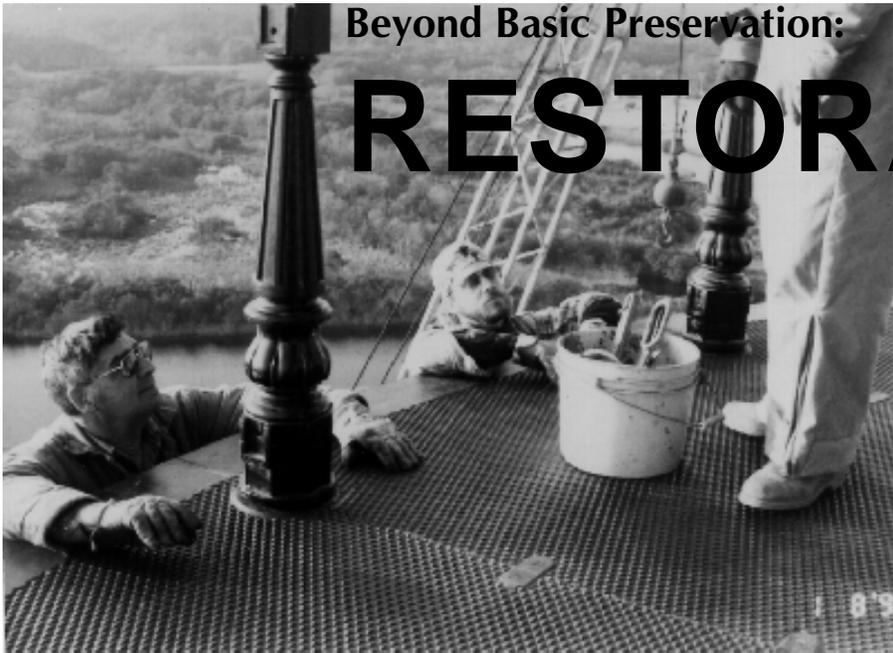
**Figure 1.** New ornate cast-iron handrail posts were recast and installed on the new gallery deck as part of a restoration at Cape Hatteras Lighthouse, Buxton, North Carolina.
