## Historic Lighthouse Preservation Handbook

The Historic Lighthouse Preservation Handbook was created through a cooperative partnership between the National Park Service, [U.S. Coast Guard](#), Department of Defense Legacy Resource Management Program, and U.S. Lighthouse Society. The 328-page preservation manual, released in August 1997, focuses primarily on the maintenance problems associated with the many different materials and construction techniques used in these unique structures. In addition to

sections devoted to preservation treatments, it includes a brief history of the U.S. Lighthouse Service and lighthouse construction types; existing historic preservation laws, standards, and guidelines; case studies for both lighthouse rehabilitation and restoration projects; related activities (interpretation, funding, safety management, etc.); and sources for more information.

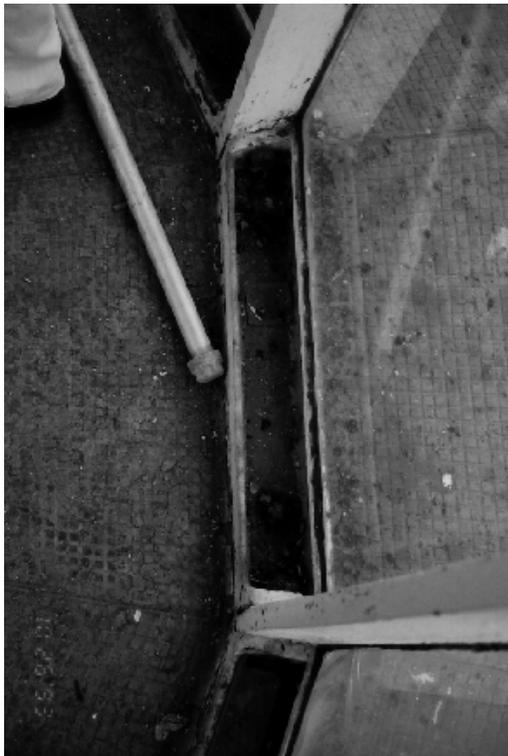
**Figure 2 (left).** Condition of the bronze sill sitting on the lantern deck inside the lantern room. The sill is wedged between two vertical cast-iron stiles, which are anchored into the masonry below.

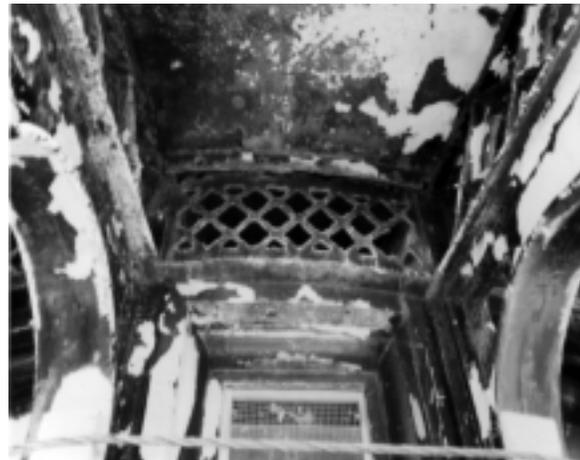
**Figure 3 (above).** Horizontal mullions run in between the stiles and serve to keep the stiles straight and frame the individual pieces of glass. Before restoration, the mullions and sills had been bolted in place over 140 years.

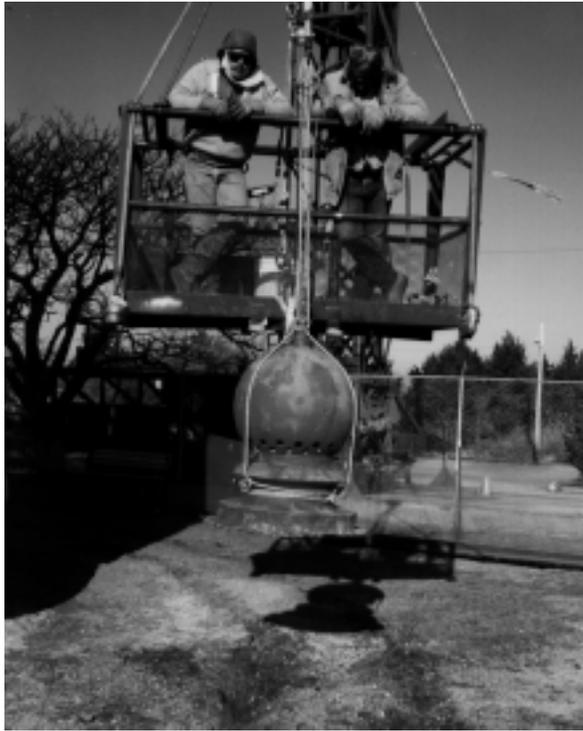
**Figure 4.** The first step in removing the roof was to take off the vent ball. The vent ball not only serves as a lightning rod but also provides ventilation to the glass in the lantern room, limiting condensation.

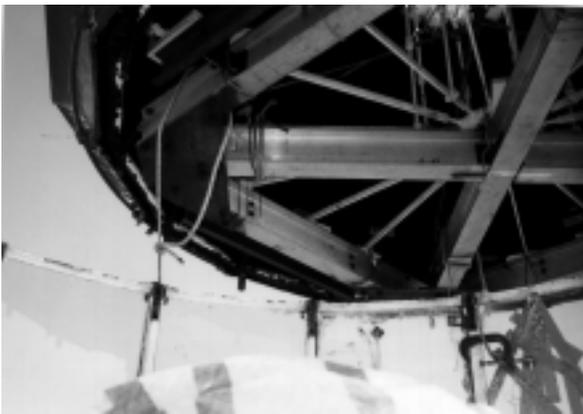
**Figure 5.** As the roof is being removed from the lighthouse, the tie rod system, supported by ICC's aluminum roofing frame, is visible. This frame was designed to fully support the roof and alleviate any stress or strain on the roof during the lift. Protruding down from the roof are the ends of the rafters which connect to the top of the stiles.

system of cantilevered beams that concentrated the load on the brick column of the tower. A lifting jig was designed and installed underneath the roof, and the roof was disconnected from the window wall system.

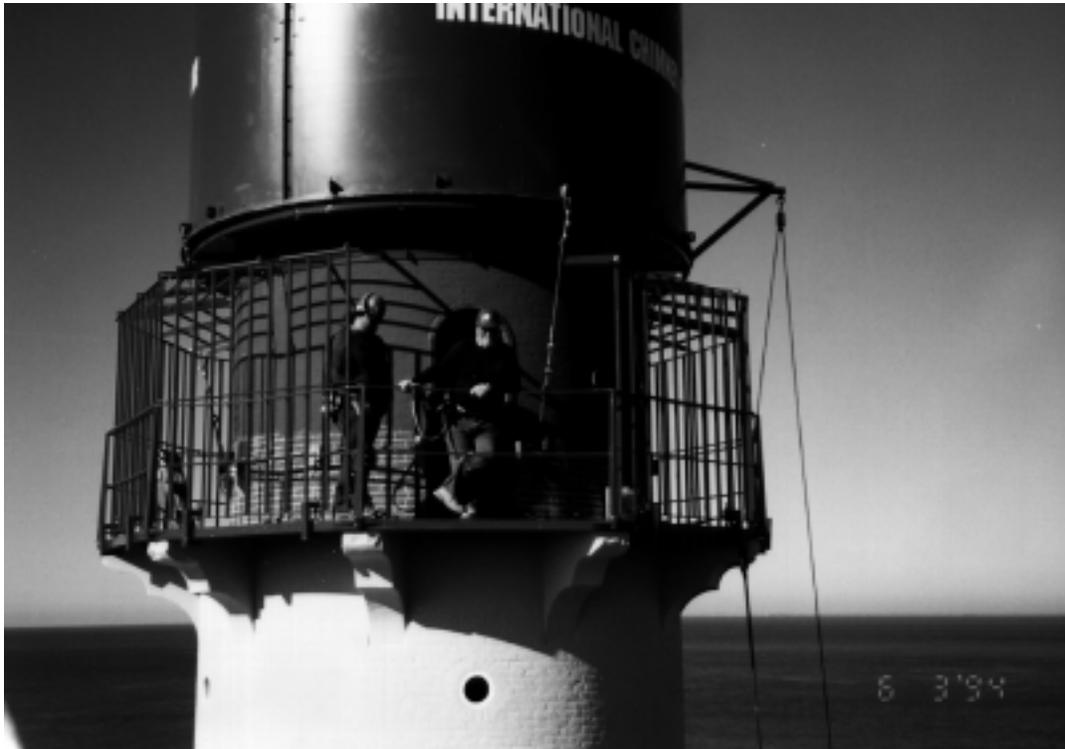
**Figure 6.** During the restoration, this ‘Campbell Soup Can’ was installed over the lantern room in order to protect restoration efforts from the environment.

Necessity is truly the mother of invention. The job was replanned to include disassembly of the roof only and rework of the lantern in the field. A large temporary steel enclosure, affectionately referred to as the 'soup can', was fabricated to fit over the window wall system and allow craftsmen to work in relative comfort during the coldest winter in Cape May history. The temporary steel enclosure, designed to accommodate both interior lighting and ventilation, was installed on a

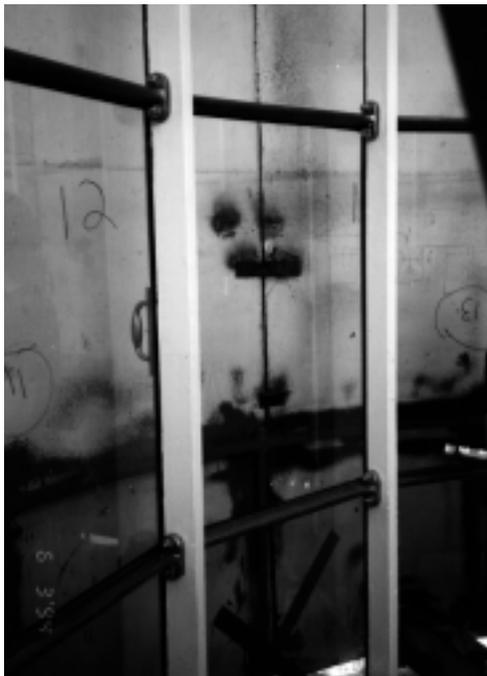
**Figure 7.** Inside the lantern room, the mullions have been reworked and reattached to the stiles. New stainless steel bolts have been used to prevent corrosion and teflon tape has the used as a gasket between the bronze and the cast iron. Teflon washers also separate the bronze from the stainless steel bolt.

In June 1994, all preparations were complete for reassembly of the lantern room and roof system. The matched, marked pieces were carefully refitted with new stainless-steel hardware and teflon tape which acts as an isolator between the dissimilar bronze and cast-iron metals. In the 19th century, little was known about the chemical reaction between dissimilar metals. When a copper-based metal is placed in contact with a ferrous-based metal, an anode-cathode reaction occurs, similar to a battery. This changes the molecular structure of the ferrous metal, causing corrosion.

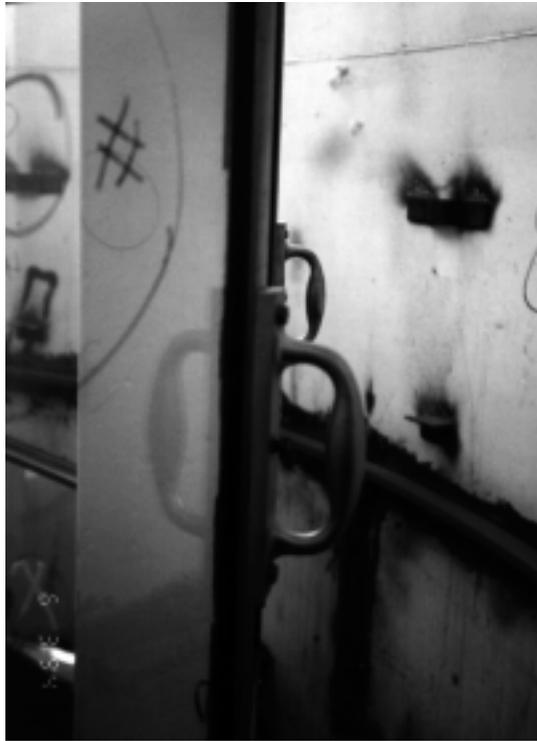
**Figure 8.** New hand holds were replicated to replace missing pieces. These exactly match the originals.

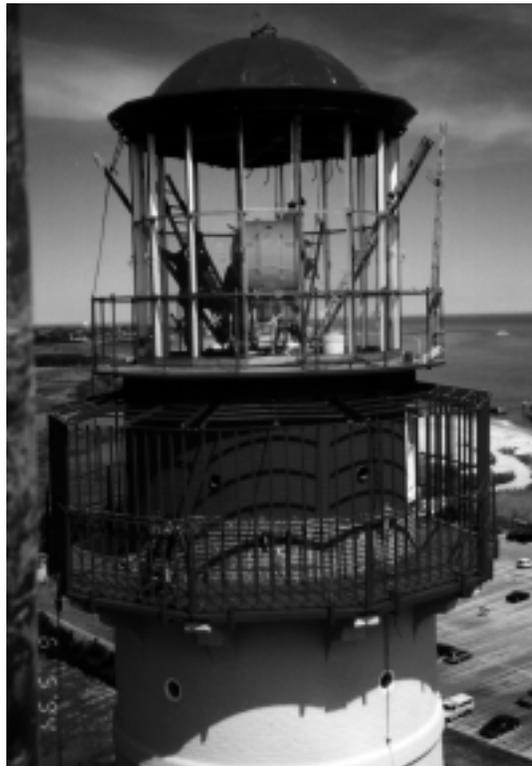
**Figure 9.** The refurbished roof is replaced on the lantern room. The fit is almost exact.

Meticulous preparations were made on the ground and in the air for the lift. The refurbished roof was centered as close as possible to the center line of the lighthouse and turned to allow for the proper fit in its original position. ICC's craftsmen were perched on ladders waiting for the roof to be hoisted. When all was ready, the signal was given and the lift began. The roof was centered above the window wall and began its descent. The result was anticlimactic. The roof came down exactly into position as if sucked in by a giant magnet. The major portion of the restoration was complete.

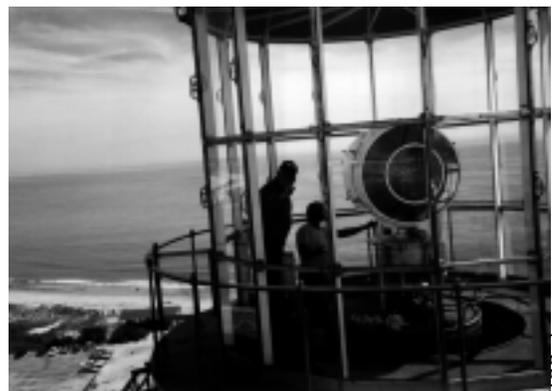
**Figure 10.** All glass is now in place and final preparations are made for the reopening.

New safety glass was installed on the window wall system, and the 'soup can' was no longer needed. A relatively calm wind would be required to remove the enclosure and set down the newly refurbished roof. On the June 4, 1994, conditions appeared favorable. The enclosure was lifted and, for the first time in five months, the efforts of the craftsmen were revealed. The newly lacquered bronze mullions, glazing bars, and sills gleamed in the bright early summer sun.

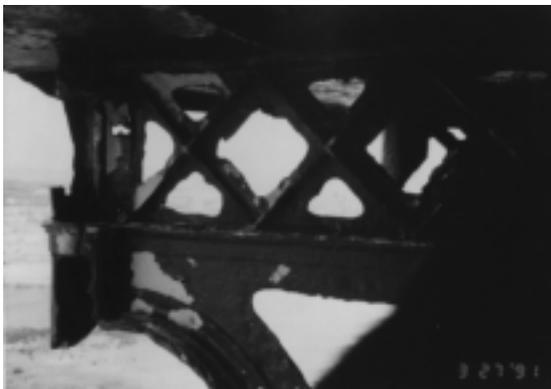
**Figure 12.** Some brackets were so deteriorated that they were totally exposed to the elements.

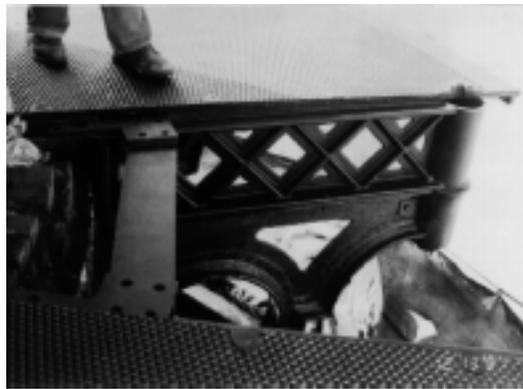
**Figure 13.** After the most severely deteriorated portion of the brackets were removed, new cast-iron pieces were made and installed; and new deck plates installed.

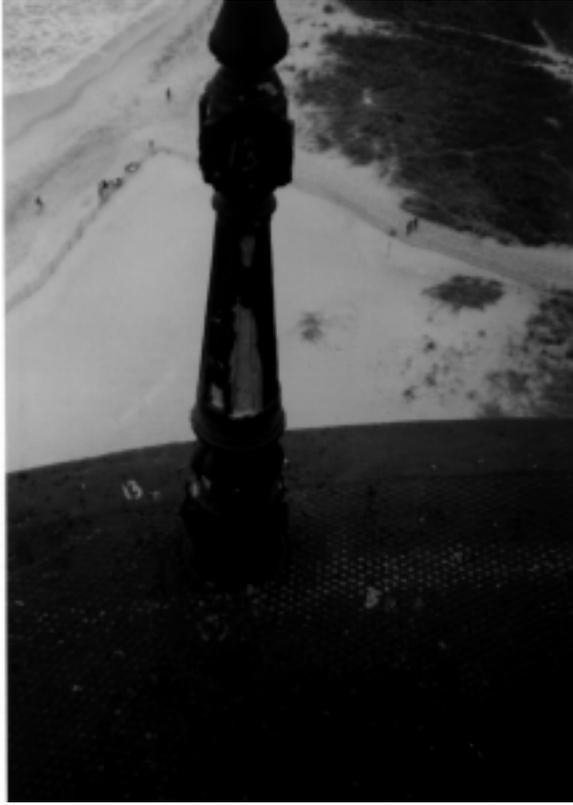
**Figure 14.** The handrail assembly has been removed and the ornate cast-iron post is ready for removal.

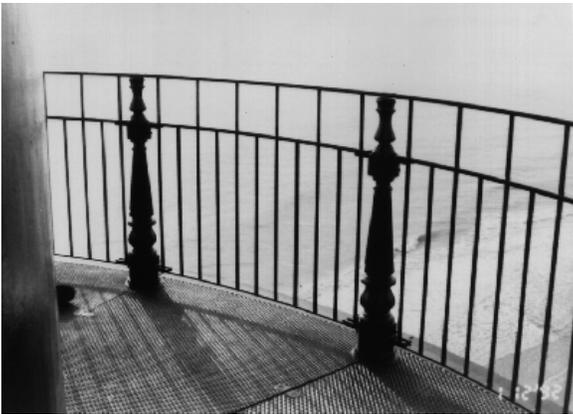
**Figure 15.** A replica handrail is installed.

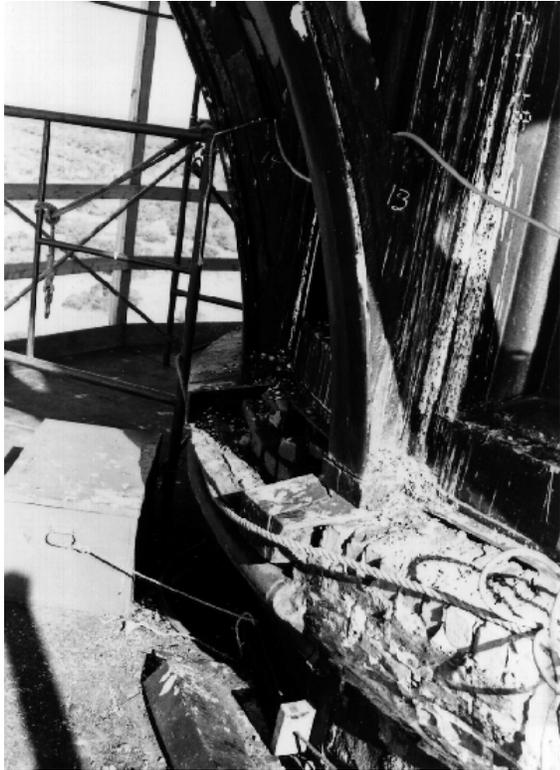
**Figure 16.** At the base of the brackets, the cast-iron belt course is removed, exposing deteriorated masonry below.

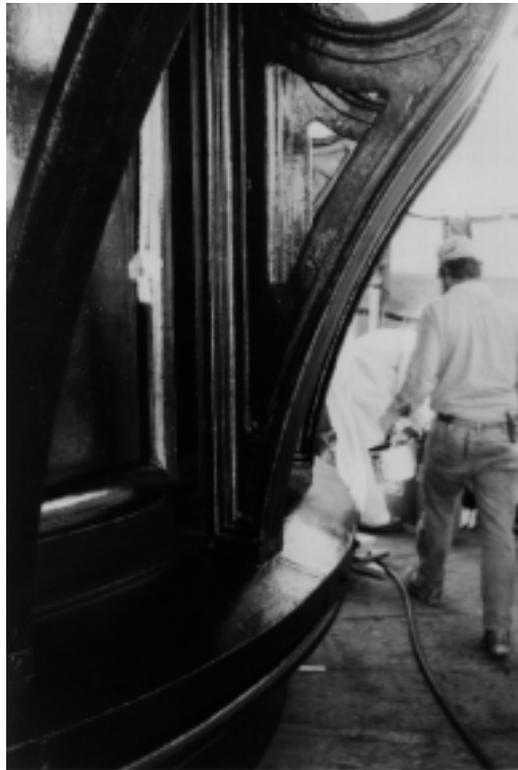
**Figure 17.** The cast-iron belt courses are repinned to new masonry beneath.

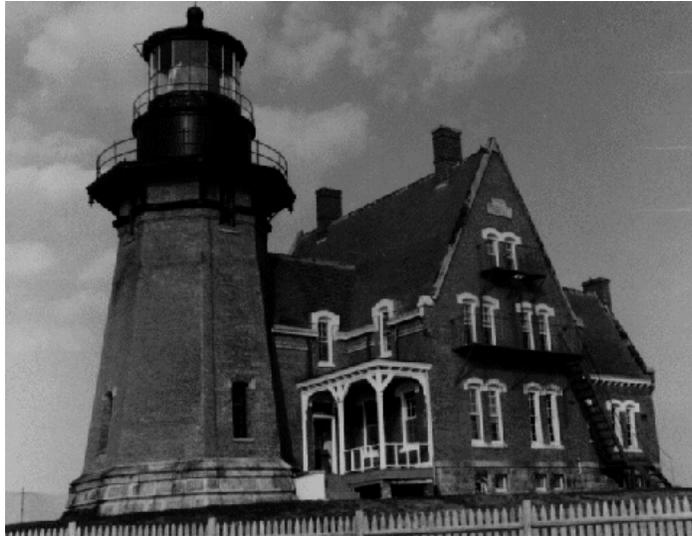
**Figure 11.** Block Island Southeast Light Station before the move.

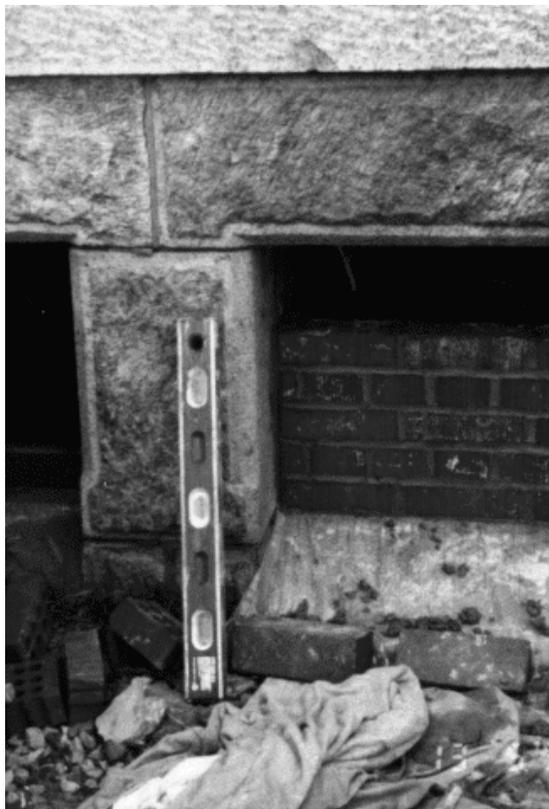
**Figure 12.** In preparation for the move, the cellar windows openings are temporarily bricked in to stabilize the masonry above the lift point.

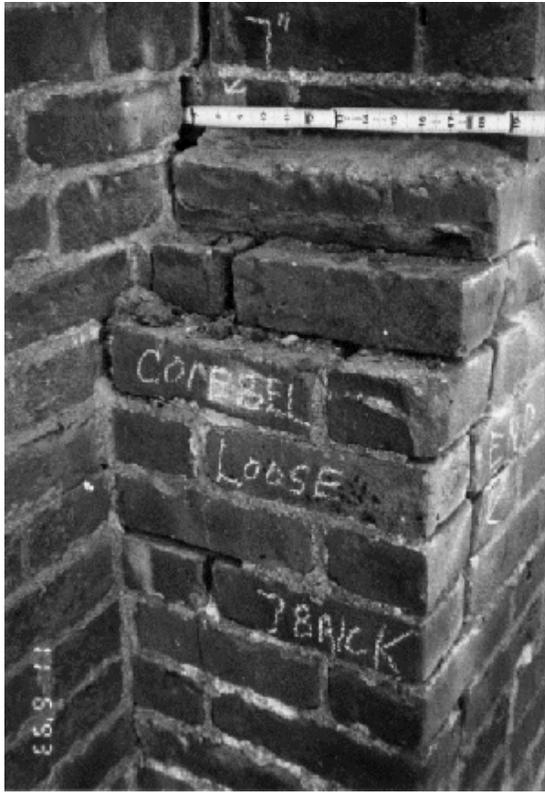
**Figure 13.** A complete structural survey of the building was performed and documented in order to perform the structural repairs necessary to move the building intact. All loose or eroded mortar joints were cut out and carefully pointed with a new mortar mix designed to closely resemble the original. All chimneys were braced and cabling installed around the perimeter to catch problem areas.

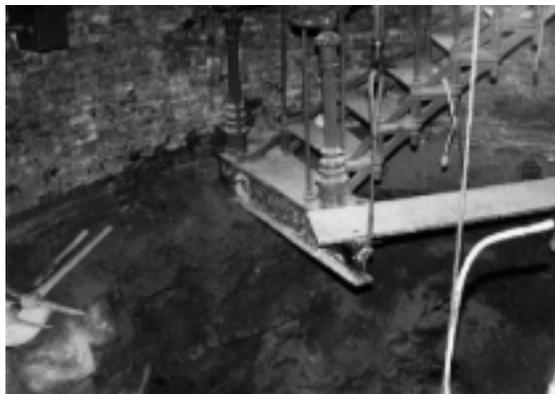
**Figure 14.** The concrete floor of the light tower was removed and earth excavated by hand in order to perform stabilization from the interior of the structure.

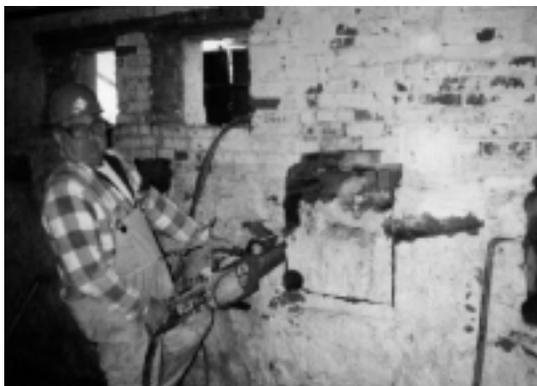
**Figure 15.** A hydraulic chain saw with industrial diamond teeth is being used to cut openings below the grade line for insertion of the steel beams.

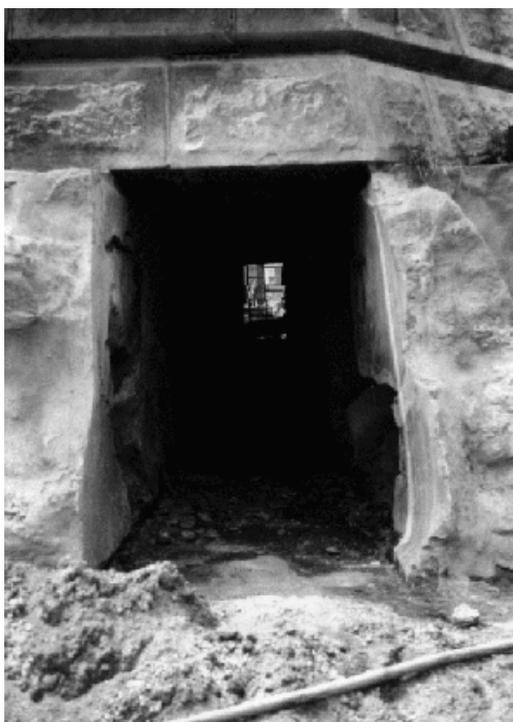
**Figure 16.** Close-up of the opening for the beam cut by the wire saw measuring 5 feet high by 3 feet, 6 inches wide. The depth of the cuts ranged from 18 inches to 16 feet for multiple wall cuts.

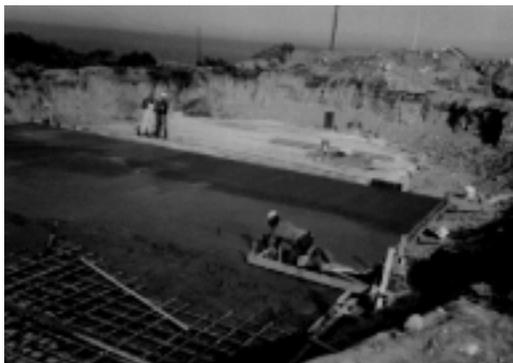
**Figure 17.** A foundation slab is being poured using 36 tons of rebar and 245 yards of concrete. This 18-inch-thick slab was designed to handle the dynamic load of the building travelling across the slab to its final position.

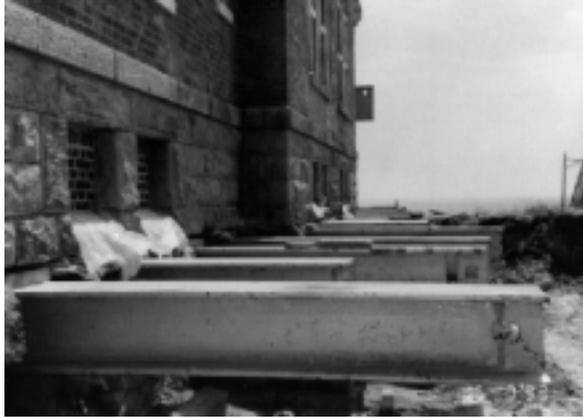
ICC photo

**Figure 18.** Large cross steel beams are inserted into the cut opening to form part of the grid that will carry the building.

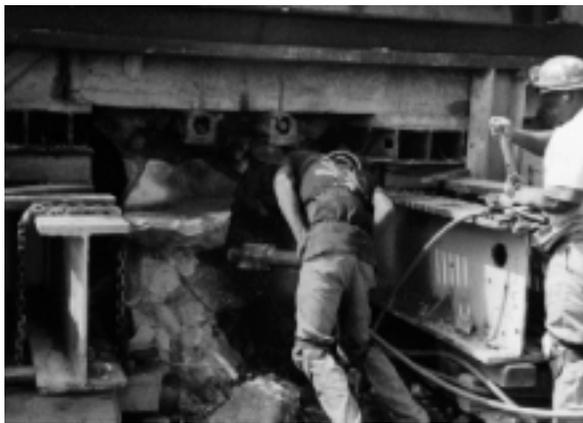
ICC photo

**Figure 19.** Once the initial lift was performed, the remaining foundation between the beams was removed.

Following the transfer of the lighthouse load from its foundation to the beam grid, all 38 hydraulic lifting jacks were activated in unison and the entire structure was raised vertically approximately 2 feet from its original elevation. The structure was then cribbed on oak timbers, tracks positioned below and parallel to the main beams, and the hydraulics for the jacks rerouted to three separate zones to allow for compensation on uneven surfaces during travel, i.e., no stress would be placed on the structure if a bump or soft spot was encountered, because the structure would roll like a ship rather than bend. By August 11, 1993, preparations were complete. The lighthouse was ready for the move.

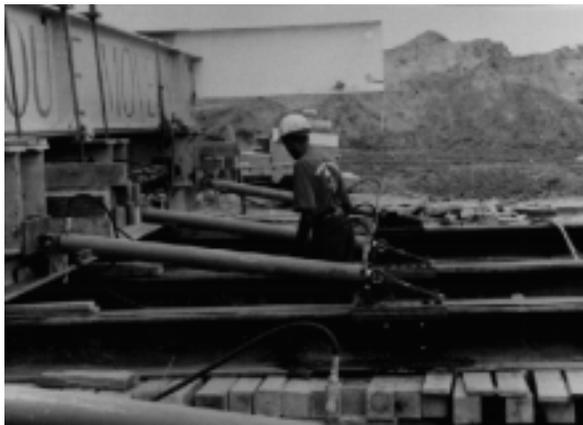
ICC photo

**Figure 20.** Four hydraulic rams set into the track steel pushed against the main steel to set the lighthouse in motion.

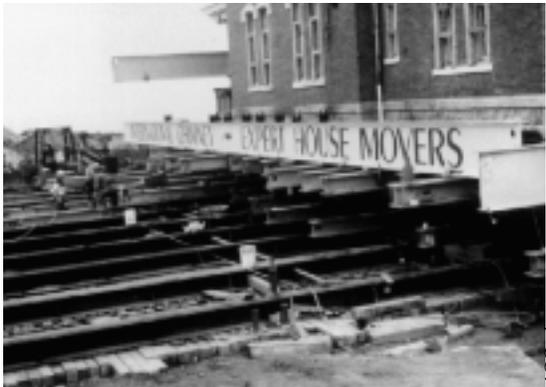
ICC photo

**Figure 21.** After the first leg of the journey was completed, the track steel was repositioned for a 90° turn.

crisscrossing steel beams and then pushed along tracks to its new home. The tracks were made of steel beams with case-hardened strike plates and laid on oak cribbing along a zig-zag path between the old lighthouse location and the new. In all, approximately 800,000 pounds of steel was used in the beam grid and track system.

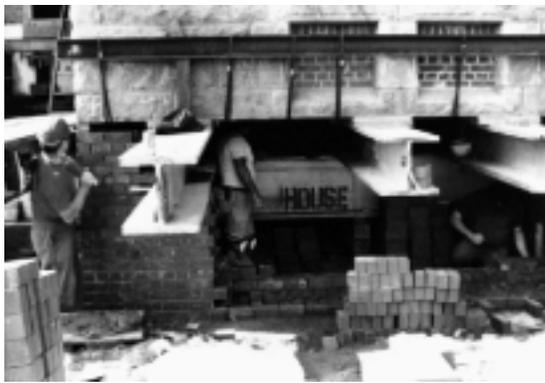
ICC photo

**Figure 22.** Construction of a new foundation around the support beams.

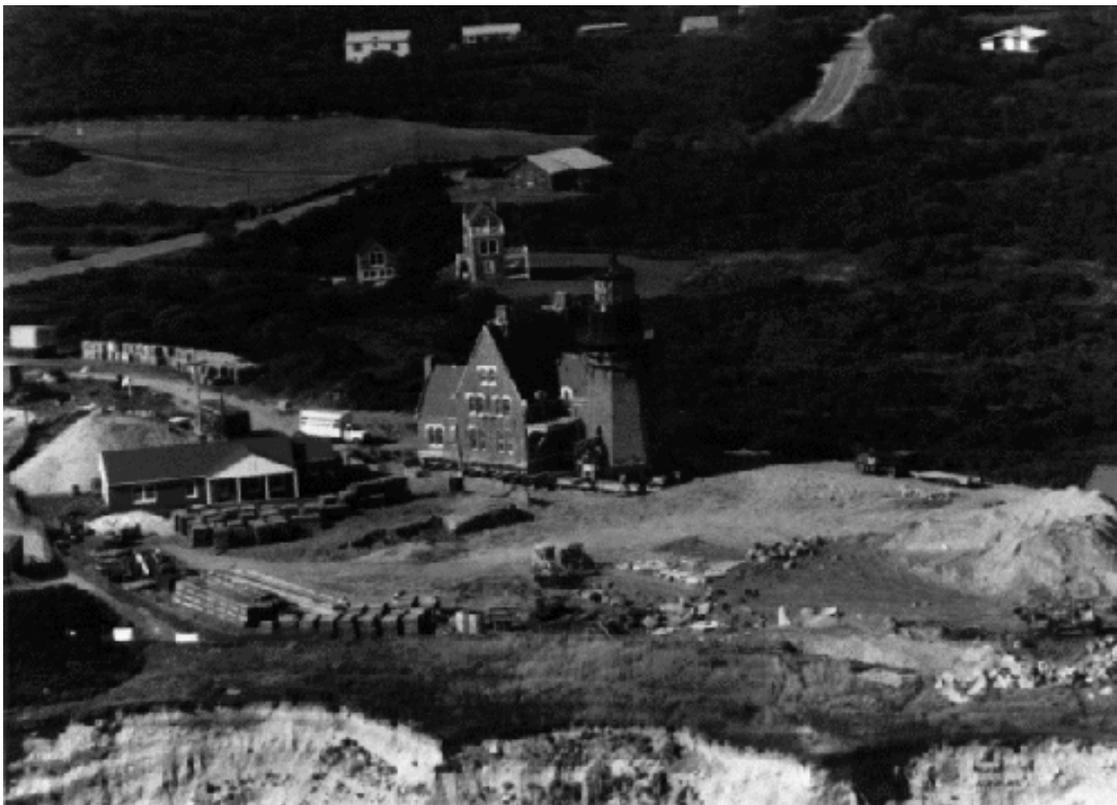
ICC photo

**Figure 23.** On August 23, 1993, the Block Island Southeast Light Station reached its new home.

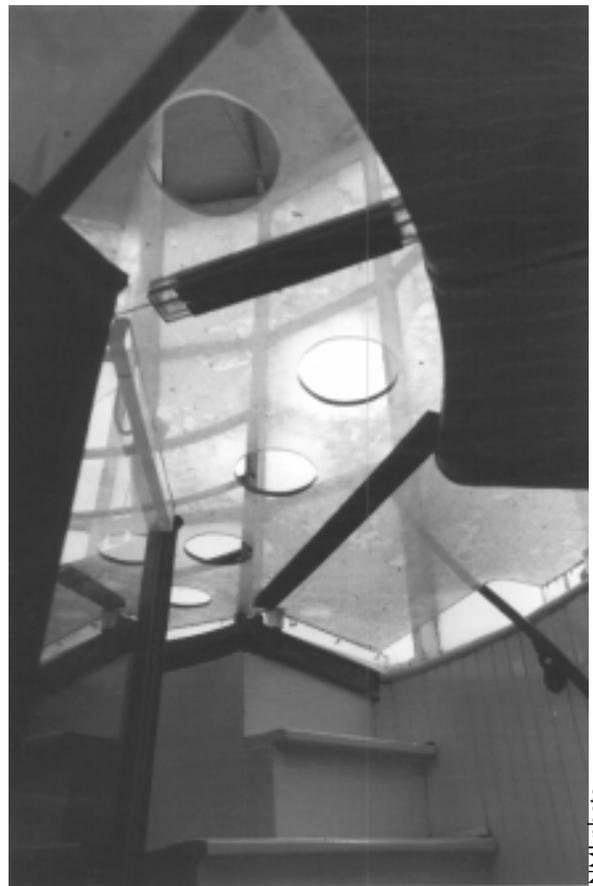
**Figure 24.** Visitors are prohibited from the Barnegat Lighthouse's lantern room; however, they can view it from the watch room through plexiglas sheets. While these protective sheets prevent access to the lantern room, they do collect dust and need periodic cleaning. In other lighthouses, a person is stationed in the watch room to prohibit access to the lantern room as well as control visitor behavior.

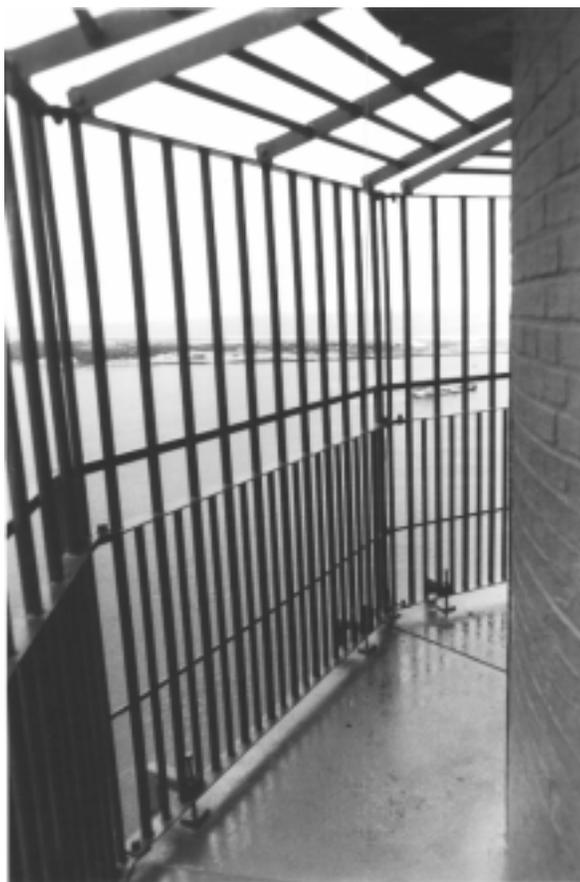
**Figure 25.** To protect visitors from falling or jumping from a lighthouse tower, a safety railing system or ‘cage’ is often built around the gallery decks. The cage at Barnegat Lighthouse was designed so that it has minimal impact on the historic structure and can be removed with little, if any, damage to the original fabric. Note that the cage is also enclosed to prevent climbing over the top.

method used by many lighthouse groups is to build a metal cage that fits around the gallery deck. The maximum space between pickets should be no more than four inches (BOCA, Building Officials & Code Administrators, International). The pickets need to completely extend to a structural element above or bend back to the tower/lantern wall so no one, even if deliberately climbing, could get over the top. One lighthouse suicide in 1995 was accomplished by climbing between overhead cage pickets with 9-inch spacing. Cages can be designed so they are attached reversibly to light towers without doing any permanent damage to the historic fabric of the structure.

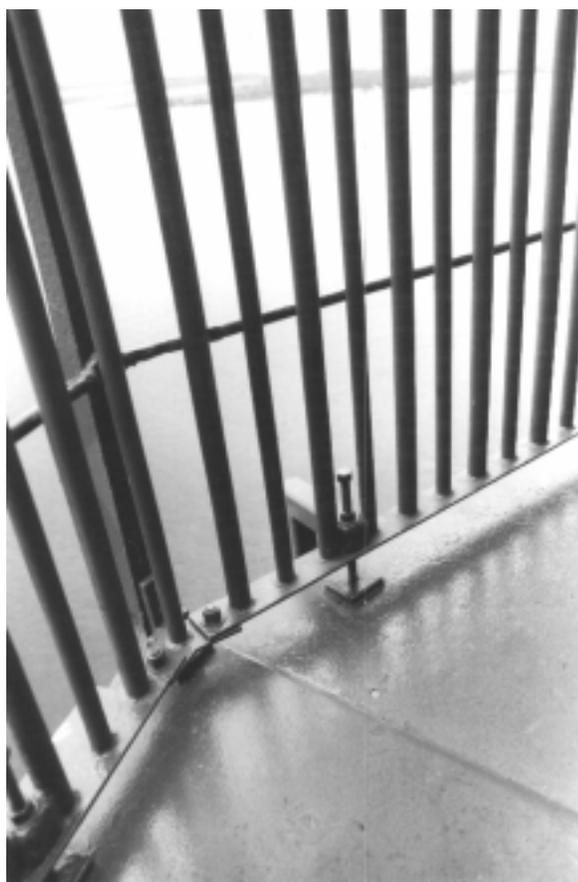
**Figure 26.** Note how the cage is clamped to the gallery deck, minimizing any impact on the structure's original fabric.
